## EXAMPLE BUILDING DAMAGE CAUSED BY MINING EXPLOITATION IN DISTURBED ROCK MASS

LUCYNA FLORKOWSKA

The Strata Mechanics Research Institute of the Polish Academy of Sciences,  
ul. W. Reymonta 27, 30-059 Kraków, Poland.

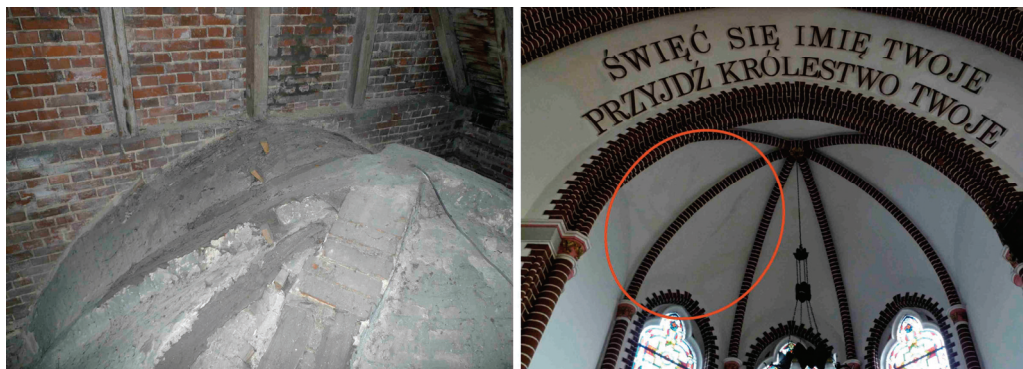
Fig. 8. Repair work done to top and bottom surfaces of vaults

levels. Despite repairs and reinforcements fitted to church building, new damage occurred on a regular basis. It was predominantly cracking vaults – repaired several times through wedging and cementation at first. In recent years, epoxy resin packing materials were used (Fig. 8). Cracked walls were also repaired, as was damaged floor. Stained glass windows were replaced – mining damage.

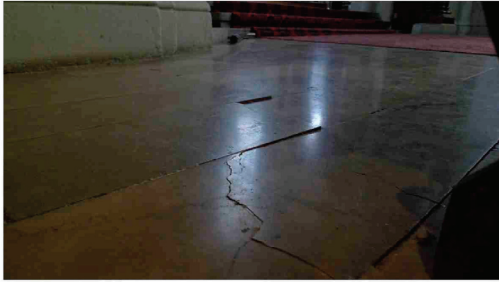
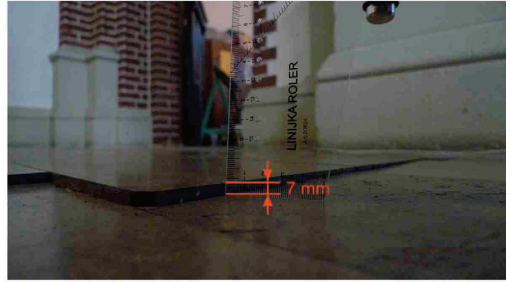
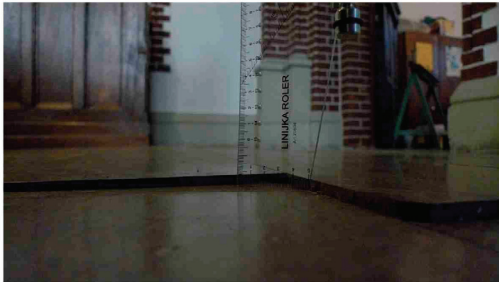
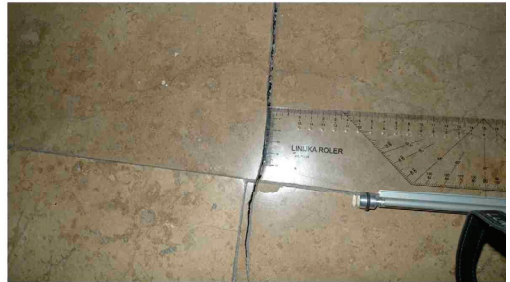
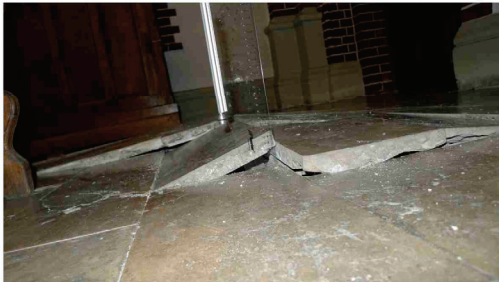
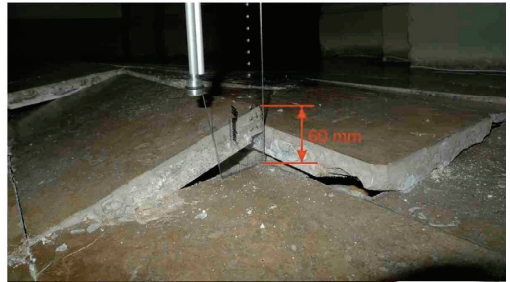
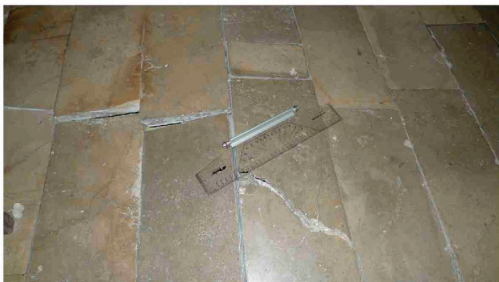
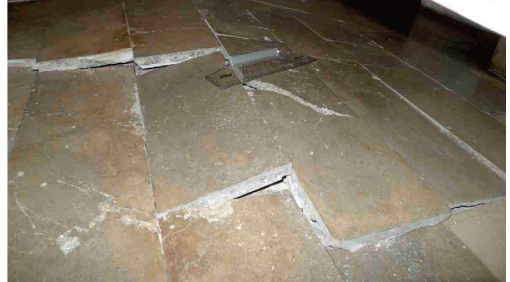
the state prior to December 9, 2012 (fot. 02-12-2011 r.)

the state after 9 December 2012 (fot. 5-01-2012 r.)

Fig. 9. Damaged church floor

the longwall 18a/bed 510wd is being mined, which progresses from South to North. Despite longwall face being beyond the reach of major influences (as on January 2012), both the building and its surrounding show worrying deformation and damage. The church's floor made of stone plates became unevenly deformed. There are considerable floor bulges in the aisle located in the Northern part of the church. Evident were also cracks and vertical displacements of tiles. The condition of the building significantly worsened as of 9 December 2011, when the floor abruptly elevated and shattered with acoustic effects accompanying. Figure 9 illustrates a comparison between the state of the floor from 2 December when property condition was surveyed and its state after the abrupt event.

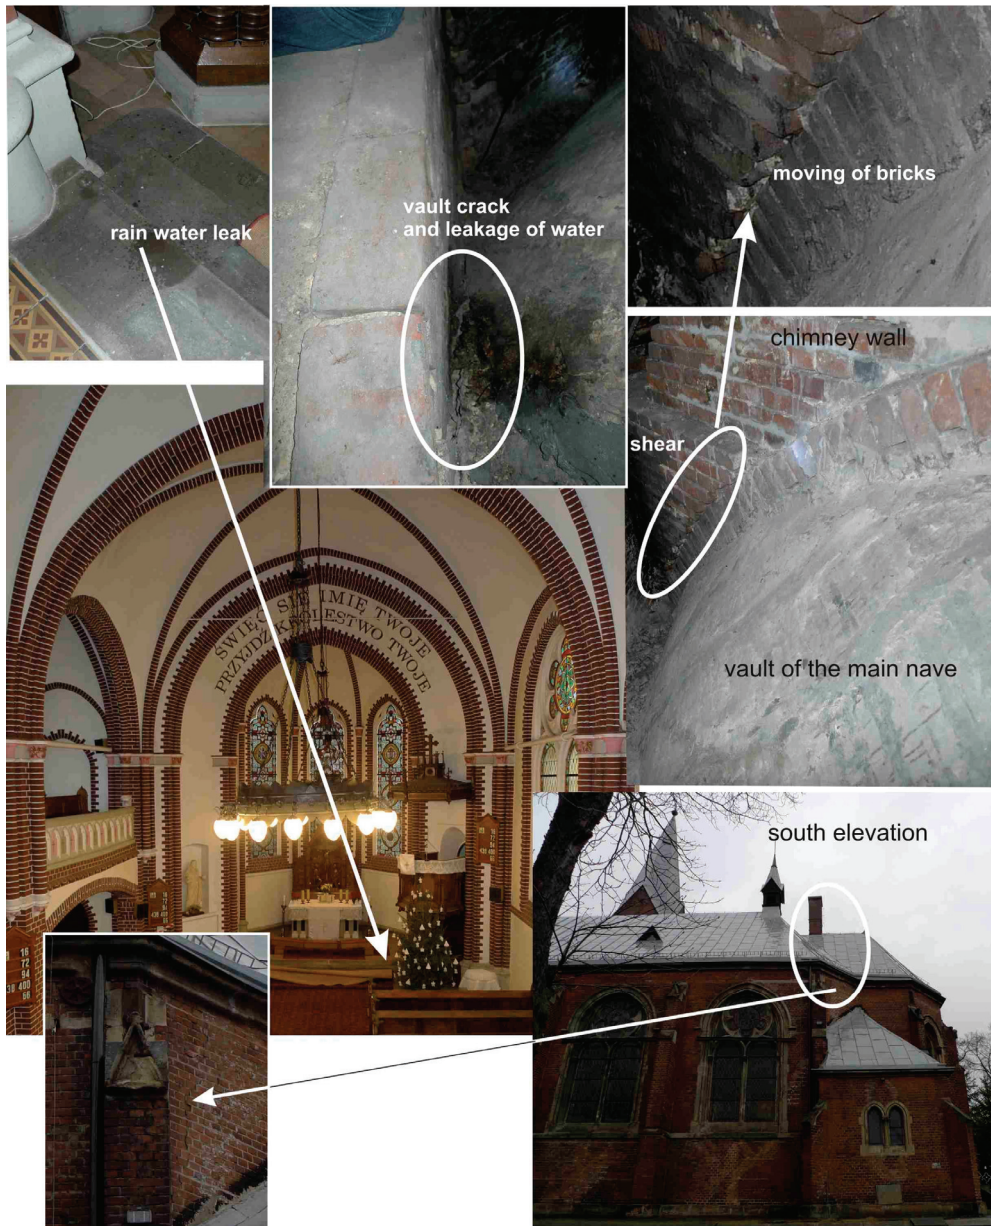
Fig. 10. Damaged vaults and crosswall of the church

Because mining exploitation is still taking place nearby the church, the structure sustains damage on an ongoing basis. Due to excavation of longwall 72a/bed 507wd, the structure became located in the zone of permanent surface deformation. Currently

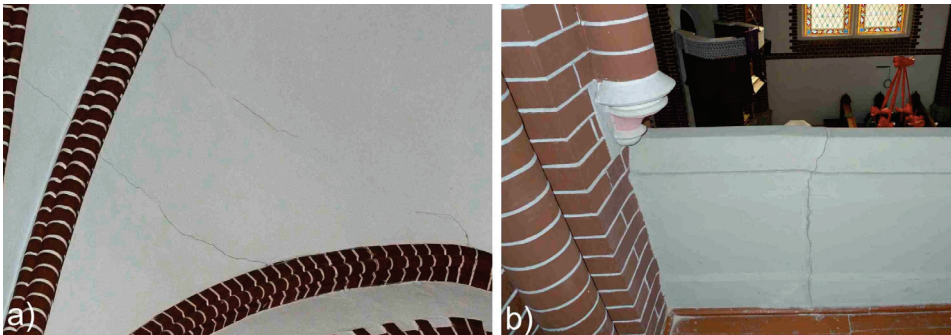
Cracks in the floor have also surfaced in other parts of the church. The crevice above the alter becomes ever-more evident. The line demarcating change in the slope of church's body also runs through that point. Said line seems "broken" along the wall parting presbytery and main nave. Vast cracks in the vault are also visible there, which lately (about 5 January 2012) increased enough for the rain water to leak in and drip on the altar's steps. This is indicative of sheet metal roof also becoming damaged. Figure 10 illustrates said damage. The stack partition, which is under shear stress becomes alarmingly deformed. The photograph shows major displacement of bricks composing stack partition, both in the loft and exterior wall – Southern elevation.

Fig. 11. Damage sustained by the church: (a) cracks in vault above main nave, (b) cracks in choir loft

Apart from the aforementioned, the entire church is riddled with numerous cracks both in church's vaults and walls. Figure 11 illustrates a selection of places, where damage surfaced: main nave's vault cracks and cracks in choir loft's parapet, located in the aisle.

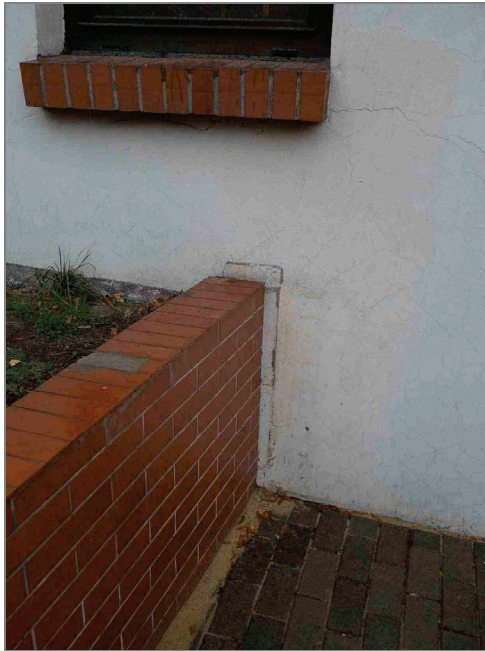
years. Figure 12 shows displacement of small wall's curvature, illustrating surface deformation. Figure 13 illustrates crack in the exterior wall near the South-East corner of the structure.

Fig. 12. Displacement of the building illustrated by original location of retaining wall

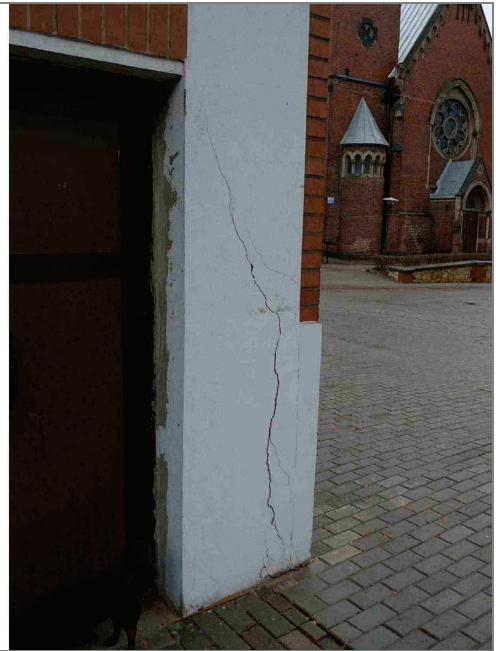
Fig. 13. Cracked wall near South-West corner of the Nursing Home

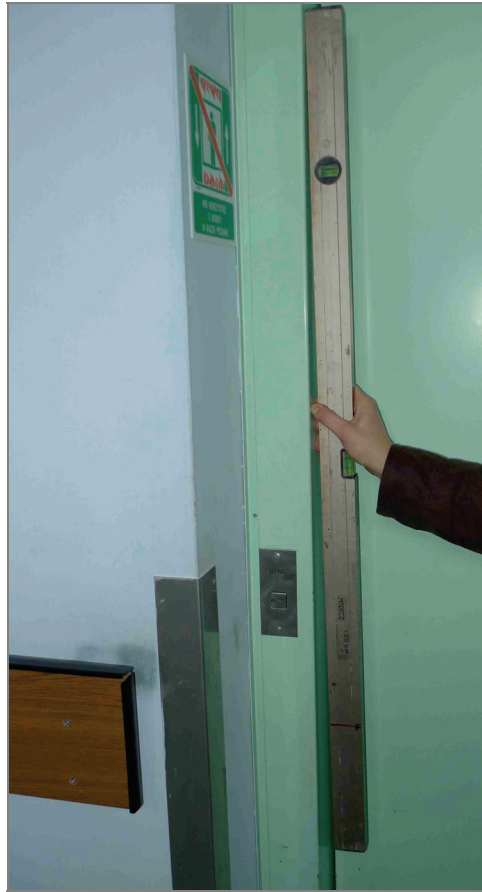
The tilted body of the building makes it difficult to use it. Moreover, due to specific function of the building, even the slightest ignorable for healthy individuals slope of the floor is spawning issues. According to the measurements that were made in August 2012 the tilt of the building is 1.6% in the southern part and more than 3% in the northern part. Significant vertical tilt hampers using the lift (Fig. 14). Substantial cracks in segment joints are visible (Fig. 15). Due to displacements of walls and ceilings, also deformed became sanitary and heating infrastructures. Figure 16 illustrates a pipe indented caused by pressure of wall, which had to be removed to prevent major damage to the installation. Similar situation is illustrated in Fig. 17, where apart from indent pipes and need to wall cutting, deformation of vertical segment of the pipe is shown.

Fig. 14. Vertical tilt of lift shaft

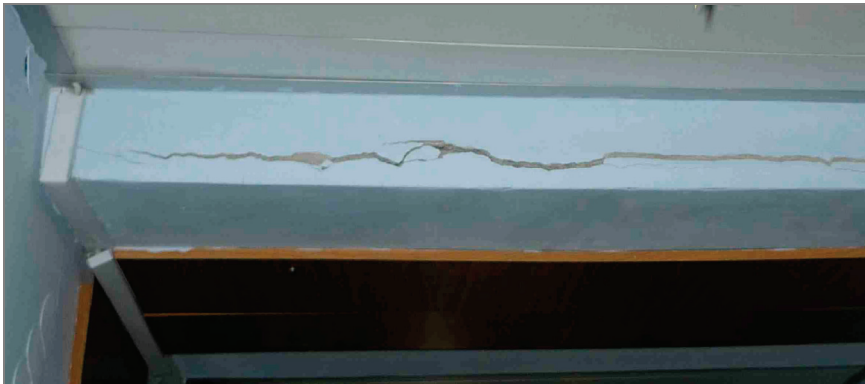
Fig. 15. Crack in places of dilation between building's segments

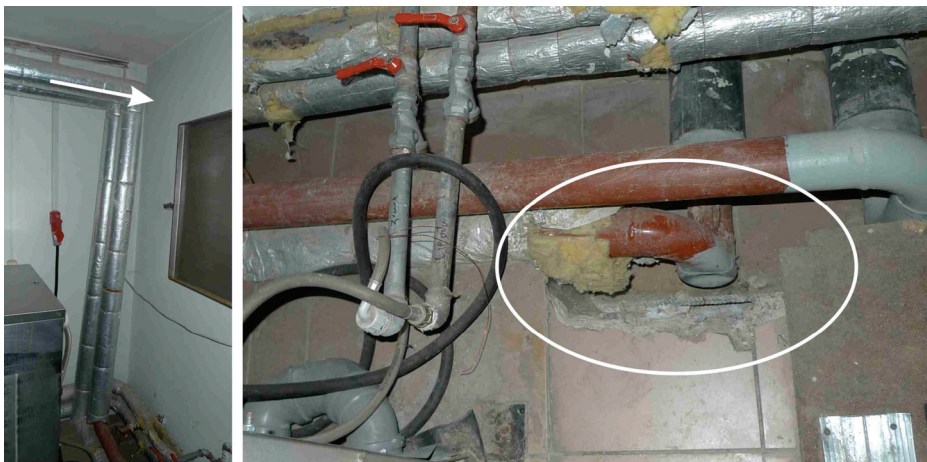
Fig. 17. NH laundry room. Visibly bent pipes and incuts made to protect the piping from damage
