The Consequences of Non-Uniform Founding of Concrete Tank in Weak Wet Subsoil

Abstract: The article presents problem of non-uniform foundation of structures in weak wet subsoil. The problem is illustrated with the case study of two-chamber-reinforced concrete water tank constructed in 1920s of 20th century, which cracked during construction. Under part of foundation, where the peat was found, the concrete piles were introduced.

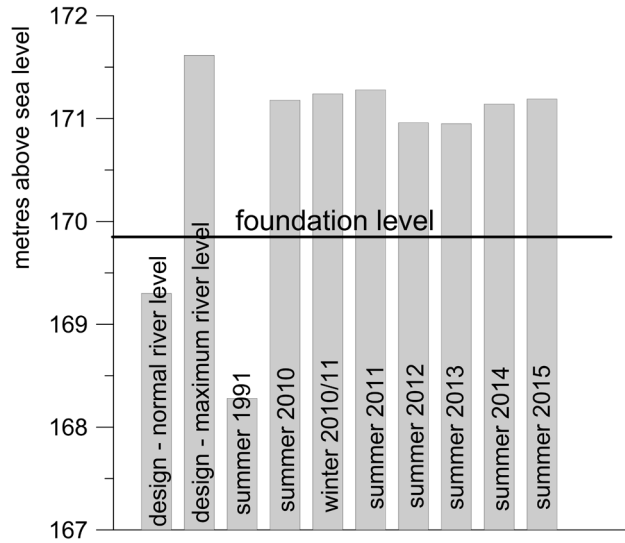
The underground water level has changed since the years. During geotechnical testing in 1991, the underground water level was stabilised from 167.27 up to 168.29 m above sea level. Therefore, it was more than 1 m lower than that of tank foundation. Meanwhile, in 2000, in the place of bottom slab depression inside the tank, two holes were found, from which the water came out to the surface under pressure. This indicated the rise of underground water level. What is more, the water appeared in the adjacent pump station, also proving the underground water level rise. In the spring of 2010, the owner started the piezometric measurement of underground water level (Fig. 5).

Figure 5: The levels of underground water in relation to foundation level: the water in the river in accordance to design drawings (normal and maximum) and the water level found nowadays (maximum).

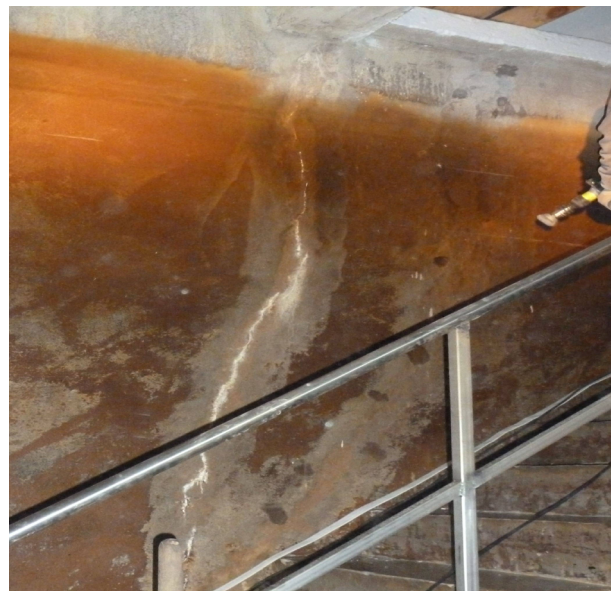
Figure 6: The exemplifying crack with salting out in the longitudinal partition wall.

Several cracks were repaired. The most of them remains closed, but in some of them, in the longitudinal partition wall, the secondary cracking and salting out appeared.

allowed but the repair works were recommended. The injection of cracks with elastic material dedicated for open movable cracks was recommended. This ensures the tank water tightness as well as further movement of separated parts in relation to each other without waterproofness loss.

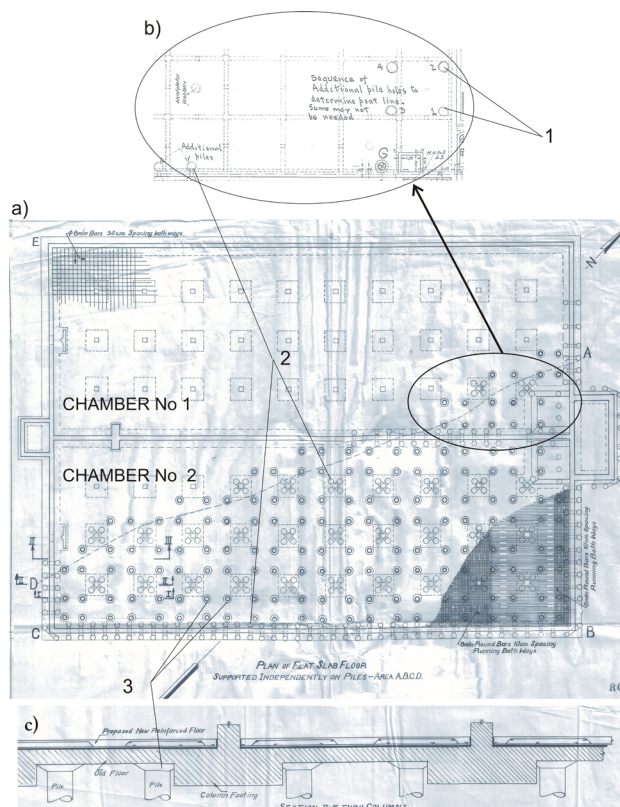
The troubles concerning the tank foundation occurred during its construction yet. The evidence of these troubles constitutes the handwritten remarks made with pencil on the original design drawing (Fig. 8b). In the chamber No. 1 next to the transverse north-east wall, the circles were drawn and described as follows: *‘sequence of additional pile holes to determine peat line. Some may not be needed’* (notation ‘1’ in Fig. 8b). There was, most likely, the program of additional geotechnical testing. In the town archives, there is information that *‘the tank was built without tentative tests, and as the consequence the tank settled demonstrating cracks’* [8]. The next hand-drawn element nearby the longitudinal partition wall (notation ‘2’ in Fig. 8b) is described as *‘additional piles’*.

The above-mentioned handwritten remarks were made probably before concreting of the continuous walls foundation of chamber No. 2 (partition and outer wall) as well as the spot foundations and after finding out the peat in the excavation. In the original drawing of tank strengthening (Fig. 8a), the piles located on the both sides of the longitudinal walls making a pair and four piles crosswise connected under some spot foundations are present. It is not known what type of piles was designed. It can be supposed that there were timber piles, similar to that in the adjacent pumping station. Additional

Figure 8: Original design drawings concerning the tank strengthening [1]: (a) location of piles in the ABCD region, (b) hand-made remarks, (c) cross section of bottom slab with concrete piles; (1) location of holes planned for peat level determination, (2) ‘additional piles’ (probably timber piles), (3) concrete piles under foundation slab.

strengthening was executed probably after finishing the tank construction. It was written in the town archives that *‘there was a necessity to strengthen of the foundation with concrete piles’* [8]. In Figure 8a and 8c, the design sketch of this strengthening is quoted [1]. The piles were designed not under whole tank but only in the ABCD region – under chamber No. 2 and under small part of chamber No. 1. The

piles were located nearby the corners of spot foundations and a new bottom slab was supported on them (notation '3' in Fig. 8a and 8c).

Finally, on the basis of the analysis of Figure 8, it can be supposed that there are two types of piles under tank: piles made during construction under some foundations (probably timber piles) and concrete piles nearby the corners of some spot foundations supported the bottom slab. The tank owner and the experts preparing the previous technical assessments were not aware of existence of these piles.

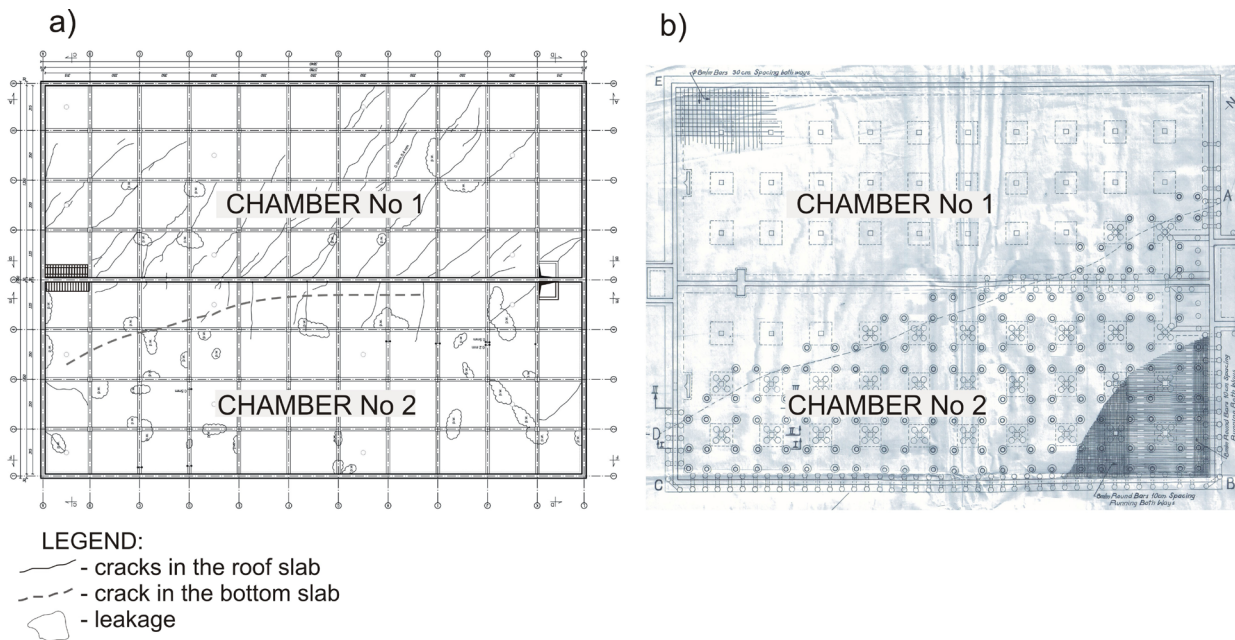
Figure 9: Crack pattern (a) versus region with piles (b).

The crack pattern indicates the reason of cracks, which is the non-uniform tank settlement. In Figure 9, the crack pattern is compared with the region, where piles were added. The cracks in roof slab and walls indicate the 'break' of tank as a consequence of non-uniform settlement and separation the part with piles from part without piles. This is confirmed by the crack in the bottom slab in chamber No. 2, which is almost in line with the piles region border and then runs along the edge of foundation of longitudinal partition wall.

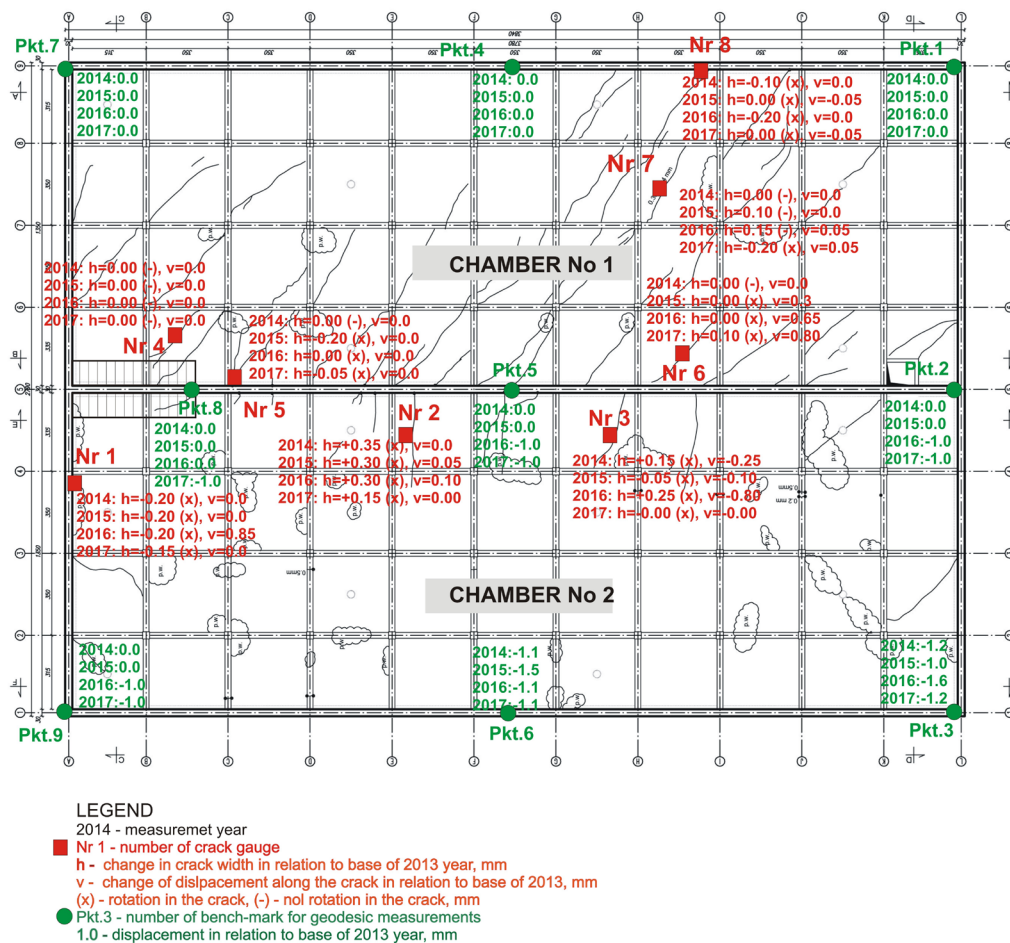
The crack width was measured with eight crack gauges allowing to assess the changes in crack width as well as displacement along the crack (Fig. 10). The location of the gauges is shown in Figure 11. The measurement results are shown here as well. An analysis of the data from Figure 11 indicates that the crack measured with gauge No. 4 in the chamber No. 1 is immovable. The remaining cracks in this chamber show little changes in width (up to 0.2 mm). They also show very little displacement along crack (up to 0.05 mm), except the gauge No. 6 fixed next to longitudinal partition wall in the region with piles. This gauge was found to get displaced along a crack of 0.85 mm between 2016 and 2017. The crack width in chamber No. 2 changed to a maximum of 0.30 mm. The displacement

Figure 11: The location of crack gauges and places of vertical displacement surveying and the measurement results in 2014–2017.

along crack was equal up to 0.25 mm, except the crack in the transverse south-west wall measured with gauge No. 1 (0.85 mm in 2016).

The results of crack width measurement may be recapitulated as follows. The cracks, particularly cracks locating next to boundary of piles region, are not stabilised. Most intensive movement was observed in 2016. It is difficult, however, to compare their values to the measurement of underground water level, because piezometric tests were stopped in this year.

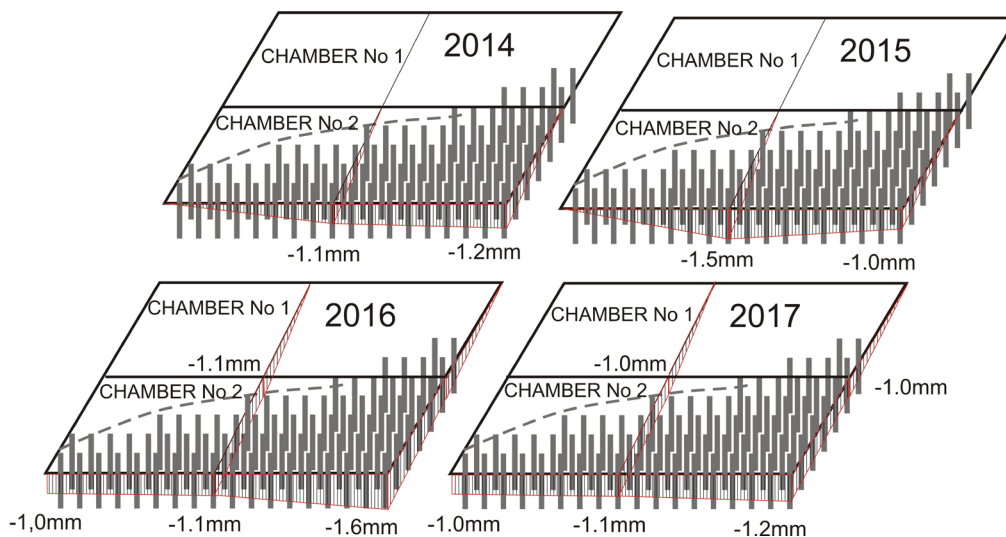
The results of tank vertical movement estimation may be recapitulated as follows. There is a trend of the vertical displacement of some controlled points in relation to the initial position. There are minor but clear changes. The changes in position of point No. 3, No. 6 and No. 9, located along the axis of the outer longitudinal wall, were revealed in all the measurements.

The five-year crack width measurement and vertical tank displacement surveying show that part of tank is not stable yet. The part of tank supported on the piles is subjected to minor but clear settlement. This is manifested by vertical displacement of walls in chamber No. 2 and changes in crack width.

Figure 14: Displacement of controlled points.
