Joanna M. Arszczyńska*

Marek R. Gogolin**

Church in Marianka by Pasłek. The results of analysis of the inner face of the walls carried out during research and conservation works on the mural paintings

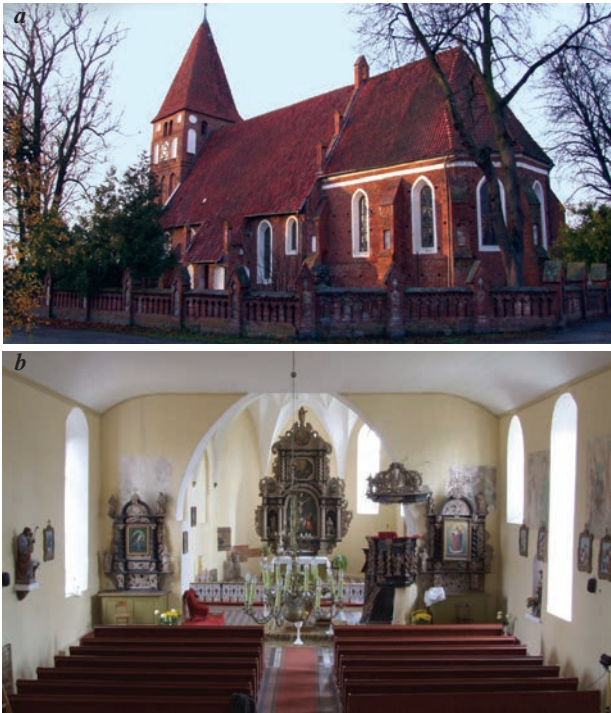
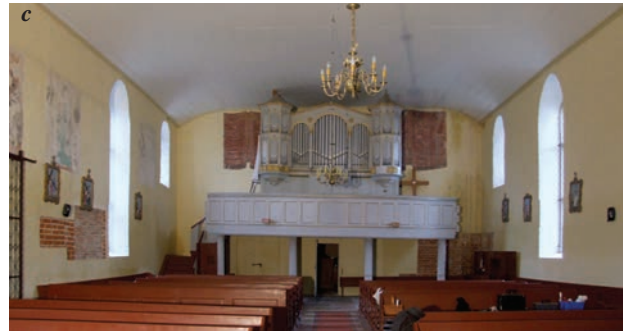
Fig. 1. Church in Marianka by Pasłęk: a) view from south-east, b) view of the interior towards east, before starting research and conservation works, c) view of the interior towards west, before starting research and conservation works (photo: J.M. Arszyńska)

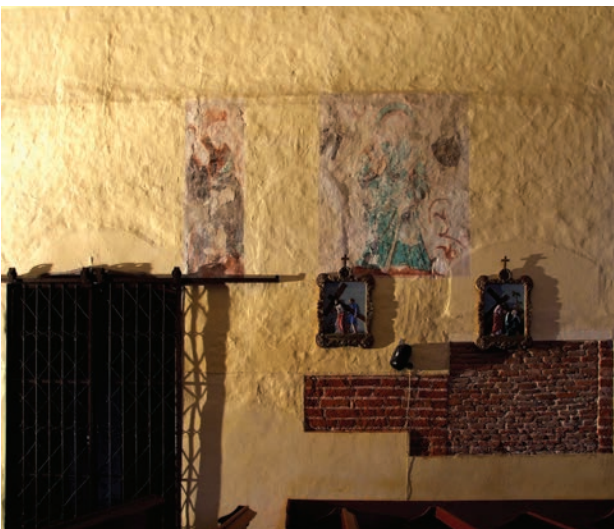
Fig. 2. Photograph of the inner face of the wall in raking light, a base for further analysis (detail of the south wall) (photo: J.M. Arszyńska)

First pieces of information on the occurrence of bricked-up recesses in the church walls have been obtained already during the initial research works carried out at the end of the year 2007, when – among others – an analysis of the nave walls in raking light was performed (Fig. 2) More information was collected during the mentioned above strip-sampling carried out in summer of 2008. At the end of 2008 and in summer of 2009, following the conservators' recommendations the secondary plastering – applied in the 1950's – along with a layer of bitumen insulation of lower section of the walls have been removed – except the west and east (rod) wall³. In result of those works the brick face of the lower part of walls has been revealed, which allowed to complement the information on the size, shape and location of the existing alterations and bricked-up recesses (both in the nave and in the choir). Subsequent information on the recesses has been collected during conservation works on mural paintings on the north wall of the nave initiated in summer of 2008. In that time the scene of the Ecstasy of Mary Magdalene has been revealed from under numerous secondary layers of white-wash and paint, as well as the boundaries of five recesses present in the east section of northern wall [3]. Two of them, accessible from ground level without any scaffolding have been next completely uncovered (i.e. emptied of secondary bricks), which allowed to measure their depth.

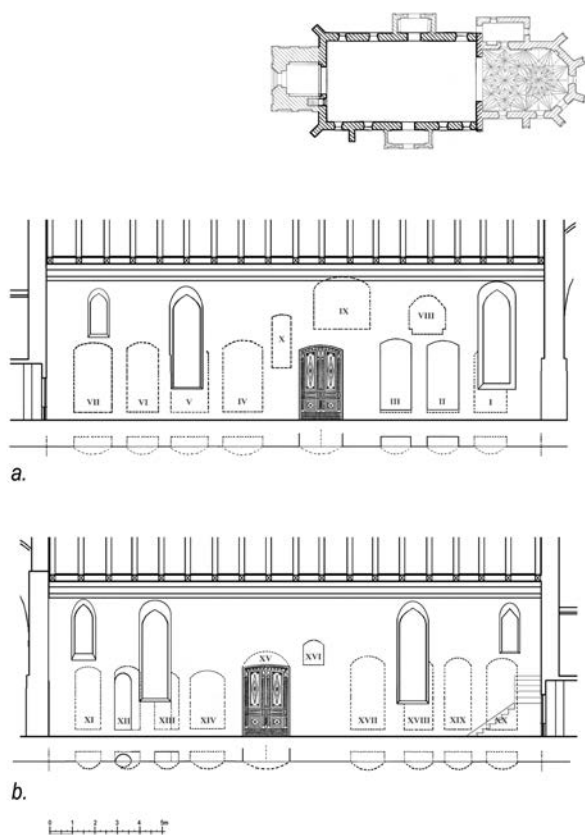
Fig. 3. Recesses in the church walls: a) south wall, b) north wall (drawn by M.R. Gogolin, J.M. Arszyńska)

In the south wall of the nave the location and extent of 9 large recesses have been traced (ca. 120–150 cm wide and ca. 200–300 cm high) in the bottom part of the wall (ca. 30 cm above the present floor level). Two of them (No. XIII and XVIII) are only partially preserved (damaged during enlarging the windows) and two (No. XII and XIII) have been at least two times altered and changed both their shape and dimensions. Moreover, in the upper part of the wall, in its central area one recess have been found (No. XVI), of much smaller size (ca. 100 × 100 cm). There is a secondary opening, in which a door leading to the south porch has been set in 19th cent., located in a large recess found in the middle section of the wall (No. XV). The original shape of the recess is marked by a characteristic, regular outline of the boundary of modern plaster patch above the door, on the level matching the upper edges of recesses located in the west section of the wall (Fig. 3a). Earlier, this recess contained much smaller, pointed arch opening, the remnants of which are traceable on the porch-side of the wall.

In the north wall of the nave the location and extent of 7 large recesses (ca. 150 cm wide and ca. 300 cm high) have been found in the bottom part of the wall (ca. 30 cm above the present floor level), including two only partially preserved (No. I and V – damaged in 19th cent. during enlarging the windows). Moreover, one smaller recess (No. VIII, ca. 150 × 150 cm) has been found in the upper part of the wall in its east section as well as two openings (No. IX and

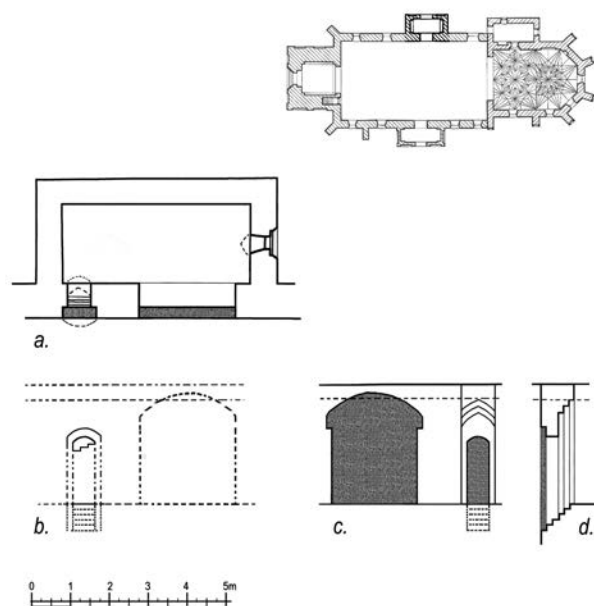
Fig. 4. Preliminary interpretation of the openings in the upper floor of north porch: a) throw on the level of discovered openings, b) view from the church side, c) view from the porch side, d) cross-section on the level of smaller opening (drawn by M.R. Gogolin, J.M. Arszyńska)

X), that used to connect the church with some room on the upper floor of the north porch (Fig. 3b and Fig. 4).

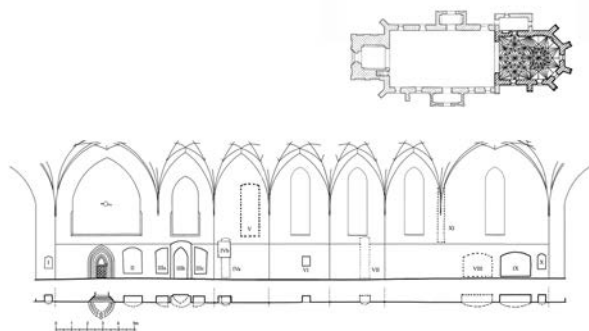
In the walls of the choir the location and extent of 11 recesses of various shape and dimensions have been traced. Some of them have been emptied off the secondary bricks. In the north part of rod wall (the choir side) one small recess (ca. 70 cm wide and 100 cm high) has been found. This is the only one that has originally been plastered inside. Directly on the plaster there are traces of quite long inscription executed in bright-red paint, unfortunately hardly readable. In the north wall of the choir, right of the vestry door there is one recess ca 120 cm wide and ca. 150 cm high. Further to the east a set of three recesses have been discovered. Their composition suggested, that they might have served as sedilia. The middle recess, ca. 120 cm wide and ca. 170 high (measured from the present, secondary floor level, the original profile reached much deeper) is closed – as the majority of others – with a segmental arch. Both side recesses, lower and narrower, each measuring ca. 80 cm. wide and ca. 120 cm. high (from the present floor level) end 30 cm. above the present floor level and are closed with half- segmental arches, sloping sidewise. After emptying those recesses off secondary bricks (summer 2009) it turned out, that inside the middle one there is next, somewhat narrower (ca. 100 cm. wide) and lower, pointed-

Fig. 5. Recesses in the walls of the choir (drawn by M.R. Gogolin, J.M. Arszyńska)

arched recess. A crevice in plaster along the brickwork filling the recess and its side wall suggested, that the bond between them is rather weak. This has been confirmed by a strip-sample, that revealed information indicating, that there was an opening in the choir wall. Its inner walls have been carefully plastered and its location and dimensions roughly match the location and dimensions of a bricked up, pointed-arched opening visible from the outside. This may suggest, that at the early stage of the church history, there was a vestry adjoining this section of the choir wall, probably erected in a not durable technology, that was later replaced by the present, brick-built one. After the inner opening was bricked-up, the remaining three recesses might have for some period serve as sedilia; later they have been closed and the inner face of the wall was smoothed.

In the next section of the choir wall (north-east) an elongated, narrow recess (No. IVa) has been discovered, completely bricked-up. In its upper part later another recess (No. IVb) has been made, to house a wooden sacarium with painted, figurative decoration, dated back to mid-15th century⁴. On the wall above the sacarium,

right of it, observation in raking light revealed an outline of another, large (ca. 120 × 320 cm) recess (No. V), closed with a segmental arch.

The east wall does not contain any original, medieval recesses. There is only one small, rectangular recess, housing the control board for the wiring, made probably in early 20th cent. In the lower part of the south-east wall there is a trace of bricked-up recess resembling that in north-east wall, however here it is not disturbed by further alterations. The upper end of this recess reaches the window level. In the south wall of the choir appear two large, quite low recesses, ca. 200 cm wide and ca. 150 high (from the floor level), as well as one small, resembling the above described small recess in the north section of rod wall.

In the south wall of the choir, below a console supporting the vaulting a narrow (38 cm) recess was found, ending at the level of 262 cm above the present floor level. Defining its function requires further research. If the presence of the same structures is confirmed in proximity of other supports of the vault, one will be entitled to draw a theory, that there was some other conception of vaulting planned at the stage of building the walls, finally not executed (Fig. 5).
