Ewa Łużyniecka *

Architectural examinations of the parish church in Dobrzyki

Description of examinations

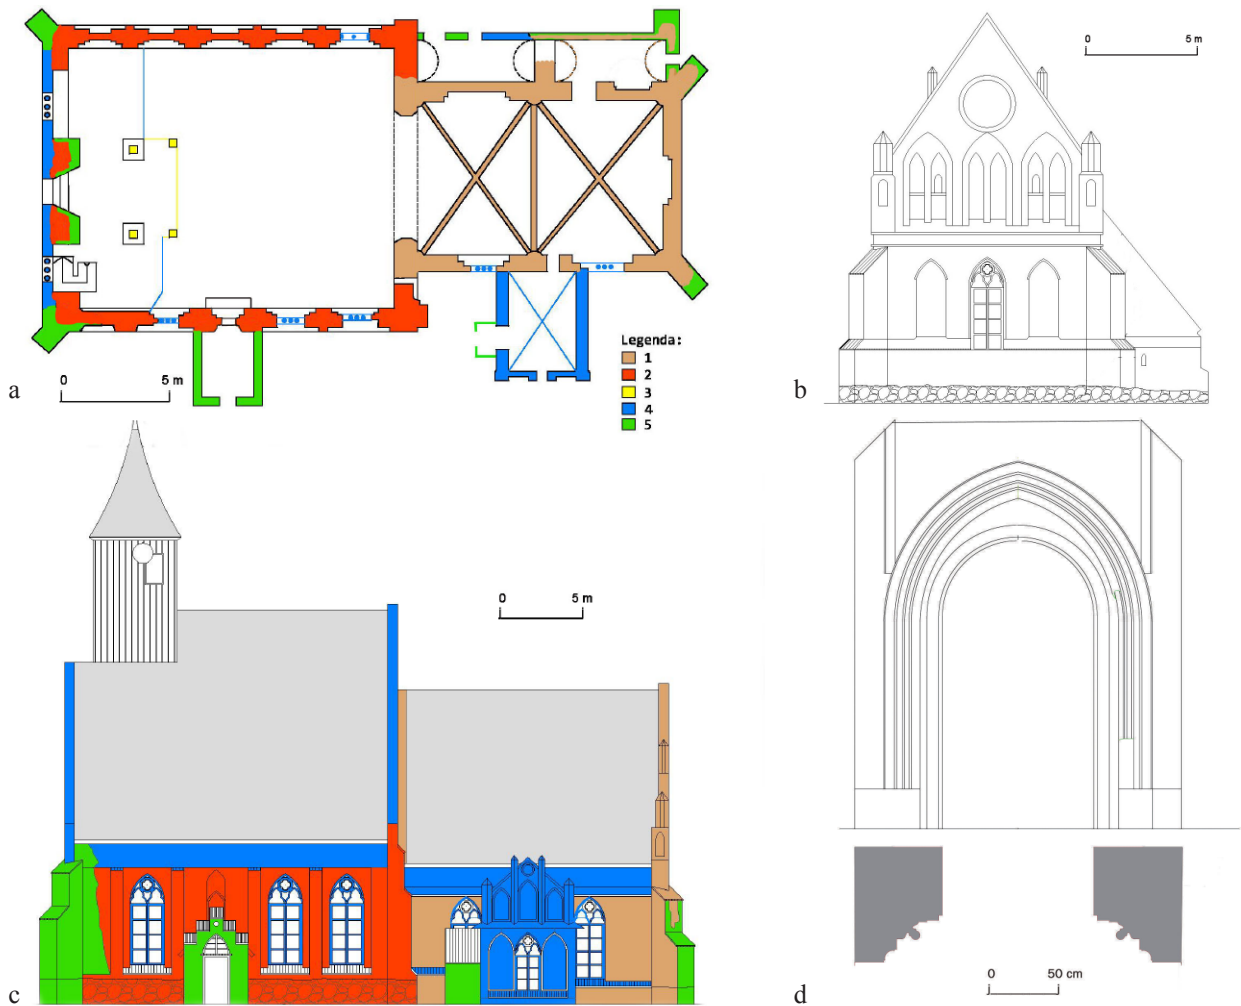
The church in Dobrzyki is now a building 29.90 m long, which consists of the chancel with the dimensions 11.90 × 7.0 m and by the name with the projection dimensions 18.0 m × 13.70 m. An additional element of the building is its northern extension as well as the porch built in the south and the sacristy. The church is not built homogeneously and formal and technological differences of particular parts of the construction allowed us to distinguish five main building phases (Fig. 2).

Fig. 2. Dating suggestions and measurements of the particular parts of the church: a) projection; b) eastern façade; c) southern façade; d) southern portal; 1. beginning of the 14th century; 2. first part of the 14th century; 3. circa 1776; 4. circa 1864; 5. circa 1910 (by ZWAPWr)

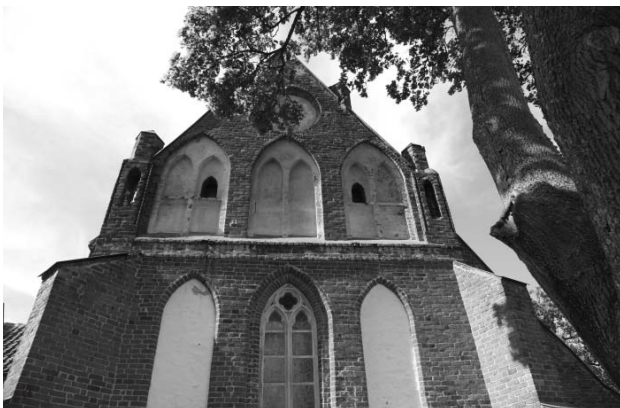
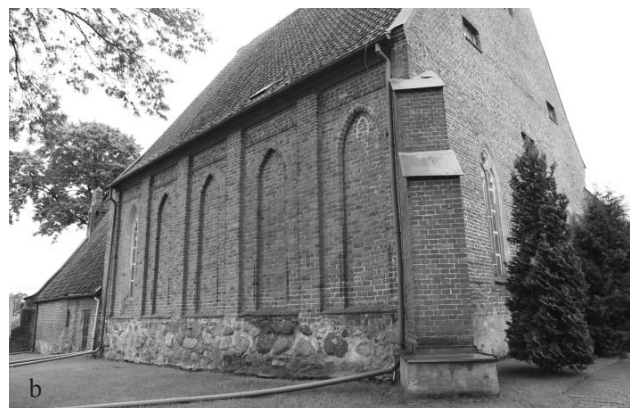
Fig. 3. Church façades; a) eastern of the presbytery; b) northern of the nave, 2010 (photo: E. Łuzyniecka)

while in the northern façade there are arcade blind windows of the same size. Façades were additionally segmented – between gothic arches vertical ledges (German: *lisene*) were placed and along with cornices they form a frame system (Fig. 3b)

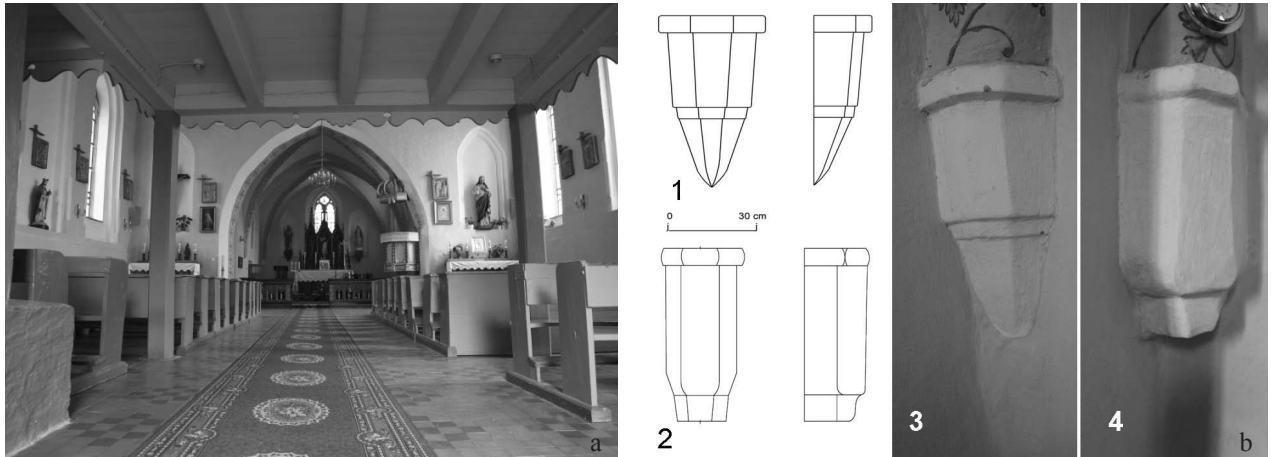
Fig. 4. Church interior: a) nave and presbytery ; b) cantilevers in the presbytery: 1, 3 north-east; 2, 4 north-west, 2010 (photo: E. Łuzyniecka)
 Il. 4. Wnętrze kościoła: a) nawa i prezbiterium; b) wsporniki w prezbiterium: 1, 3 północno-wschodni; 2, 4 północno-zachodni, 2010 (fot. E. Łuzyniecka)

The nave interior was covered by the ceiling from the beginning but we are not sure whether the present ceiling, which is painted from the bottom, is also original. We do not know whether the present form of the rood arch is authentic and if it was not changed during further repair works (Fig. 4).

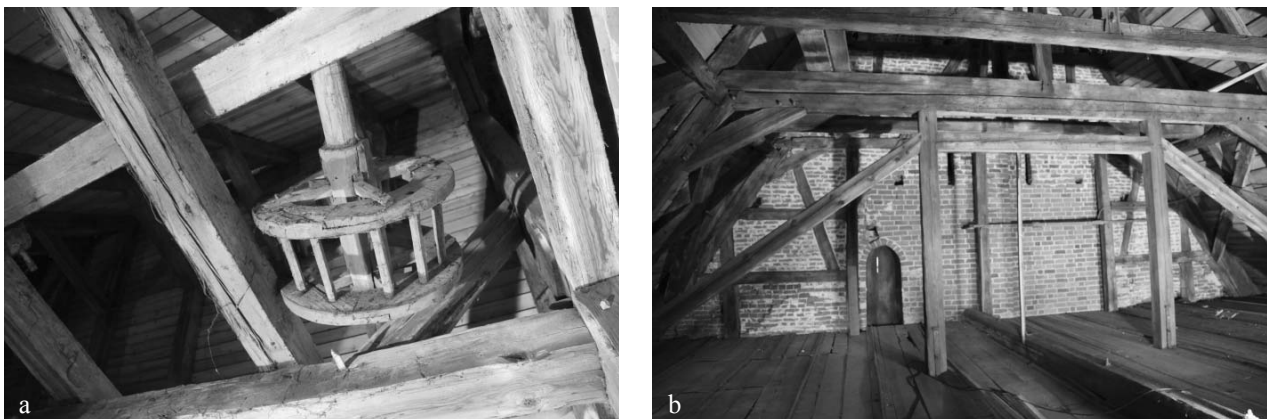
Fig. 5. Church attics: a) near the construction crane in presbytery; b) nave, 2010 (photo: E. Łuzyniecka)
 Il. 5. Strychy kościoła: a) koło dźwigu budowlanego w prezbiterium; b) nawa, 2010 (fot. E. Łuzyniecka)

ported by four columns which reach the ceiling. It is possible that in this period the wooden roof framing of the nave was built, which was based on the built up eastern top with timber framing (Fig. 5). Probably the pulpit also dates from the Baroque times. We can also assume that at that time the sacristy interior was extended to the west direction. However, in order to confirm this thesis some additional examinations are necessary.

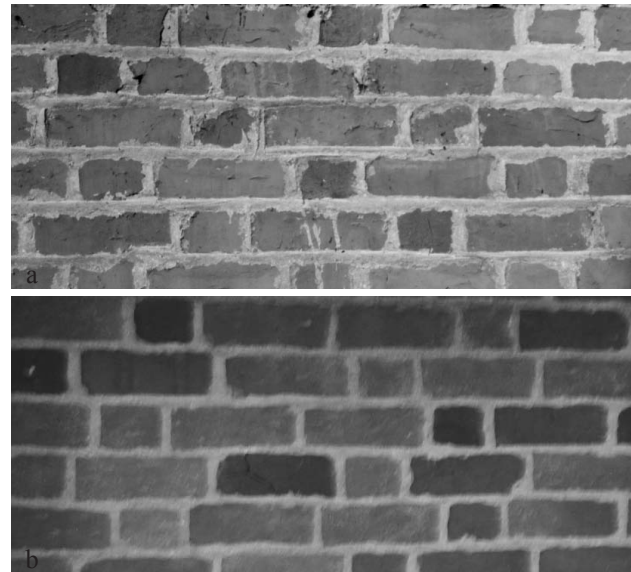
Fig. 7. Brick arrangement in gable between nave and presbytery; fronts: a) eastern, b) western, 2010 (photo: E. Łużyniecka)

ticular often appears in southern Poland, is considered to be earlier than the gothic one. In the case of the church in Dobrzyki both techniques of placing the building material were used at the same time. The top, which separates the nave attics from the chancel, constitutes the proof of this. The eastern face of the top was built of bricks with the gothic arrangement, while the western front – with the Vedic arrangement (Fig. 7).
