Conservation studies of the ruins of the Gothic Kazimierz castle (2nd half of the 14th century) in Koło (Gozdów)

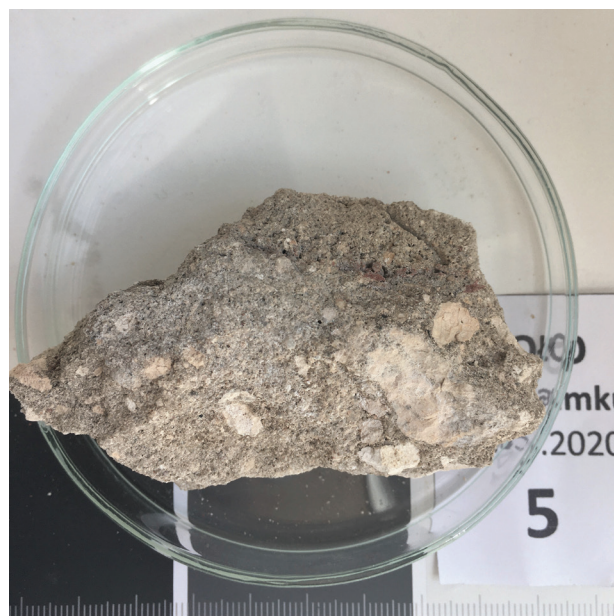
The original mortars assigned to phases I and II of the castle erection exhibit similar petrographic characteristics (Fig. 3). The composition of the grain skeleton of all samples is dominated by quartz, while feldspars and rock grains are rare. Accessory components are represented by amphibole and opaque minerals. The morphology of grains in all samples is similar. The grains are similar in size, do not exceed 1.0–1.2 mm, and exhibit a good and very good roundness. Very fine aggregates, with a diameter below 0.5 mm, dominate (Table 2).

Fig. 3. Castle in Kolo. An exemplary sample of medieval mortar (elaborated by K. Witkowska, 2020)

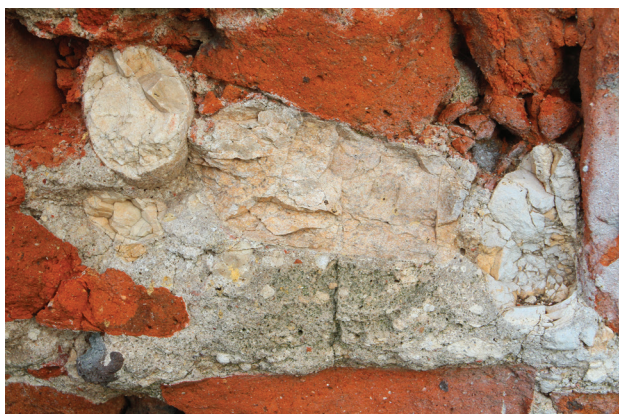
Fig. 4. Castle in Koło. Close-up of the mortar in the joint with visible fragments of calcined limestone (photo by K. Polak, 2020)

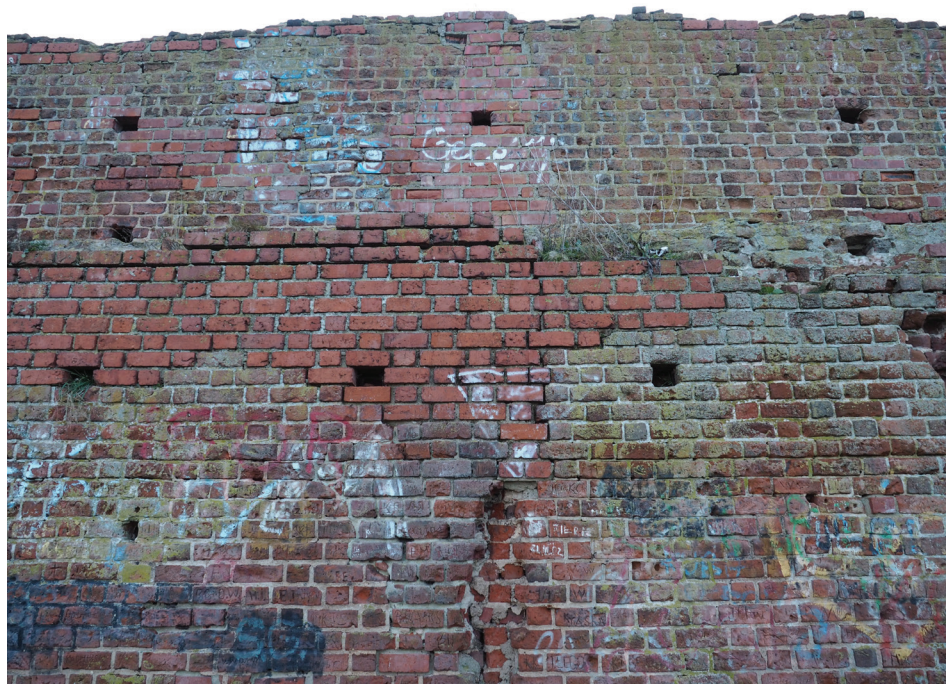
Fig. 6. Castle in Koło. The inner side of the western wall with numerous graffiti and complemented bricks on the wall face. The softly ending crown of the breast wall is noteworthy (photo by K. Witkowska, 2020)

Graffiti as well as numerous signatures and initials engraved in bricks, especially numerous on the walls from the side of the courtyard, should be mentioned as another damage that did not significantly affect the state of preservation, but negatively changed the appearance of the wall (Fig. 6). The painted inscriptions disturb the perception of the monument and, despite a certain cultural value, should be treated as an act of vandalism and removed.

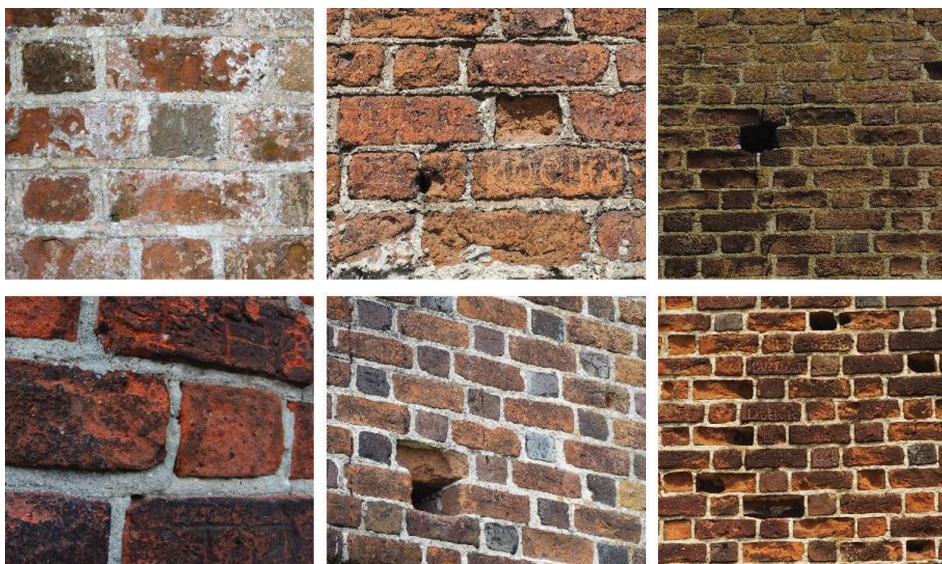
A major conservation and restoration problem is the state of preservation of the bricks (Fig. 7). Most of their face has not been preserved. Its destruction is most often the result of washing out or shedding of the surface layer. In many places, the cavities form depressions and niches, sometimes covering the entire volume of the brick. They are visible from a distance as soft-edged cavities. It has been assumed in the literature that this type of damage is associated with the presence of nitrifying bacteria, which, as a result of metabolism, produce acids capable of decomposing rock-forming minerals (aluminosilicates in this case). Damage initiated by bacteria is magnified and intensified by the action of other factors, e.g., wind. The conducted microbiological tests did not confirm the excessive content of nitrifying bacteria on the surface of the damaged bricks⁹, but their slow and long-term effect is possible.

Fig. 7. Castle in Koło. Examples of the state of preservation of the medieval face of the wall (photo by K. Polak, 2020)

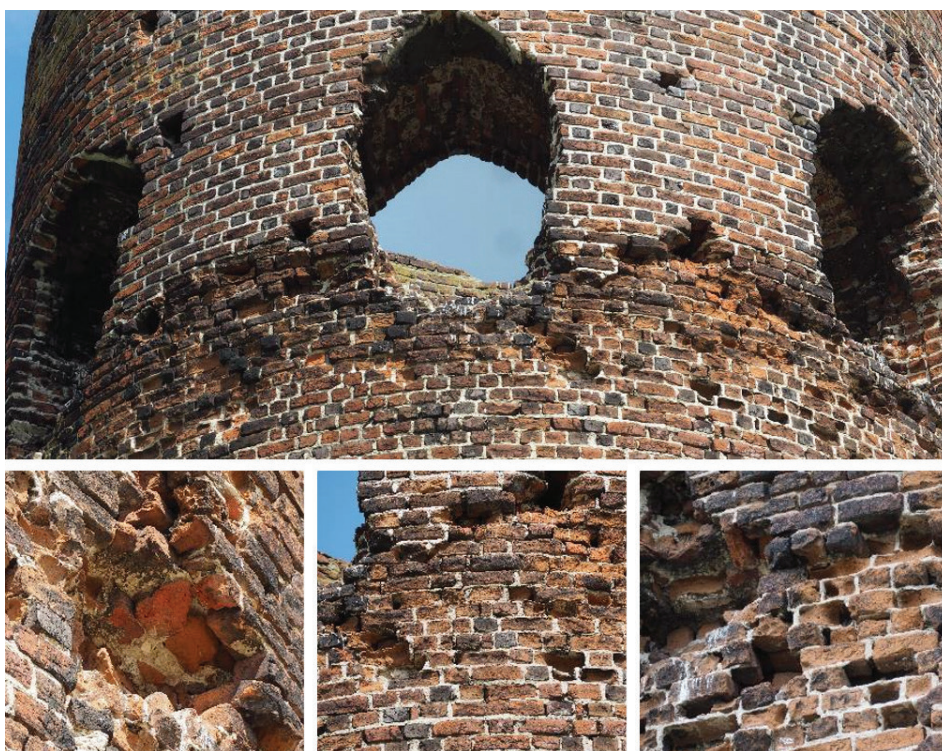
Shreds, forging and similar places are in destruct condition. These areas are dominated by damaged, irregularly cracked and crumbled bricks bonded with mortar that is crumbled, uneven, with many depressions, voids, etc. (Fig. 8).

Fig. 8. Castle in Koło. Examples of the state of preservation of the tower walls (photo by K. Polak, 2020)

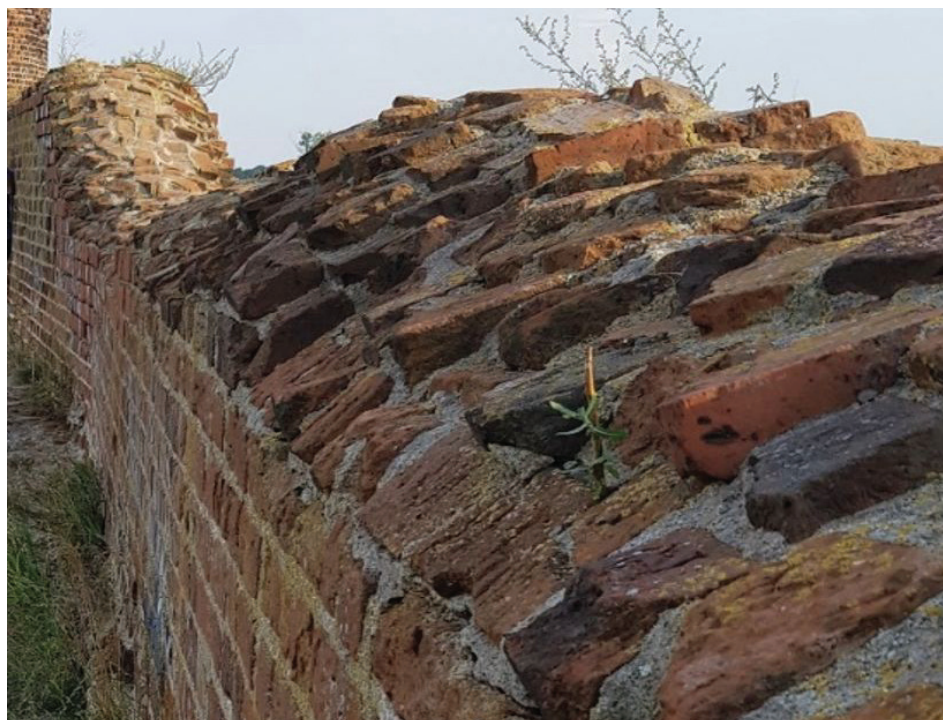
Fig. 9. Castle in Koło.
The crown of the breastwork
softly prepared during renovation
works in the 20th century
(photo by K. Witkowska, 2020)

During the last renovations, the planes of the crown of the walls were protected with a covering of bricks laid on the damaged crown without levelling the layers, which resulted in its plastic shape (Fig. 9). While the contemporary roofing on the crowns is mostly completely preserved, the pavements have missing bricks in many places, especially on the edges, where the inside of the wall structure is exposed. Apart from natural factors, the destruction of the covers is facilitated by walking on the pavements and the tops of the walls. The places of climbing are also on the tromps on the tower. Their bevels were covered with a layer of mortar to protect the surface from water and stabilize the damaged bricks. Currently, due to cracks and mortar losses, the covers do not have a protective function. The formation of cracks, hollows and voids is conducive to the colonization of these places by vegetation, which is a reason for large numbers of various plant species growing on pavements, caps and slanted and horizontal places with an exposed structure.

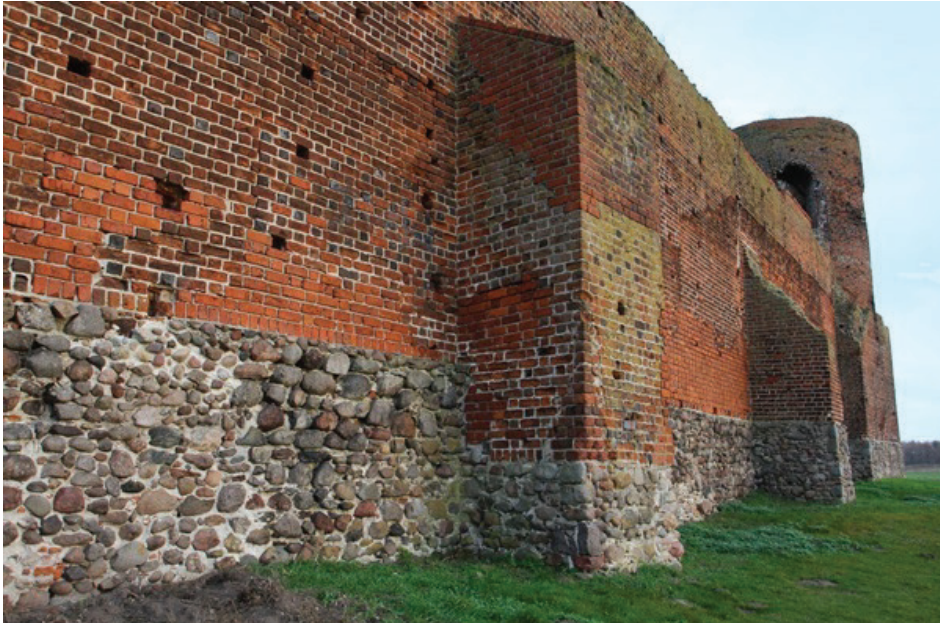
Most of the face of the stone wall (Fig. 10) was classified as repairs and additions. They are locally covered with microbial layers and graffiti. The mortars in the joints are preserved in various condition, due to various composition of the mortar and their technique of preparing. The mortar is washed out in many places. Some of the restorations do not meet the basic restoration requirements due to the accidental selection of the material, careless, unprofessional surface treatment and incorrect parameters of the applied mortar.

Fig. 10. Castle in Koło.
A fragment of the outer façade of the west wall
– visible extensive restorations of brick and stone faces as well as microbiological layers
(photo by A. Gralińska-Grubecka, 2020)
