Interpretation of traces of hypothetical quincha walls in Samaipata

Introduction – the site and the scope of work

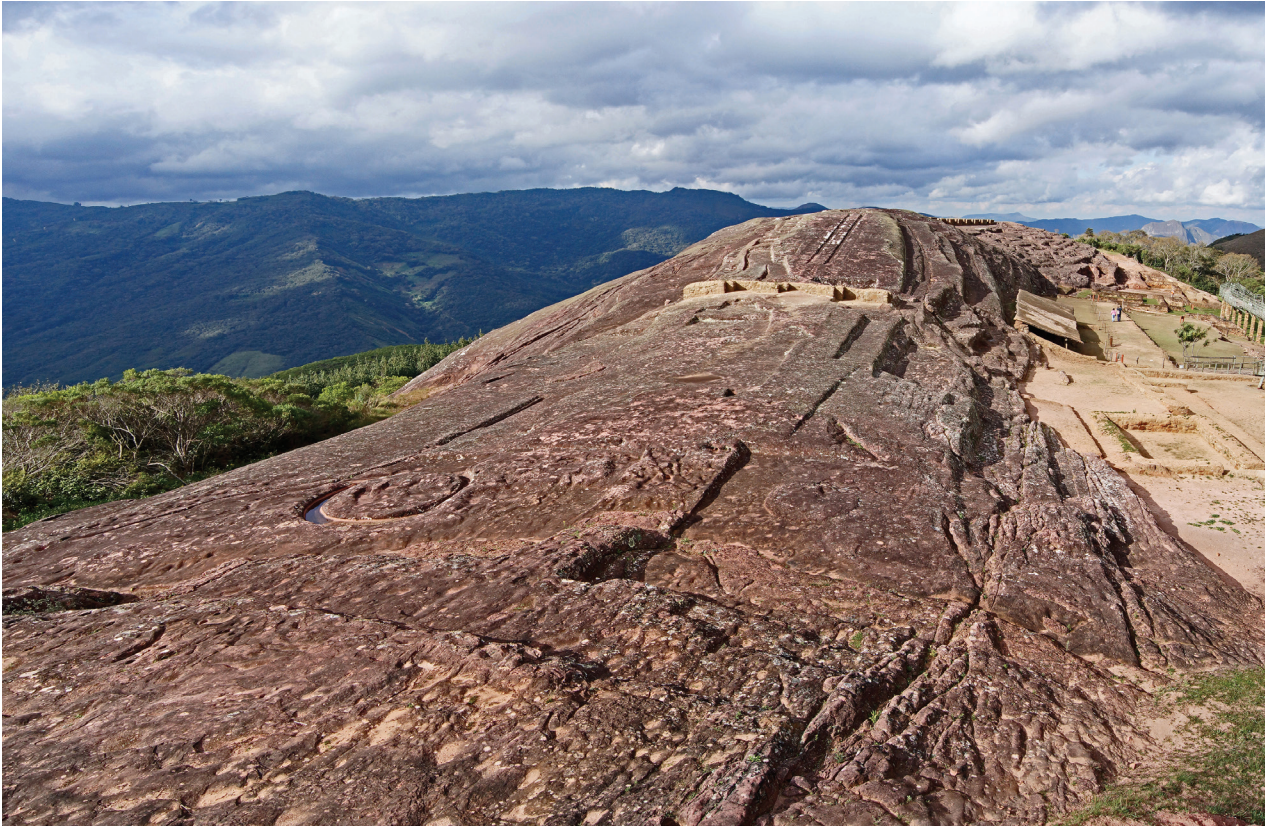
Fig. 1. El Fuerte de Samaipata, as seen from the west
(photo by J. Kościuk)

For more than two centuries, the site has attracted scholarly attention [1]–[4], mainly due to the unique scale and density of decorations covering the natural rock. These decorations include not only multiple terraces, platforms, and water reservoirs, but also many figural and geometrical petroglyphs, all of them arranged in a very complicated layout (Fig. 1).

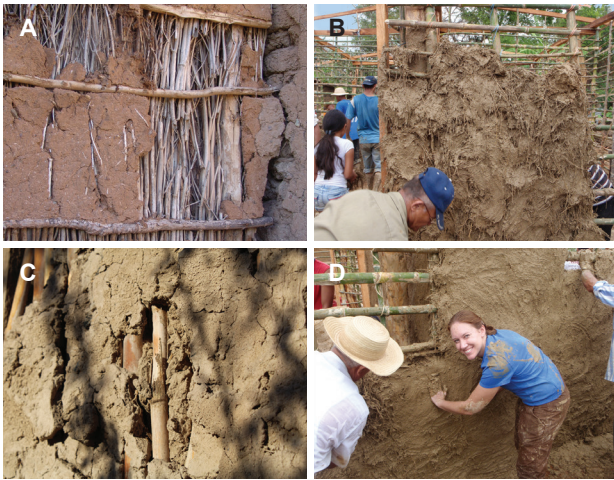
Fig. 5. Contemporary examples of traditional *quincha* walls (sources: A – <https://urbanscrawldc.files.wordpress.com/2014/07/dsc09652.jpg>; B – <https://www.revistatierracultah.cl/?p=12501>; C – <https://killpackpanamania.files.wordpress.com/2011/06/p4080190.jpg>; D – <https://killpackpanamania.files.wordpress.com/2011/06/p4080227.jpg> [accessed: 17.12.2017])

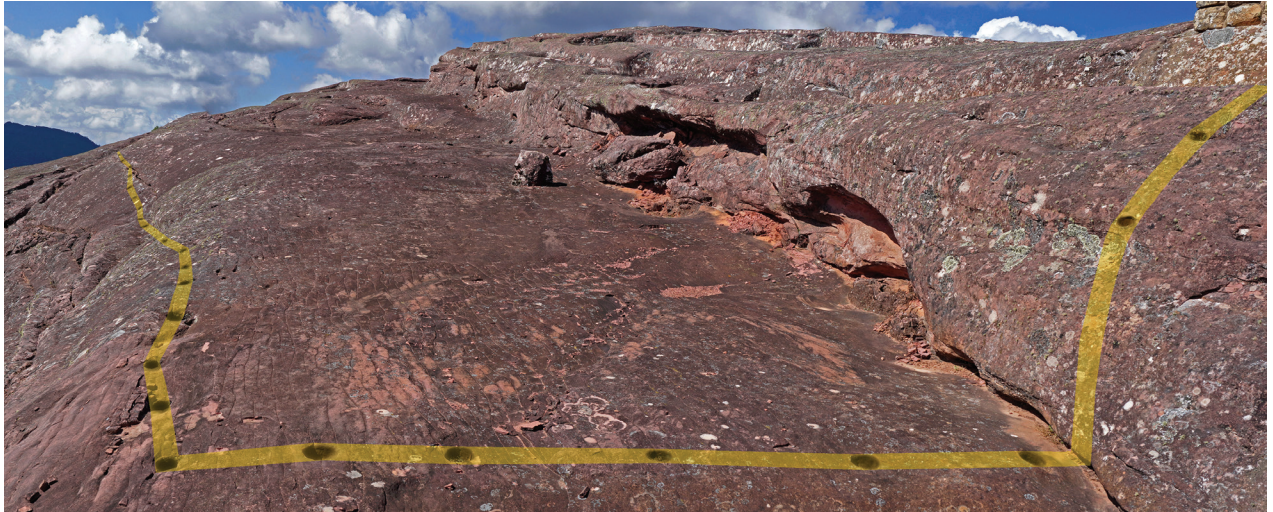
Fig. 7. The line of post-holes on the northern slope of Samaipata rock (photo by J. Kościuk)

Additionally, in many places, the holes are located not on the edge of the hill, but on its steep slope, making some posts practically inaccessible (Fig. 7).

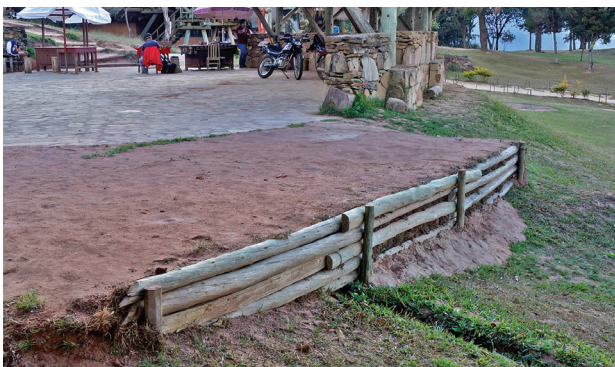
Fig. 10. A contemporary example of a terrace enlargement with a wooden wall and backfill (photo by J. Kościuk)

As already mentioned, in some places, the line of post-holes does not run directly on the edge of the artificially carved platforms, but it traverses the slope obliquely to the contour lines (Figs. 7, 9A). A hypothetical wall placed along such a line would not protect the platform behind it from the wind or unwished-for observation from outside. It seems likely that, between the line of wooden posts and the steep slope behind it, there was originally a backfill that enlarged the platform above (Fig. 9B). Today, similar constructions still occur in Bolivia – even in the immediate vicinity, at the ticket offices at the entrance to Samaipata (Fig. 10).

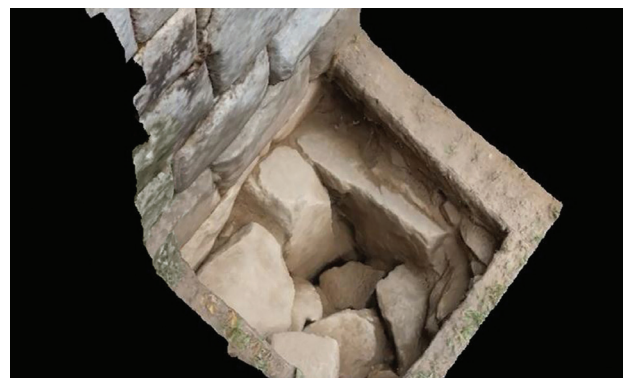
Fig. 11. El Mirador del Inkaraqay (Machu Picchu). Archaeological sounding showing the construction of the terrace on a steep slope of the rock. Visible blocks of split stone prevent the platform from slipping off the slope of the rock (photogrammetry: J. Kościuk)

of the backfill and the face of the rock. Such a solution was observed in the case of the retaining terrace (Fig. 11) of the Inca astronomical observatory El Mirador de Inkaray [14].

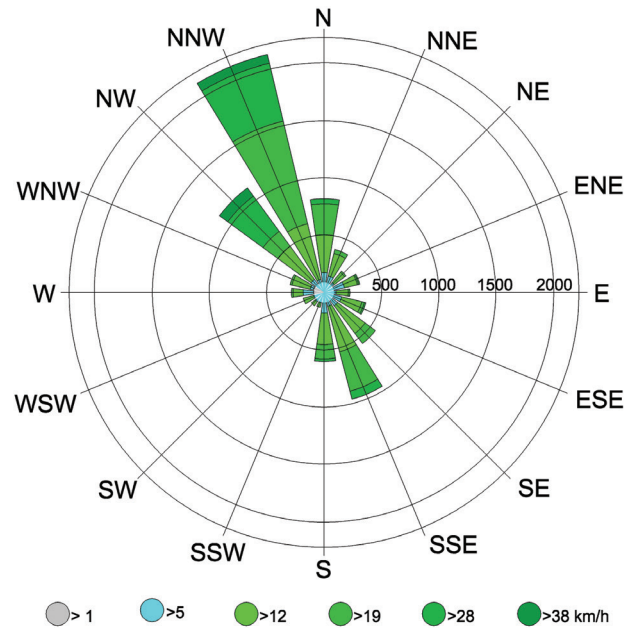
Fig. 13. The wind rose for Samaipata town (source: https://www.meteoblue.com/en/weather/forecast/modelclimate/samaipata_bolivia_11494517 [accessed: 27.11.2017])

There are no accurate meteorological data for El Fuerte de Samaipata itself, but the data obtained for the town of Samaipata indicate the same tendency we observed on the top of the hill. The predominant winds are those from a NNW direction; thus, nearly perpendicular to the line of circular, drilled holes alongside the northern slope of the rock. The main problem, however, is wind speed. While in the town located in the valley 300 m below, the wind usually does not exceed 40 km/h (Fig. 13), it is much stronger on the top of Samaipata rock. When working on the top of the hill, we experienced considerable difficulties in
