Marek Konopka*

About the quality of the Prudnik and Gogolin railway landscape

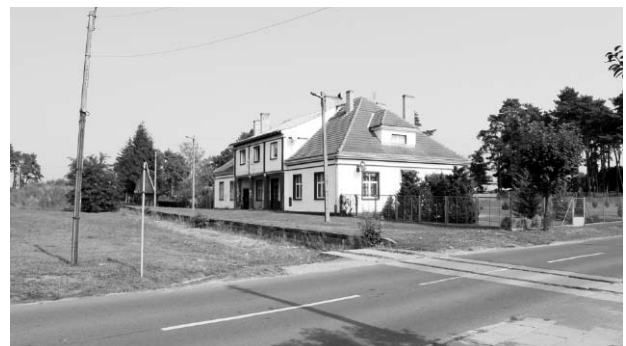
Fig. 1. Krapkowie Otmęt passenger stop. In the foreground the hole after a removed track. The railway station building has been completely transformed into living quarters and is preserved in good condition. It is one of the few modernist stations in the Opole region (photo: M. Konopka, 2009 r.)

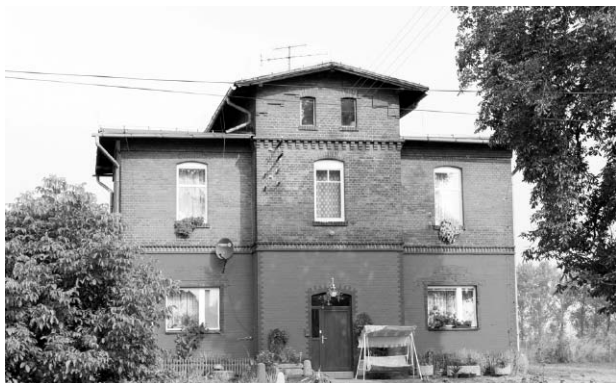
Fig. 2. Lubrza station. The building has been transformed into living quarters. Windows on the ground floor have been rebuilt and all the frames have been ineptly exchanged. The ground floor elevation has been painted (photo: M. Konopka, 2009)

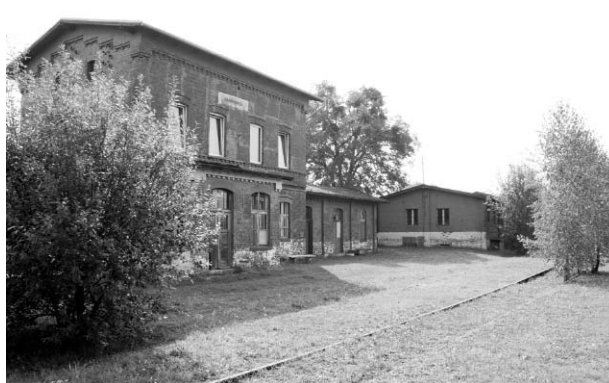
Fig. 3. Krapkowice station. The building is inhabited on the first floor. The ground floor has been unused since 1990. The building is squalid. New and ill-selected window frames in the flat are explicit (photo: M. Konopka, 2009)

to serve as a passenger service department, is still closed (Fig. 3). The residents of this building – without permission but in good faith – occupied a fragment of the station railway tracks and are trying to keep it in order. This view is complemented by two big signal boxes flanking the station entrances in Krapkowice, which are left alone and ruined. People could cross the River Oder through a huge steel bridge from which the track was removed. It still exists because it has a footbridge which significantly facilitates transport between Otmęt and Krapkowice (Fig. 4, 5). The stations in Zielina, Łowkowice, Moszna and Krobusz were treated very drastically (Fig. 6), where all the buildings were pulled down. The rest of the structures, which are connected with this railway line are not used and ruined. We can mention here the railway stations in Biała (Fig. 7), Łącznik (Fig. 8), Strzeleccki (Fig. 9) as well as the nearby warehouse and utility buildings. At the station in Biała there is also a water-tower. The route between the stations is treated differently. On the way from Prudnik to Krapkowice all railway crossings are preserved and new crossings were built along the by-passes of Prudnik and Biała. Completely different actions were taken on the way from Krapkowice to Gogolin. After the railway track had been destroyed, the embankment was crossed with several roads, including a highway, and there were no pos-

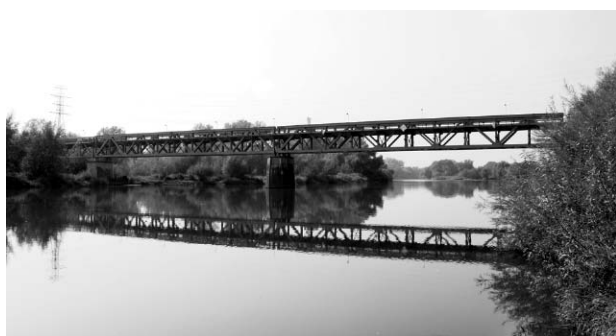
Fig. 4. The railway bridge over the Oder between Krapkowice and Otmęt. The western span fell down during the July 1997 flood. It was repaired but the traffic has not been restored (photo: M. Konopka, 2009)

This track functioned in such a form till the 1980s. Progressing regression of the railway in Poland did not omit it either. In the 1990s passenger and then goods traffic was withdrawn gradually [4]. The flood of July 1997 made it impossible to cross the Odra River through the bridge and the bridge did not function any longer. Since that time the transport of goods took place only between Prudnik and Krapkowice and it was soon limited to the distance Prudnik – Biała. At the end of the first decade of the 21st century the traffic on this railway line was stopped [1].

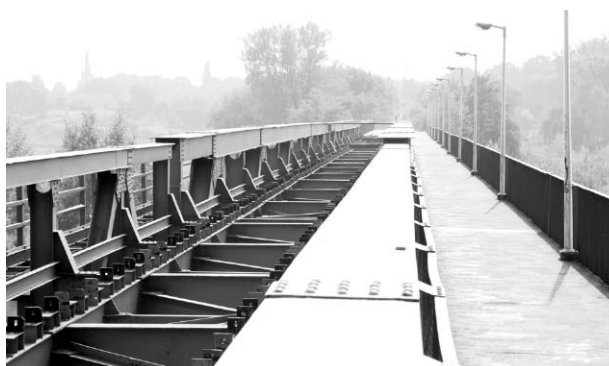
Fig. 5. The pedestrian footbridge on the railway bridge over the Oder between Krapkowice and Otmęt. The track was removed after the July 1997 flood. A pedestrian footbridge has been in operation here since the 1930s. At present the reconstruction of the bridge into a road one is under consideration (photo: M. Konopka, 2009)

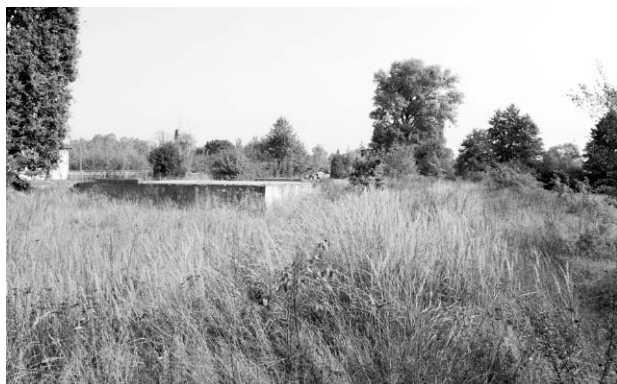
Fig. 6. Zielina station. The station buildings have been torn down. Only fragments of the ramp have remained (photo: M. Konopka, 2009)

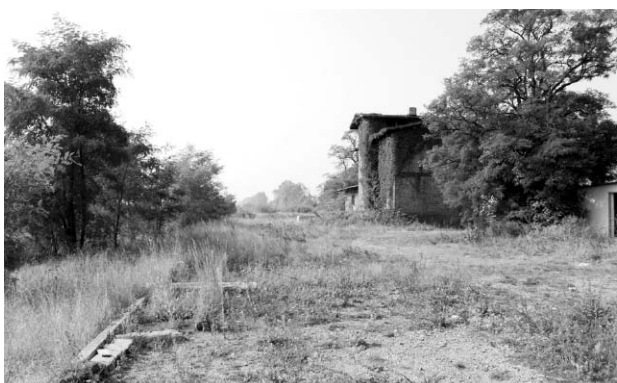
Fig. 8. Łącznik station. Currently the station building is unused. Periodically small wholesale outlets function there (photo: M. Konopka, 2009)

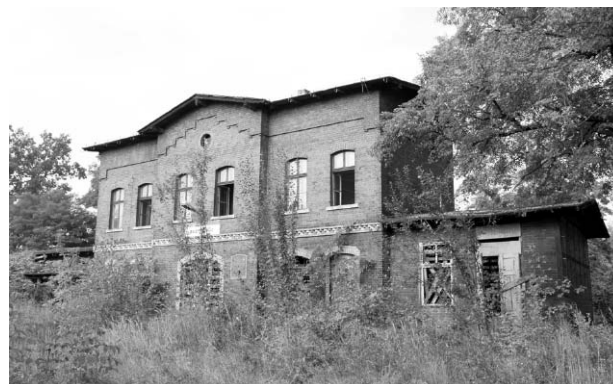
Fig. 7. Biała Prudnicka station. The station is abandoned and squalid. In comparison with other stations on this line it boasts richer brick details (photo: M. Konopka, 2009)

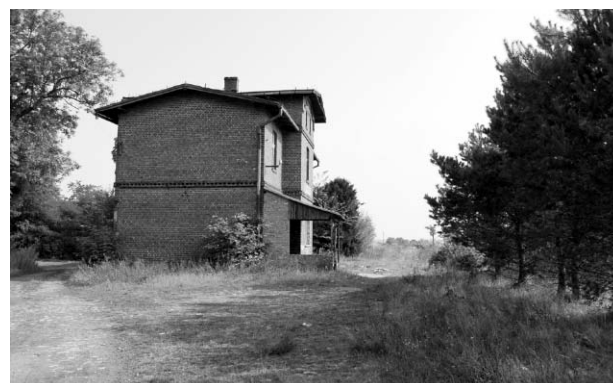
Fig. 9. Strzeleccki station. The building is abandoned and unsecured, and the area around squalid (photo: M. Konopka, 2009)

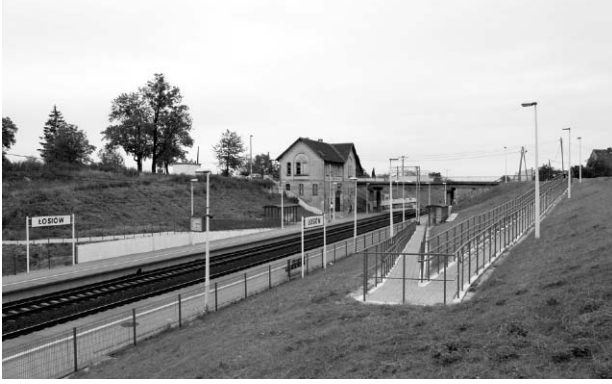
Fig. 10. Łosiów station on the Opole – Wrocław line, rebuilt in 2005–2006 as a passenger stop. Platforms were rebuilt, monumental wheelchair ramps were built, the loading ramp and additional tracks were removed. The building was left unchanged (photo: M. Konopka, 2009)

cal aspects were most important during the modernisation. Nevertheless, these objects were adapted to the present needs of the railway transport. Functions of technical buildings were changed (signal boxes – gateman's lodges), buildings of local goods transport service were liquidated (loading platforms, railway sidings, weighing machines), buildings of passenger service department (platforms, shelters, waiting rooms) were renovated and rebuilt. At the same time, accompanying residential and warehouse functions were preserved.

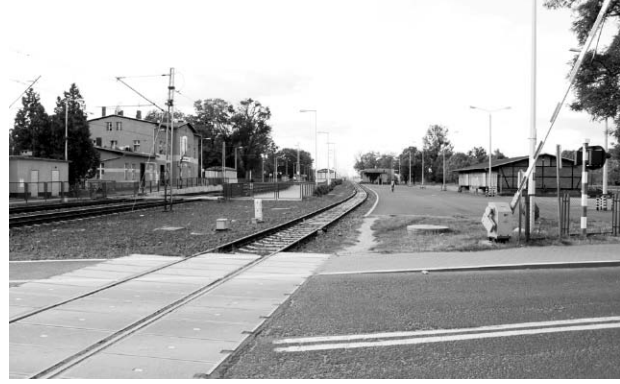
Fig. 11. Lewin Brzeski station on the Opole–Wrocław line, rebuilt in 2005–2006. Platforms were rebuilt, the network of tracks was reorganised, the signal box was reduced to the role of a level crossing attendant's post. The station building was renovated inside and the elevation was rebuilt. The freight yard was renovated. The warehouse and housing buildings were left unchanged (photo: M. Konopka, 2009)
