Anna Górk*

The role of isolated farmsteads in the open landscape protection on the example of Kashubia

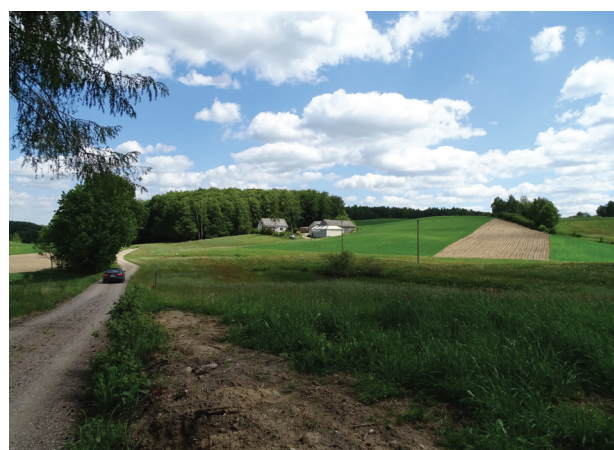
Fig. 1. An isolated farmstead in Kashubia (photo by A. Górk)

The study was conducted on the border of three communes in the Pomeranian Voivodeship, i.e., the communes of Somonino, Nowa Karczma and Przywidz. The research area centres around Pojezierze Kaszubskie [the Kashubian Lake District], whose landscape is characterised by young glacial relief with numerous hills, ravines, lakes and post-glacier depressions. The region is very attractive in terms of the views it offers, which stems from the diverse terrain and picturesque, small settlements against a background of forests or meadows and greenery-covered fields. Often, scattered farmsteads or hamlets are characterised by an outstanding landscape exposure. Due to the attractiveness of the landscape, the proximity of a large urban centre and the availability of construction land, this area has become a site of expansion of single-family residential and tourist construction. The study is focused on the development of old isolated farmsteads (Fig. 1). In the conditions of energy

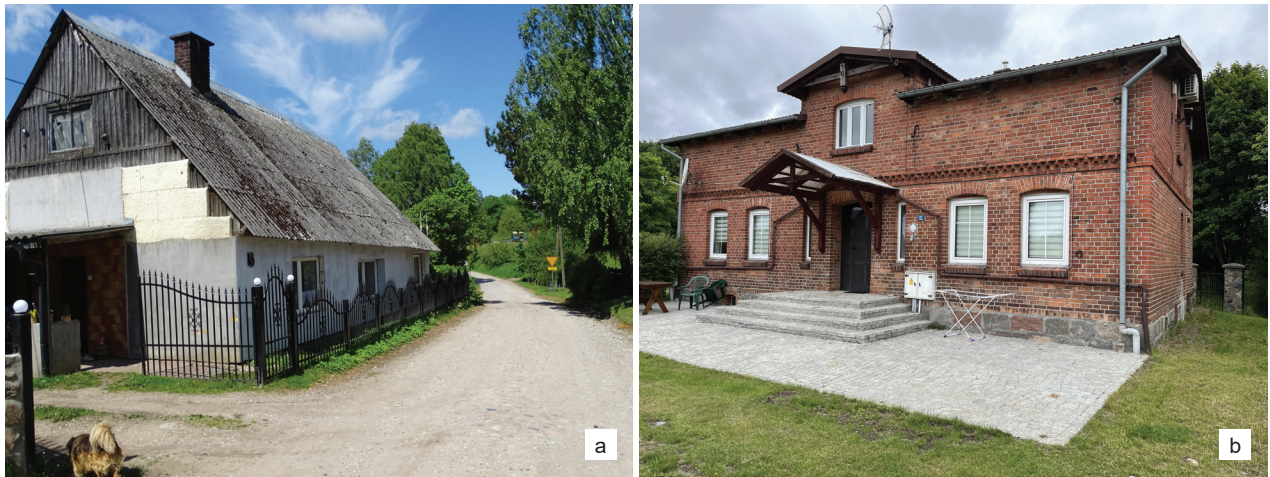
Fig. 2. Two types of farmstead houses in Kashubia:
a) a building with a high roof, b) a building with a semi-flat roof (photo by A. Górka)

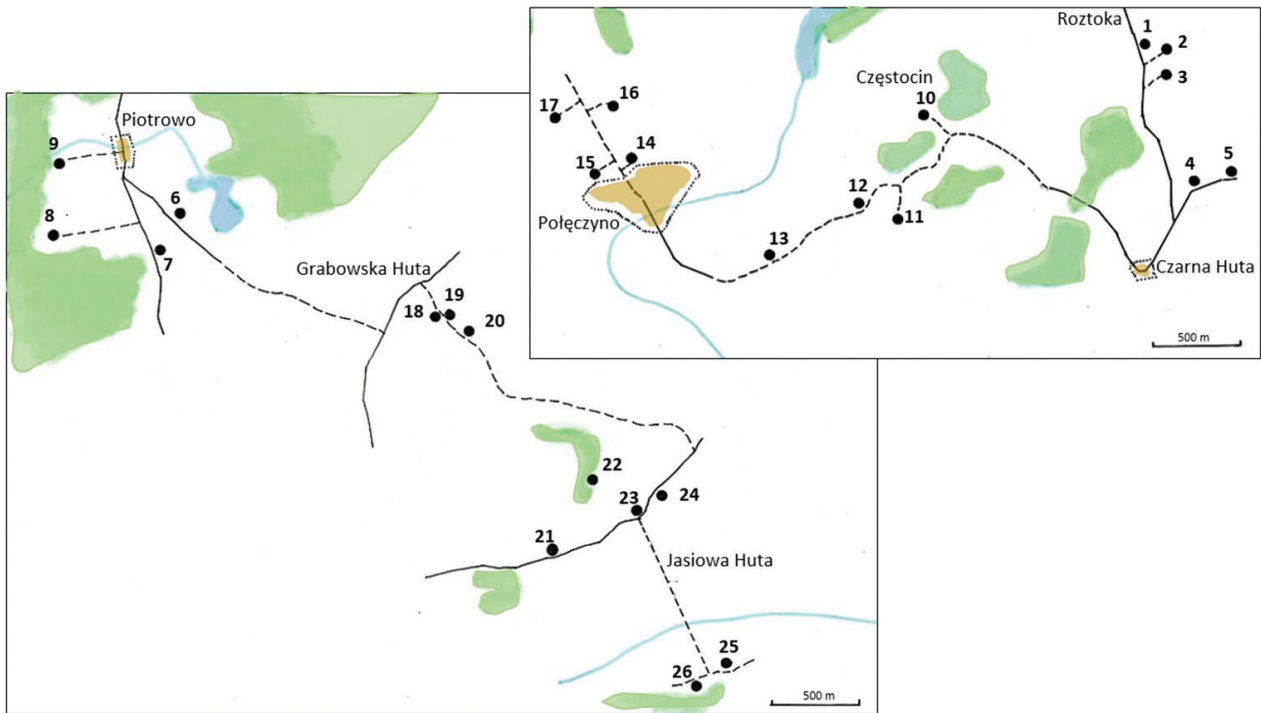
Fig. 3. Scenic routes with farmsteads. Solid lines mark local roads, dashed lines – field roads, homesteads are marked with numbers (drawn by A. Górka)

Along the scenic routes, 26 historic farmsteads were identified (Fig. 3). Each of them was described on an inventory card, in accordance with the model shown in Figure 4. Based on cartographic research and expert analysis of architectural features, buildings dating back to before 1937 and ones that were erected later were identified. They were documented in photos, their condition was described while modifications to traditional features were noted.

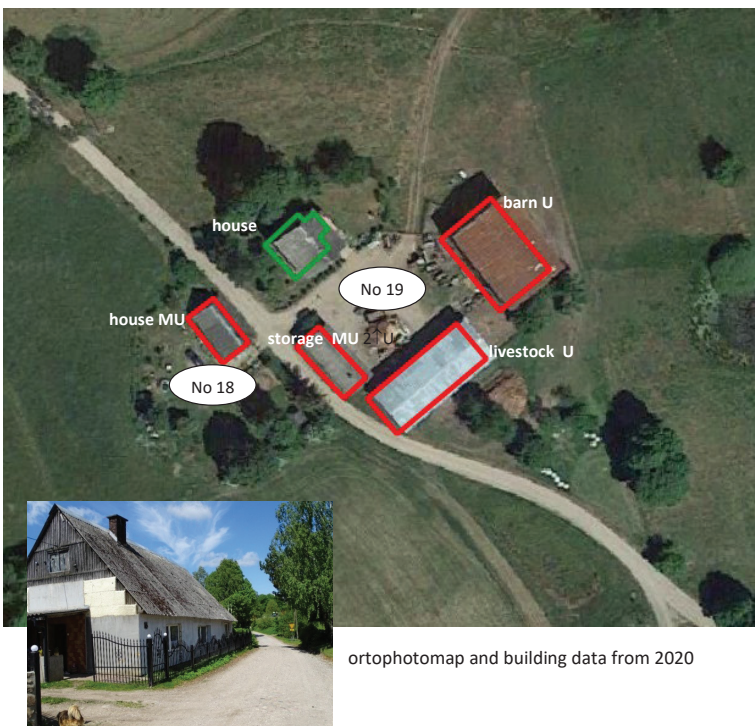
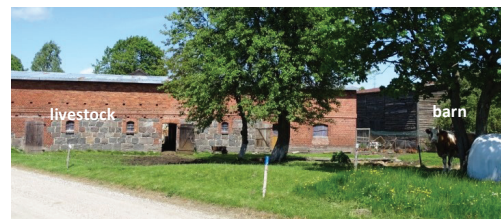
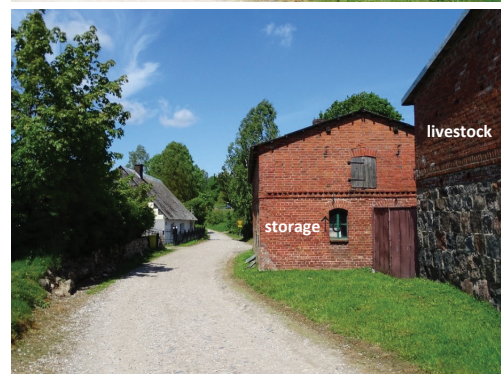
M – a modified building body or facade; U-used; D - degrading; R- in ruins

map from 1937 with building data from 2020

orthophotomap and building data from 2020

Fig. 4. An example of a farmstead inventory card (elaborated by A. Górka)

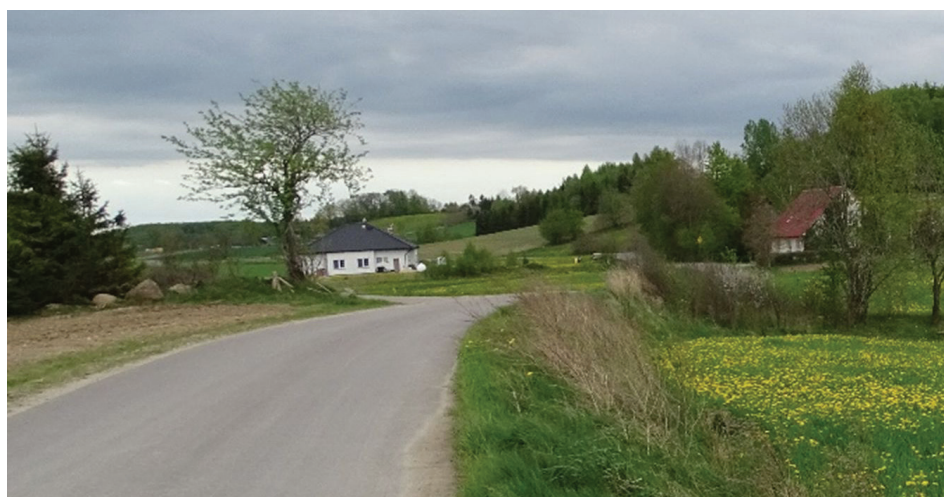
Fig. 5. New building closing the scenic corridor (photo by A. Górka)

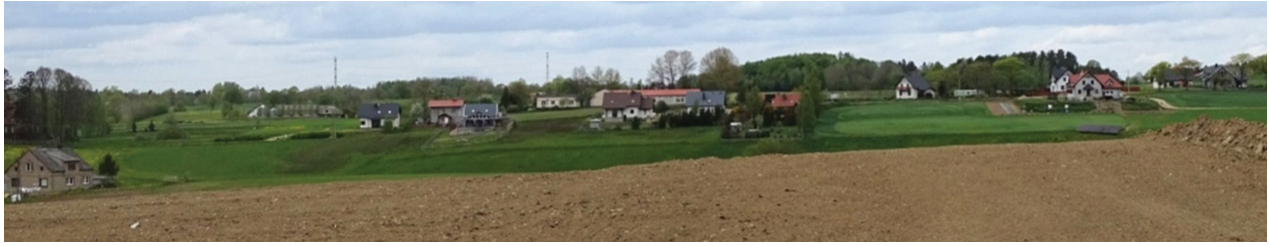
Fig. 6. Panorama of Połęczyn (photo by A. Górka)

An active building development process was observed in the touristically attractive surroundings of the Czarna Huta hamlet and in the area of Połęczyn. In the Czarna Huta area, the emergence of new single-family buildings has led to a disturbance in the picturesque view corridor marked by slopes of greenery-covered hills interspersed by farmsteads and trees (Fig. 5). The new buildings around Połęczyn led to the creation of a chaotic panorama strongly exposed from the south (Fig. 6). The integrity of the context of settlements located further away from local roads remains unaffected (for instance farmsteads 10, 11, 12, 25).
