Klara Kantorowicz*

*Usage of digital surveying techniques
in monuments of wooden architecture.
Example of documentation of churches
on Silesia and Lesser Poland border*

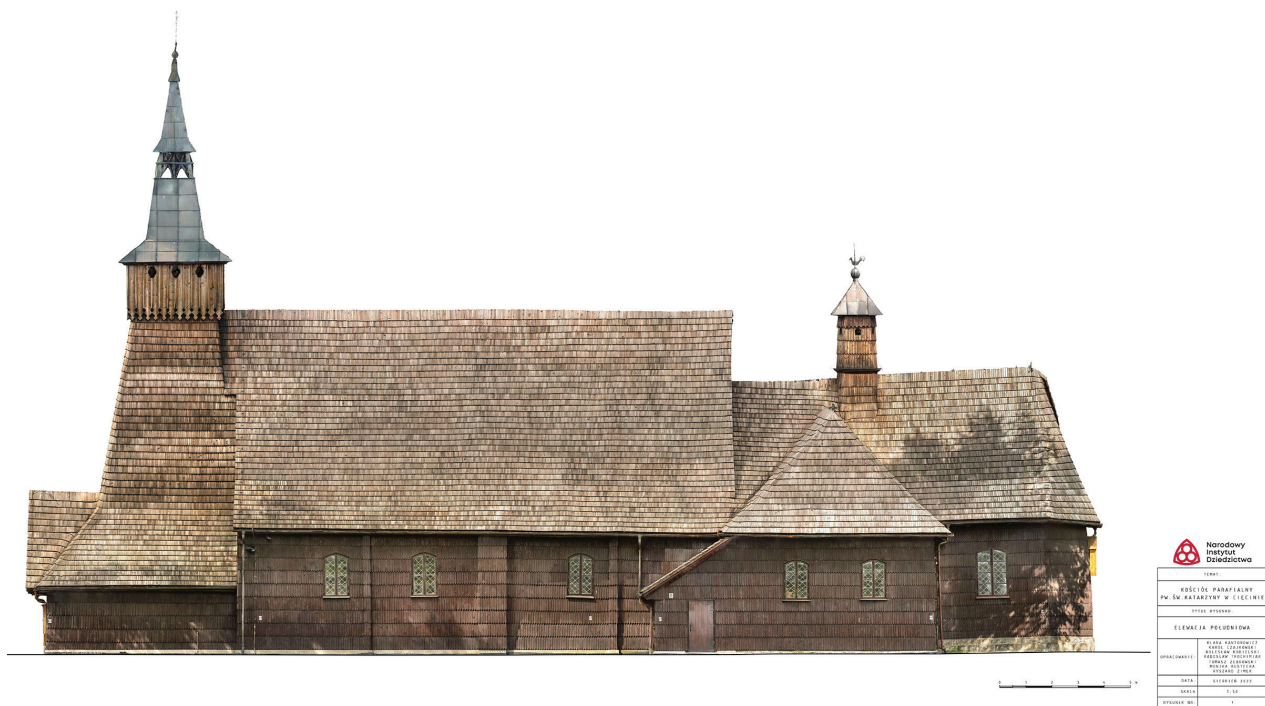
Fig. 1. Orthophotography of south elevation of church in Cięcina, 2022 (elaborated by K. Czajkowski, R. Trochimiak, K. Kantorowicz, NID)

mapping of the structure as a point cloud. Simultaneously, using an Unmanned Aerial Vehicle¹³ and a photo camera¹⁴, photos were taken, constituting starting material for the photogrammetric description of the outside of the facility. The photos were taken around the facility from each camera position: perpendicular to the façade surface and angular in two directions (to the left and to the right) in 20 MPx resolution. The overlap, horizontal and vertical, between the consecutive photos perpendicular to the façade was no less than 60%. Based on these photos, MESH models were produced¹⁵. They are shared on the NID website [34]–[38] for the reason of popularisation, and also were used to create metric orthographic photo plans of the façades (Fig. 1). Based on the data collected

Photogrammetry however yields great results in documenting paintings (Fig. 5C) or the façade (exterior shape) of the structure (Fig. 1). A comparison¹⁷ (Fig. 6) was made of a point cloud representing the exterior of Cięcina church – generated in a photogrammetric process¹⁸ and geo-referenced based on the geodetic control points¹⁹ with a point

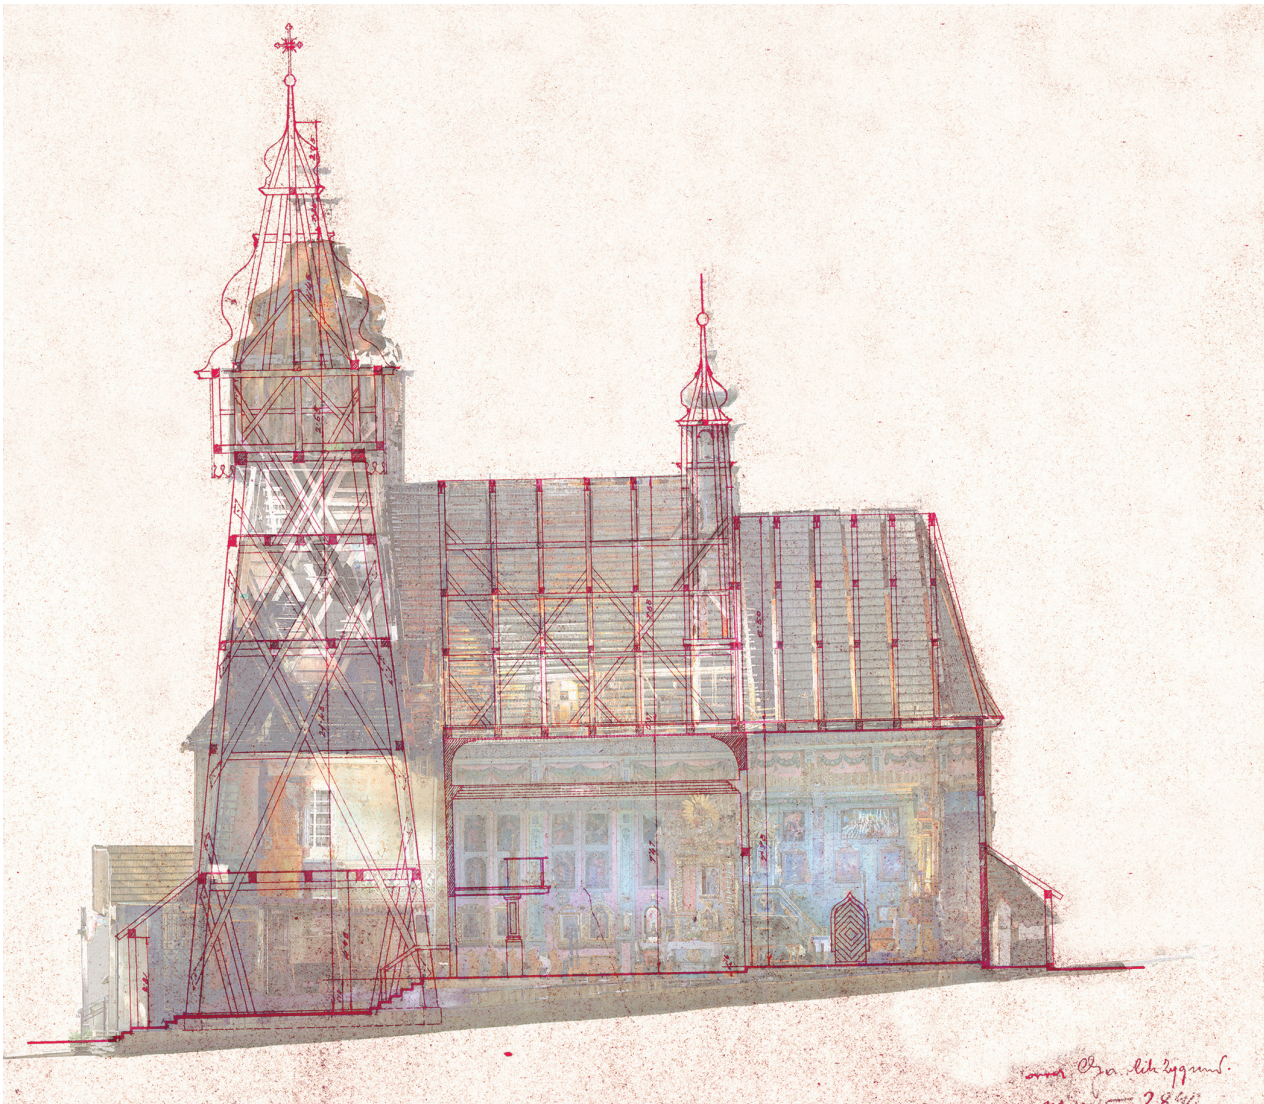
Fig. 3. Church in Stara Wieś, longitudinal section – comparison of traditional measurements with point cloud (elaborated by K. Kantorowicz on the basis of survey from 2022: K. Czajkowski, R. Trochimiak, T. Żebrowski, NID and measurements by Z. Gawlik, 1930, WA PW Collection)

section of the interiors placed on different levels is often very simplified. For instance, the positions of roof trusses relative to the nave interior (Figs. 2, 3).

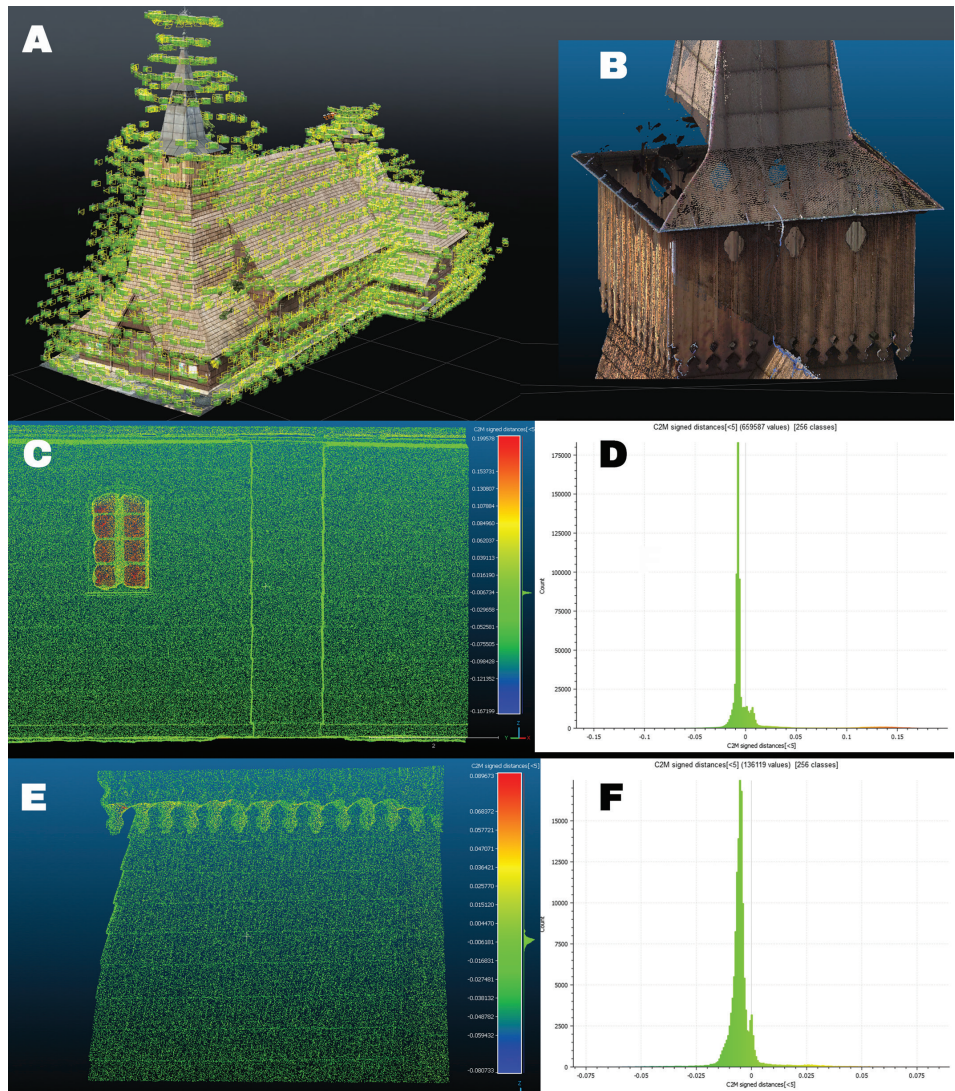
Fig. 6. Church in Cięcina:
 A – visualisation of camera poses for photogrammetric model,
 B – point cloud registered by laser scanner – blind spots,
 C, D, E, F – accuracy analysis of parts of point cloud generated in photogrammetric process in comparison with measurements registered by laser scanner with histogram (elaborated by R. Trochimiak, K. Kantorowicz, NID)

cloud registered with laser scanners in 21 positions. This comparison shows that in the case of well-lit wooden surfaces²⁰, the measurement error of the photogrammetric survey is within 1 cm range (Figs. 6C, 6D). Bigger discrepancies (up to 8 cm in a few particular spots) were noted in exceptionally shaded locations, mostly under the eave or by the sculpted elements (Figs. 6E, 6F). The most significant discrepancies between the cloud generated from scanning versus the photogrammetric one (even up to 20 cm) are localised in the glass pane parts or similar reflective materials, where the reflections of the environment prevent the photogrammetric software from making an appropriate interpretation of reflective surface geometry. Additionally, these kind of discrepancies occur in locations where the shaping of the structure itself and its environment are not attainable for the laser beam²¹ (Fig. 6B). One could state that for an appropriately detailed imaging, in favourable lightning conditions, photogrammetric measurement of an external architectural shape of a wooden structure is suffi-

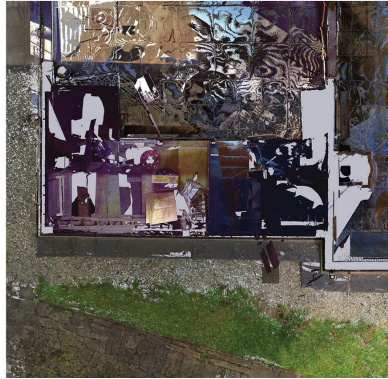
Fig. 7. Church in Cięcina – comparison of point cloud view and architectural drawings based on it, 2022
