**WSPÓŁCZESNE PROBLEMY
INŻYNIERII ŚRODOWISKA**

**Daniel Garlikowski
Krzysztof Lejcuś
Henryk Orzeszyna
Andrzej Pawłowski**

**FLOOD EMBANKMENTS MODERNISATION WITH USE
OF VERTICAL HYDRAULIC CUT-OFF WALLS
FIELD RESEARCH RESULTS**

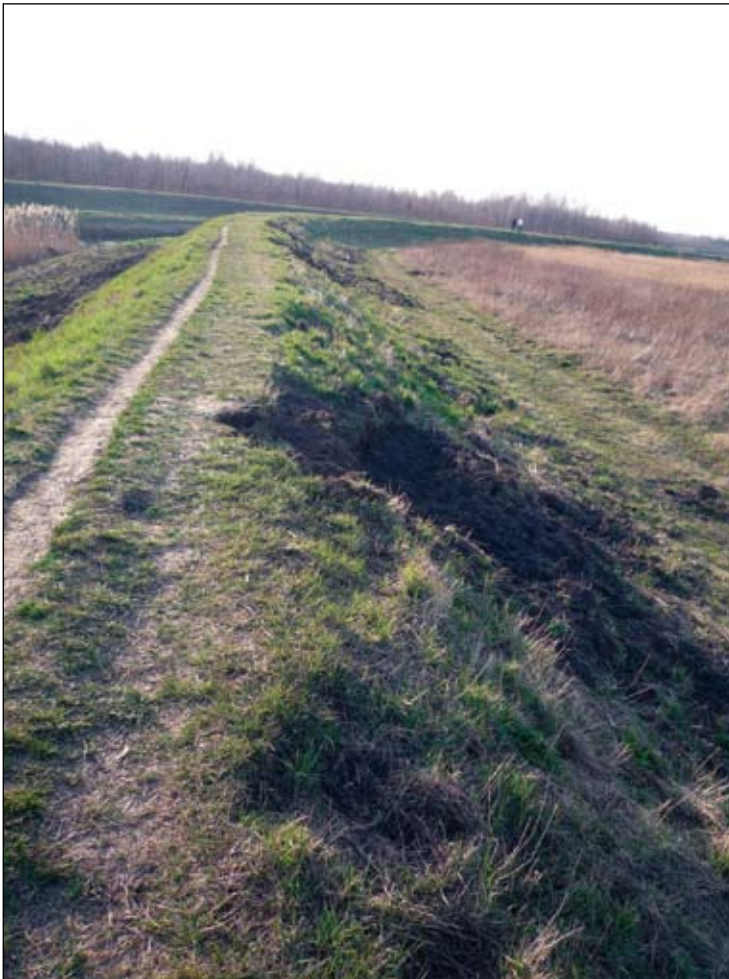
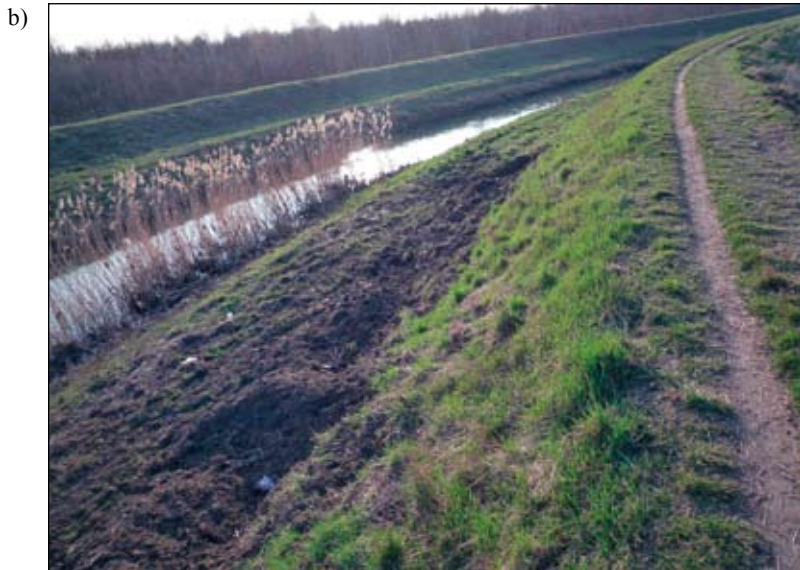
Photo 1 (a, b) Embankments of the river Śleza devastated by boars

- Subsidence of loose soil,
- Elevation by water of soil surrounding the channels bored by mammals living within the embankment (Photo 1),
- Creation of channels and zones of loosened, non-cohesive soil, as a result of water filtration,
- Cavities and exposures of the downstream slope in areas of intensive filtration effusions, and
- Suffosion

Sections, where small ponds of water exist in the direct neighbourhood of the flood banks, are significantly threatened by filtration (Photo 5). Water-soaked areas in the embankment-adjacent areas used as agricultural land, and forests, foster the population of the embankment by amphibious mammals, such as: musk-rats, grubbers; insectivorous and herbivorous mammals such as: voles, hamsters, moles, various species of mice, and other. Flood banks offer these animals comfortable moisture, thermal and trophic conditions, and the absence of human interventions enables them to build complex systems of burrows and nests inside the body of the bank (Photo 3). The perforation of the body of the flood bank creates privileged paths for filtration. Extremely disadvantageous ways of perforation of the whole cross-section of the bank may cause piping. Another problem is caused by rootling boars, which devastate the slopes of embankments in search for food, thus weakening the transverse section of the banks (Photos 1a, b).

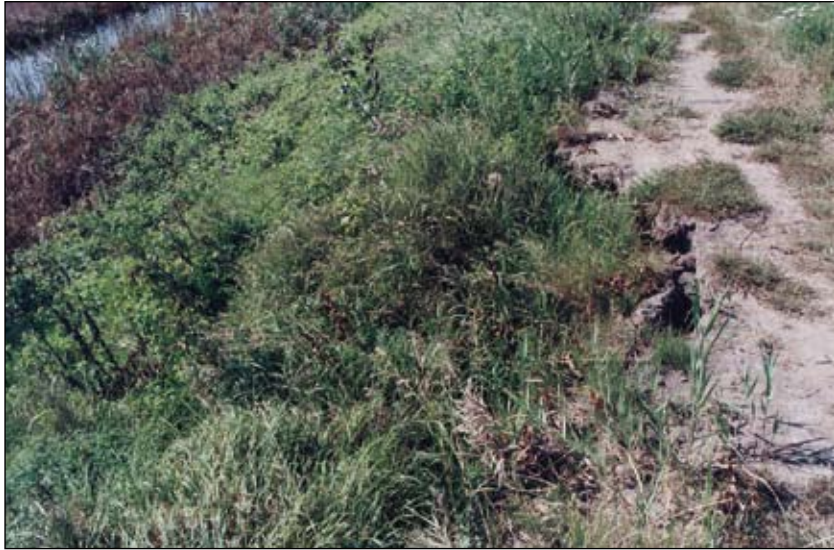
Photo 2. Subsidence of the crown of the bank

- as a result of the subsidence of loose soil (Photo 2),
- as a result of the increase in diameter of "channels" bored by mammals populating the embankment (Photo 1),
- channels and zones of non-cohesive soil loosened by filtrating waters (piping), whose outlets in the embankment-adjacent area are visible in form of cones of elevated material (Photo 4),
- external, superficial cavities and exposures of the downstream slope in places, where intensive filtration effusions exist.

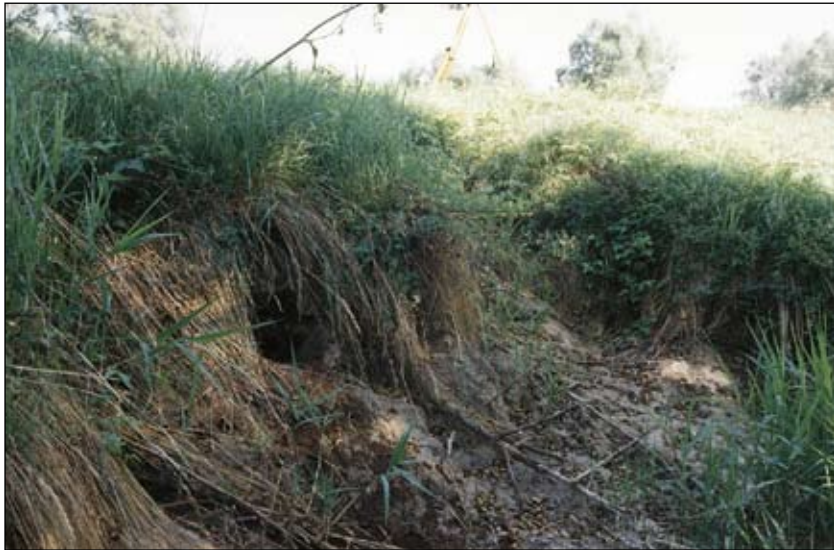
Photo 3. Burrows of animals populating the embankment

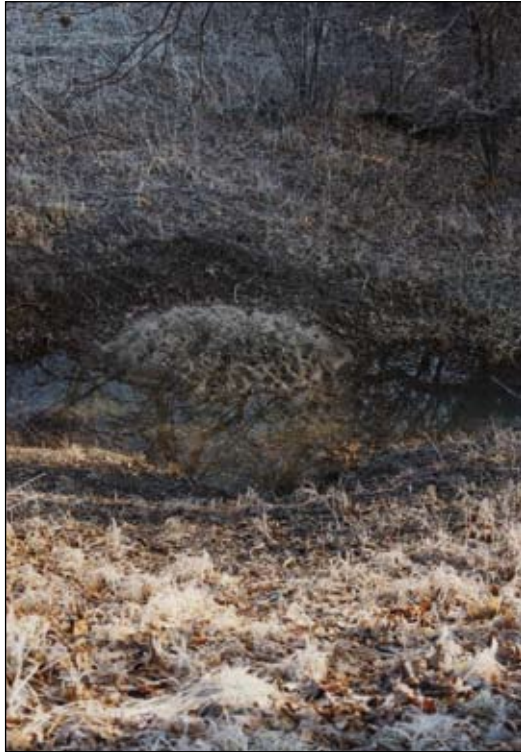
Photo 4. Zone of non-cohesive soil loosened by filtrating waters (piping)

cause piping on weakly compacted, suffosion-prone soils (Photo 4). Excessive filtration can be limited by means of elongation of the filtration path. This is achieved through the use of such construction elements as screens and horizontal cut-off walls in the foreground of the upstream slope or, more efficient, vertical hydraulic cut-off walls. Suspended vertical cut-off walls can be located inside the foot of the upstream slope and connected with the screen, or in the central zone of the flood bank, in form of a narrow core. It should be emphasised, that the purpose of such solutions is to lengthen the path of filtration, and not to seal the base of the bank all the way down to the impermeable layer, located below groundwater zone. Full sealing of permeable soil restrains the outflow of groundwaters to the river, thus the supply of groundwaters from the valley to the river could be limited or worse, eliminated. This may in turn lead to flooding of the embankment-adjacent areas, in particular during spring thawing. If local conditions force this type of solution, it is necessary to build filtration windows at the point of contact of the cut-off wall with the non-permeable layer in the deep subsoil.

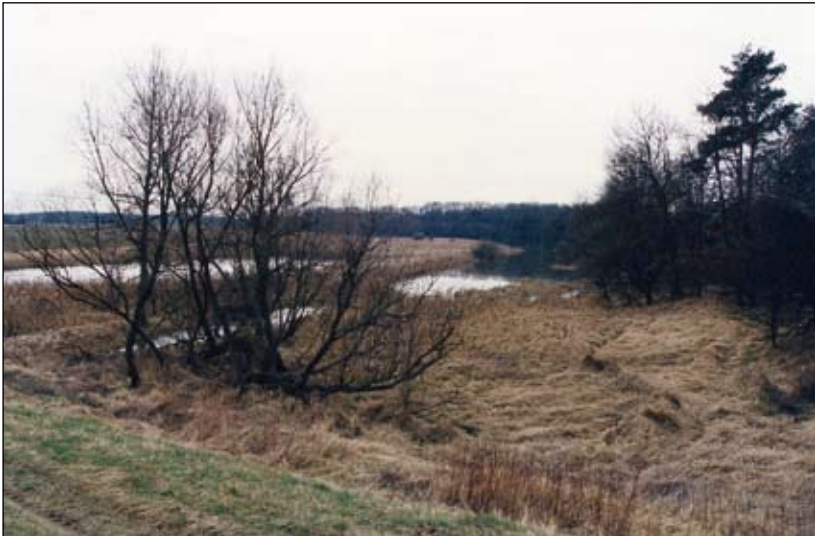
Photo 5. Small ponds of water in the embankment adjacent area

A large threat of filtration exists on those sections, where small ponds of water are located in direct proximity of the banks, both in the embankment-adjacent area, and in the inter-embankment zone (Photo 5). In cities, where the embankment adjacent area has been developed, wells are dug, and sewage tanks or underground floors of building objects are often located in the direct proximity of the flood banks. Long-term freshet causes intensive leaks, followed by the elevation of soil in the bottoms of wells, in insufficiently weighed tanks and floors in basements. The locations of such elevations create an "outlet" for the channels of piping.

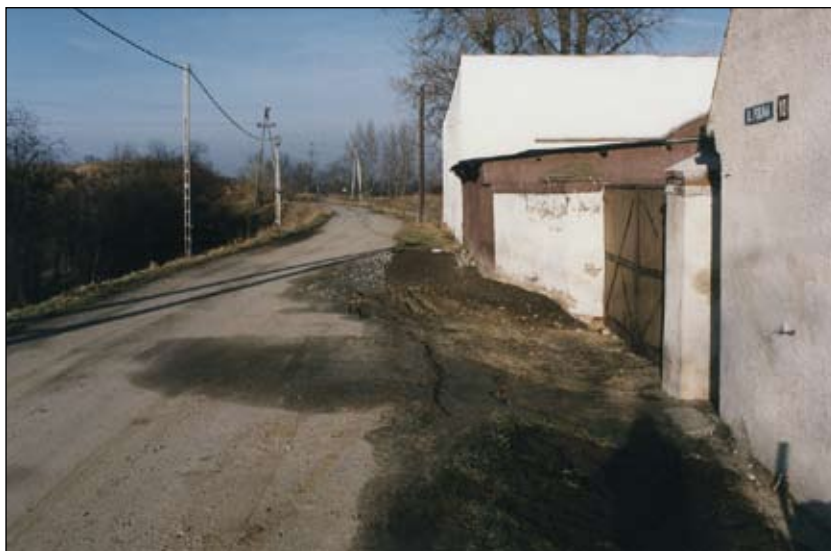
Photo 6. Subsidence of loose soil

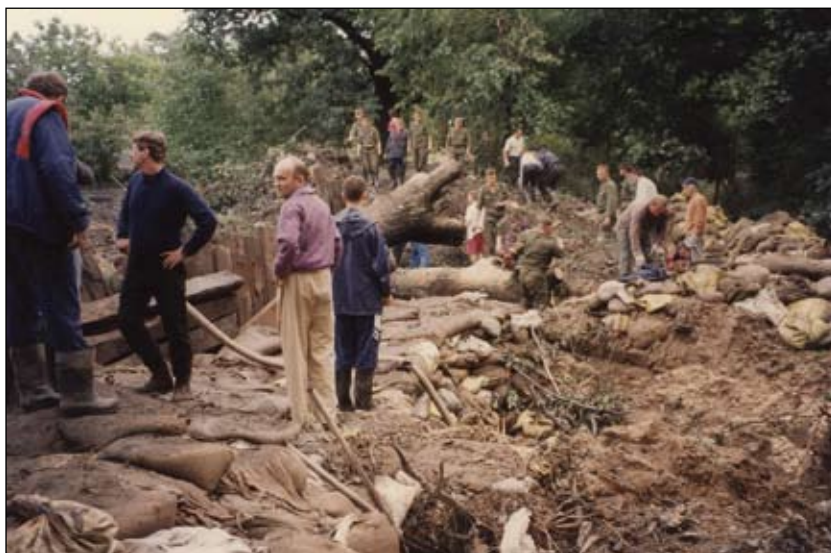
Photo 7. Gap in the flood bank on Odra created as a result of a tree falling down

In the valley of Odra, following the German tradition, during the modernisation of the flood banks system at the beginning of the 20th century, trees were planted on banks located within most cities on the river Odra. In case of long-lasting freshets, during which the bodies of the flood banks become heavily soaked, not even a developed root system, often reaching deep inside the ground, can provide the banks with sufficient stability. Short time, at which such damages occur, practically disables any effective prevention (Photos 7, 9).

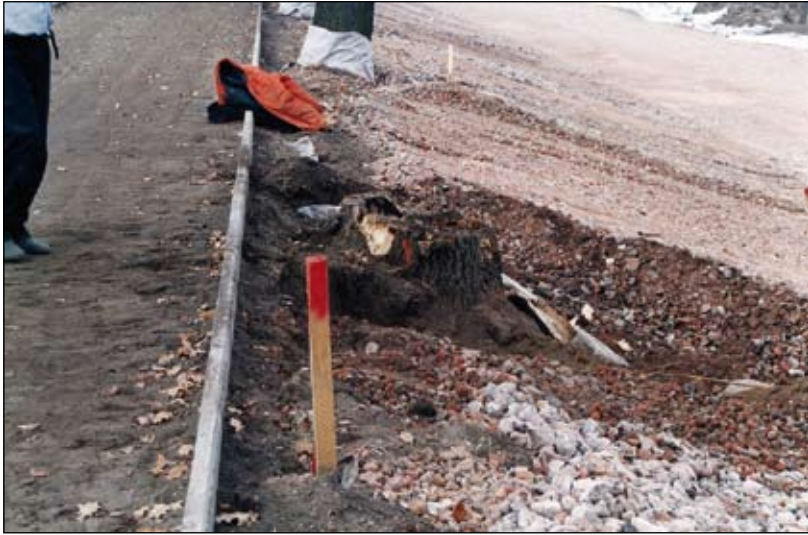
Photo 8. Trees growing on the embankments

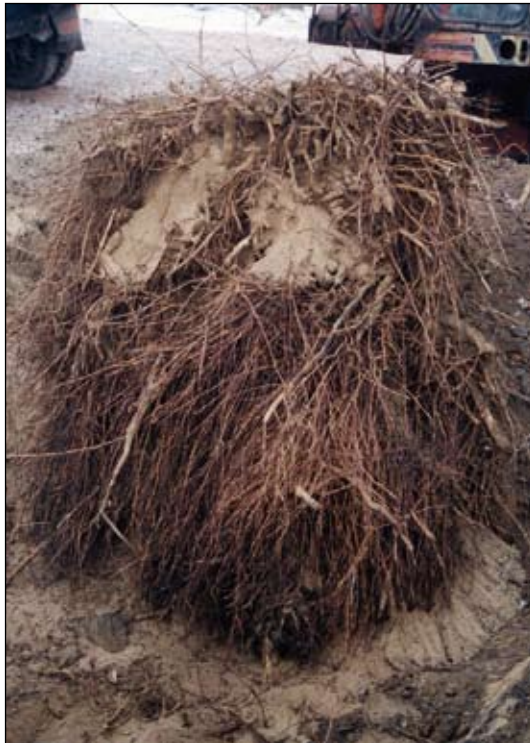
Photo 9. Root systems of trees inside flood banks. Flood bank on Odra – Residential District Zacisze

- a significant part of the damages to the banks has occurred in places, where trees were growing on the crown or on the slope of the banks (Photo 9). The root system, besides those roots that penetrated deep in search for water which, grows through the whole body of the bank and the subsoil, down to the surface of ground water, consists of some roots developed in the superficial layer, or only in the humus, loosening it significantly.

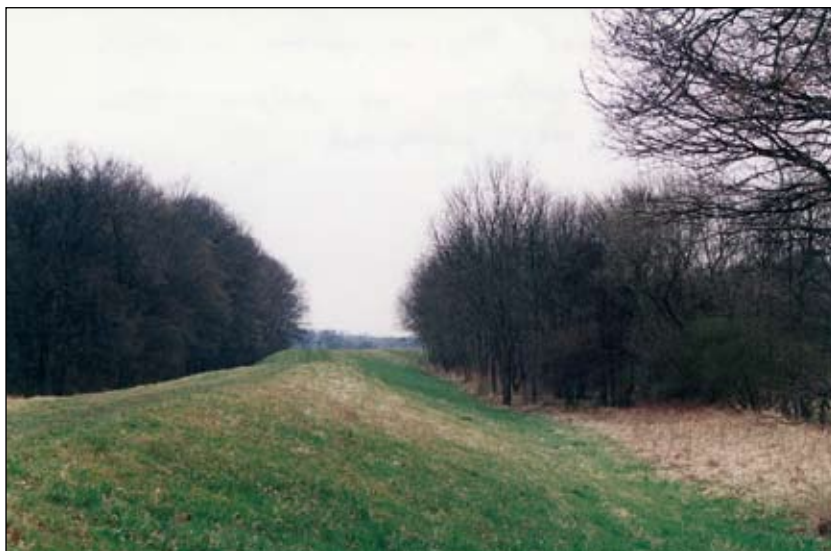
Photo 10. Inter-embankment zone grown over with trees and bushes

- bushes and trees growing in the inter-embankment zone cause a limitation to the hydraulic cross section, which leads to an artificial rise of flood waters, which can then overflow the crown of the bank (Photo 10).

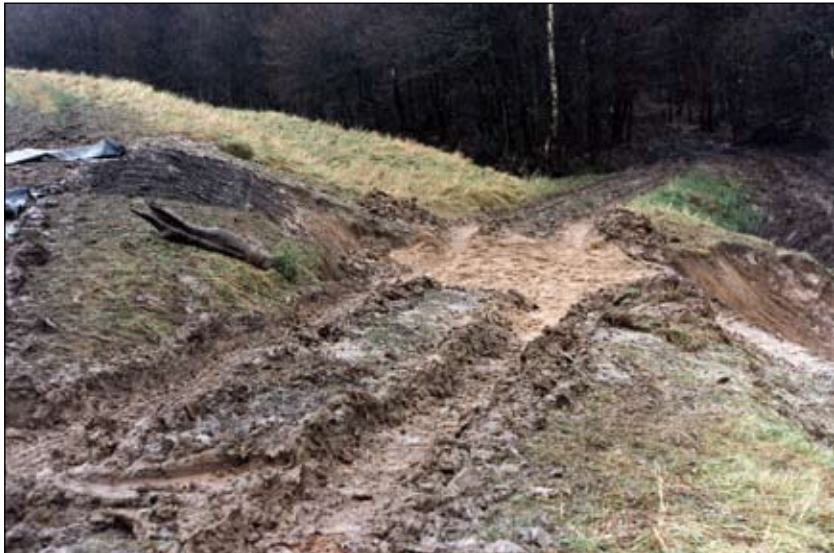
Photo 11. Crown of the flood banks driven over by cars – lack of service road

The majority of embankments are not equipped with service roads. Long sections of the crown of the flood banks are sometimes used as local pedestrian passages or cycling roads, and often driven over by cars (Photo 11). Such situation significantly impedes the creation of temporary means of prevention in case of larger as well as longer-lasting freshets.

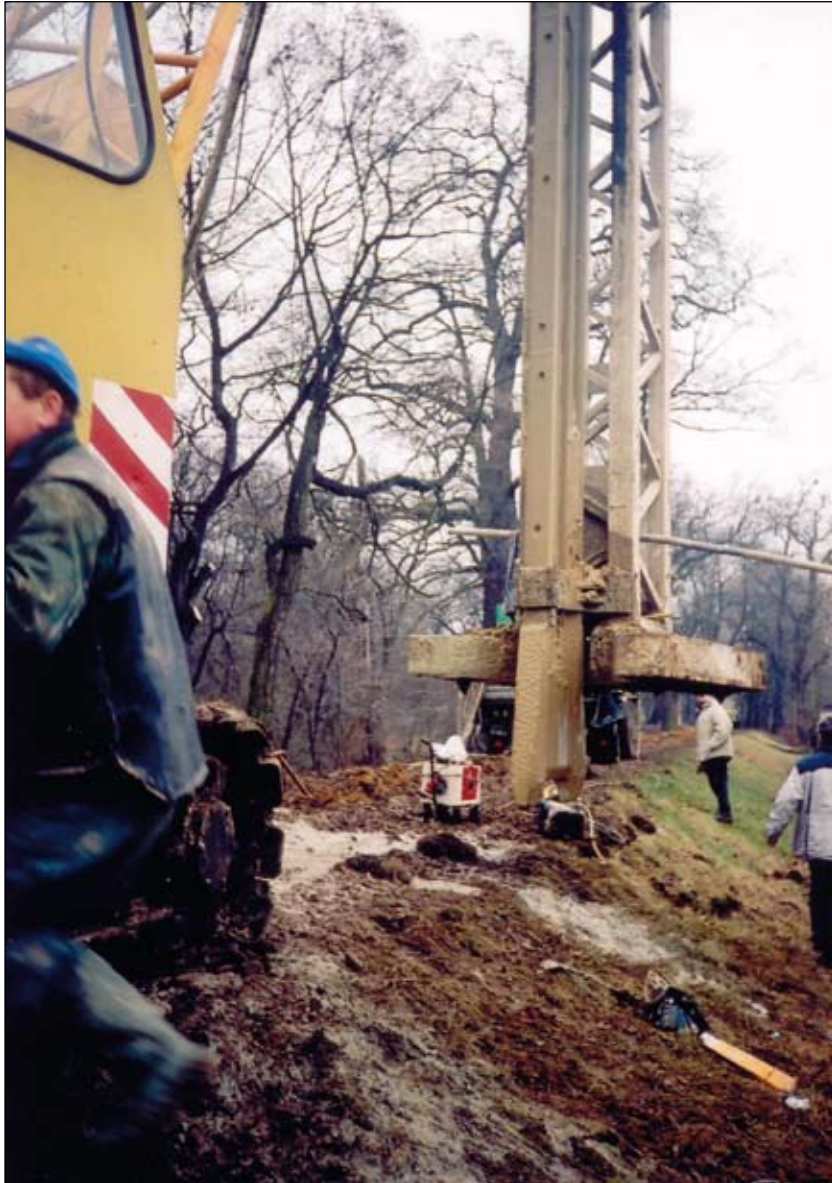
Photo 12. Construction of cut-off wall on the flood banks near Wrocław

According to Gruszkiewicz [2003], sections of the flood banks on Wisła, Wilga and Rudawa, in Krakow and the nearby region, modernised after the flood of 1997, where along the axis of the banks cut-off walls were constructed with use of DSM, vibration injection, and jet-grouting technologies, from cement and cement-bentonite grouts, were positively verified during the long lasting freshet in 2001. Similar technology was used for the modernisation of the embankments on Odra. On sections Stabłowice in Wrocław, Kotowice and Oława, above Wrocław, cut-off walls were constructed as follows: the fissure, constructed with use of the vibration method, was then filled with a pressurised bentonite and cement mixture (Photo 12).

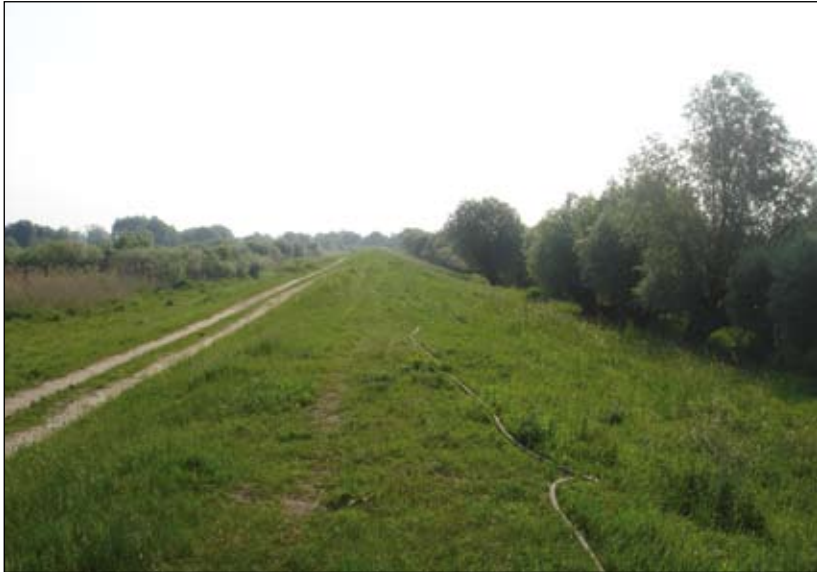
Photo 13. View of the section of embankment where the section of cut-off wall was to be constructed

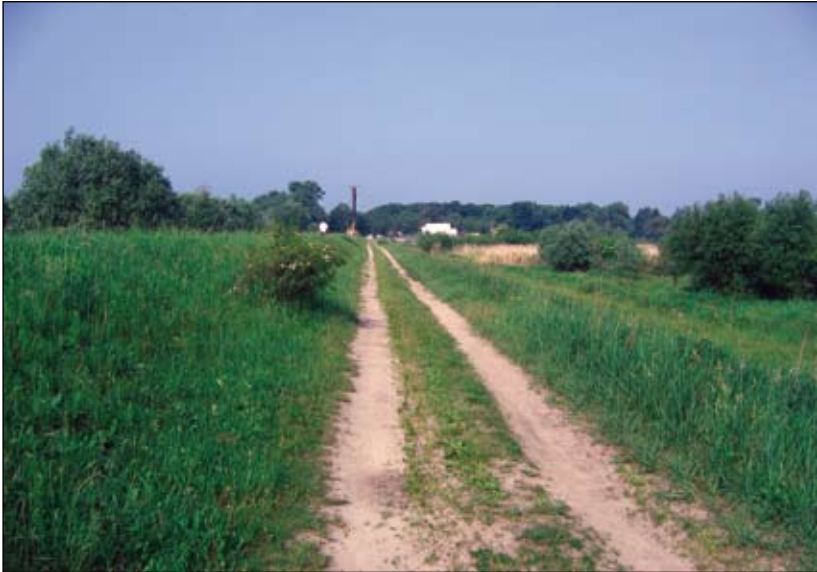
Photo 14. Bench on the embankment used as unsurfaced road

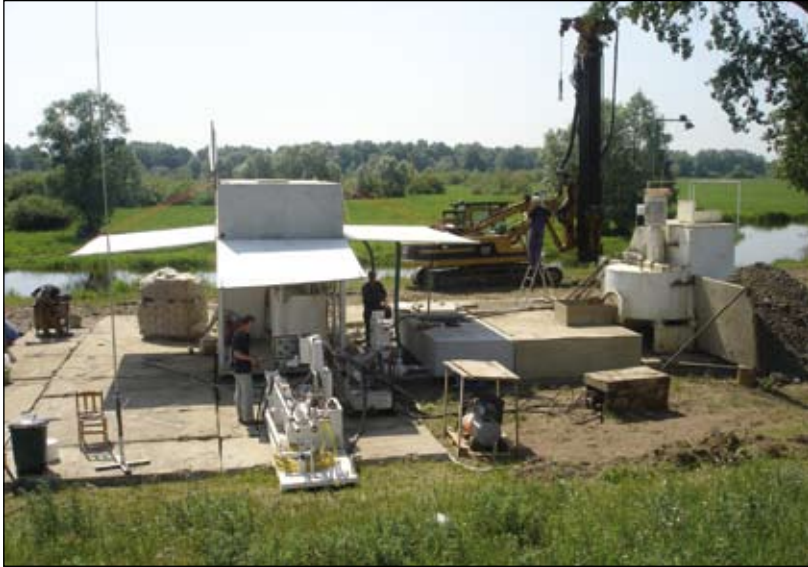
Photo 15. Equipment for the injects preparation, ready for work on the flood bank on Warta in Kostrzyn

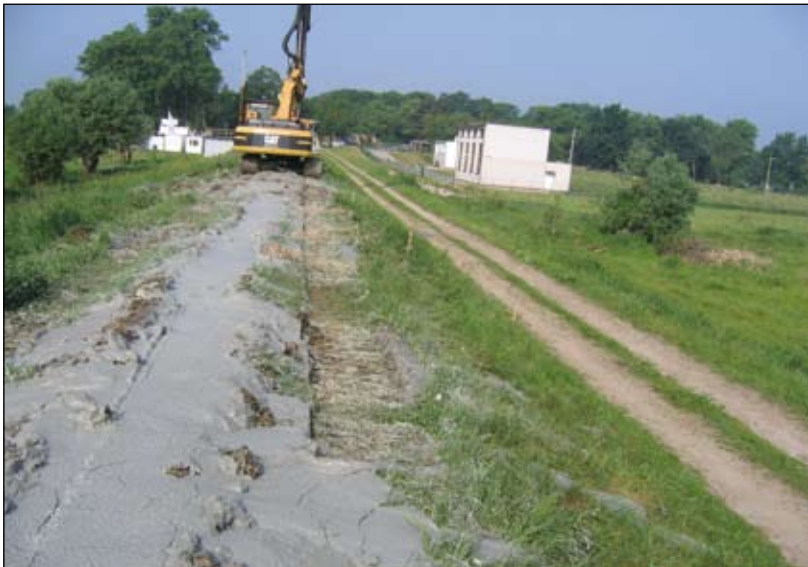
Photo 16. Fragment of the constructed hydraulic cut-off wall

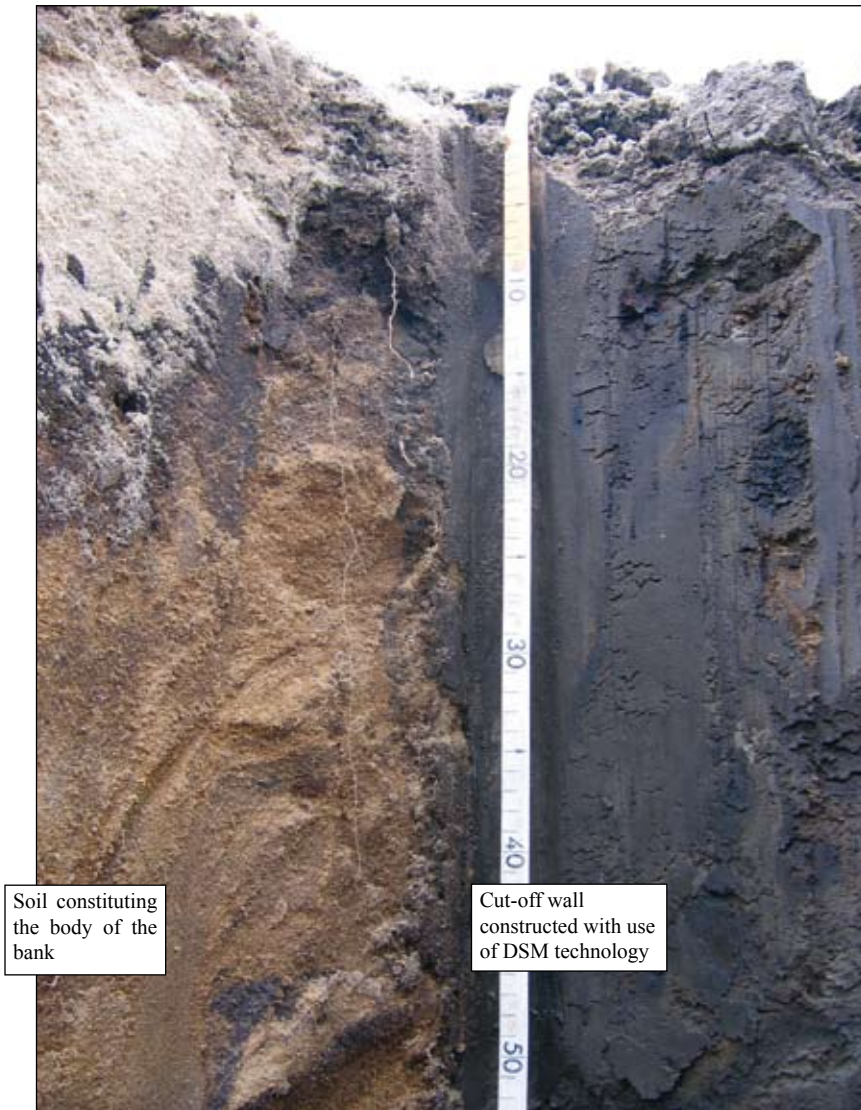
Photo 18. Upper part of open pit No. 2

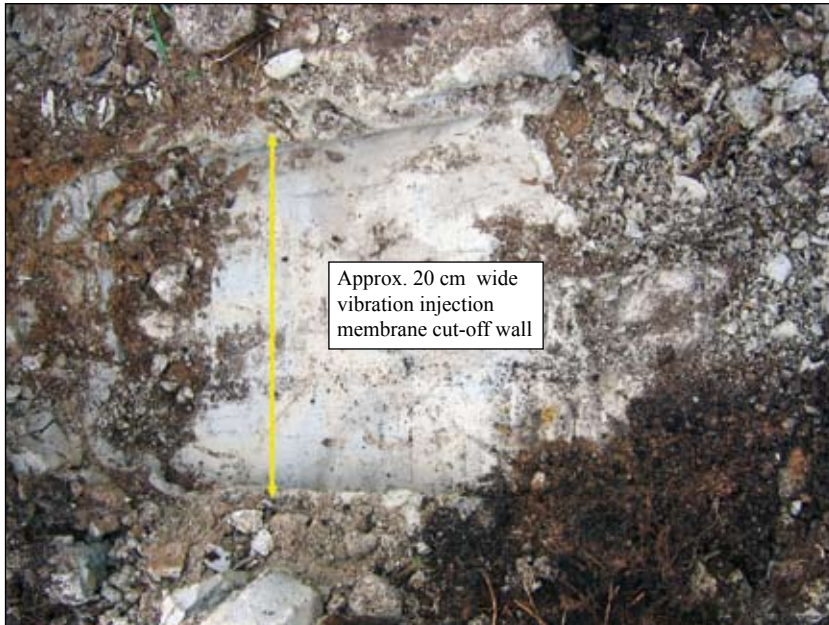
Photo 20. Crown of the embankment: exposed membrane cut-off wall constructed with use of vibration injection technology with the inject made from clay from Bełchatów

The membrane cut-off wall constructed with use of the vibration injection technology is approximately 20 cm wide. Photo 20 shows the exposed upper part of the cut-off wall, prepared for the determination of Californian Bearing Ratio (CBRd).

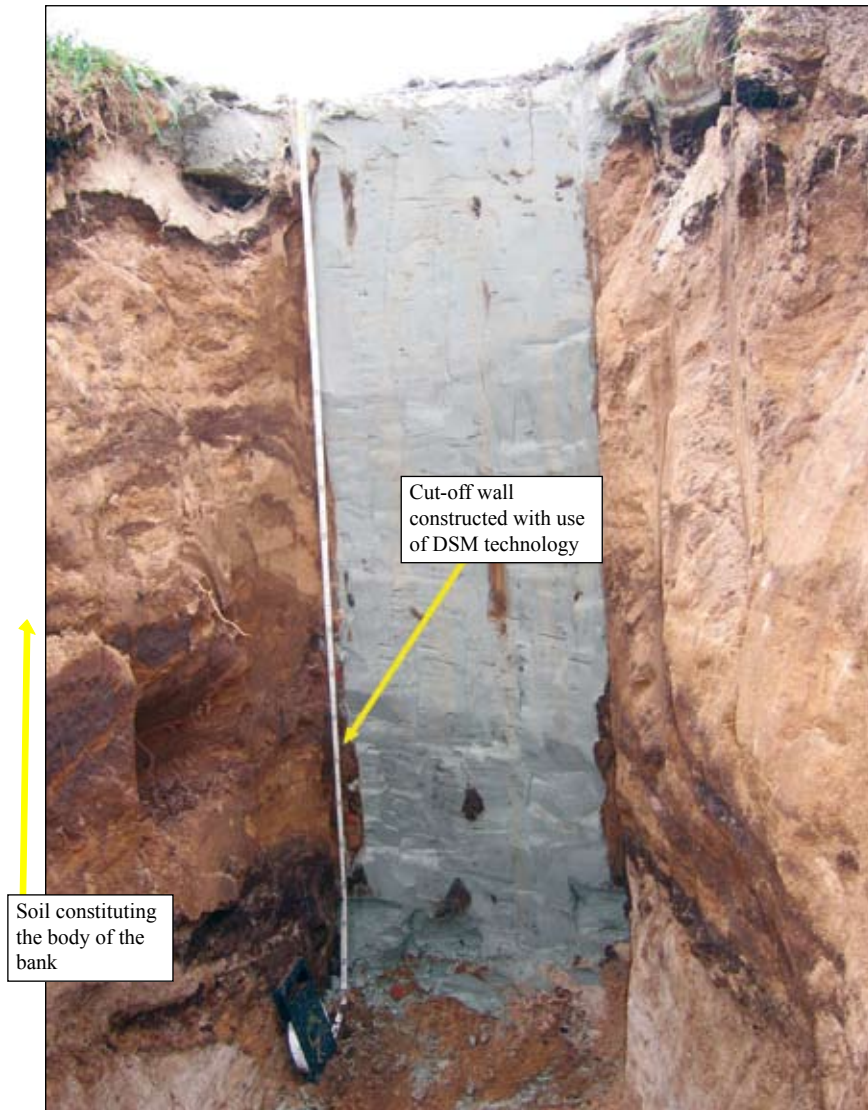
Photo 21. Open pit No. 4 – cross-section through the cut-off wall constructed with use of DSM technology grout based on clay Bełchatów

The cut-off wall constructed with use of vibration injection technology creates a compact, homogenous wall of the inject (Photo 21). Vibration injection technology enables the construction of very homogenous membrane cut-off wall, since during the application of this method, the soil is moved to the side, not mixed with inject, as in DSM technology. The form of the cut-off wall is the same, regardless of the type and state of soils, where it is applied, and thus it allows for the construction of a wall of isotropic characteristics (Photo 23). It effectively cuts through both non-cohesive and cohesive soils. A clear boundary is created between the cut-off wall and the soils constituting the bank – the soil of the embankment does not create any inserts or interbeddings (Photo 22).

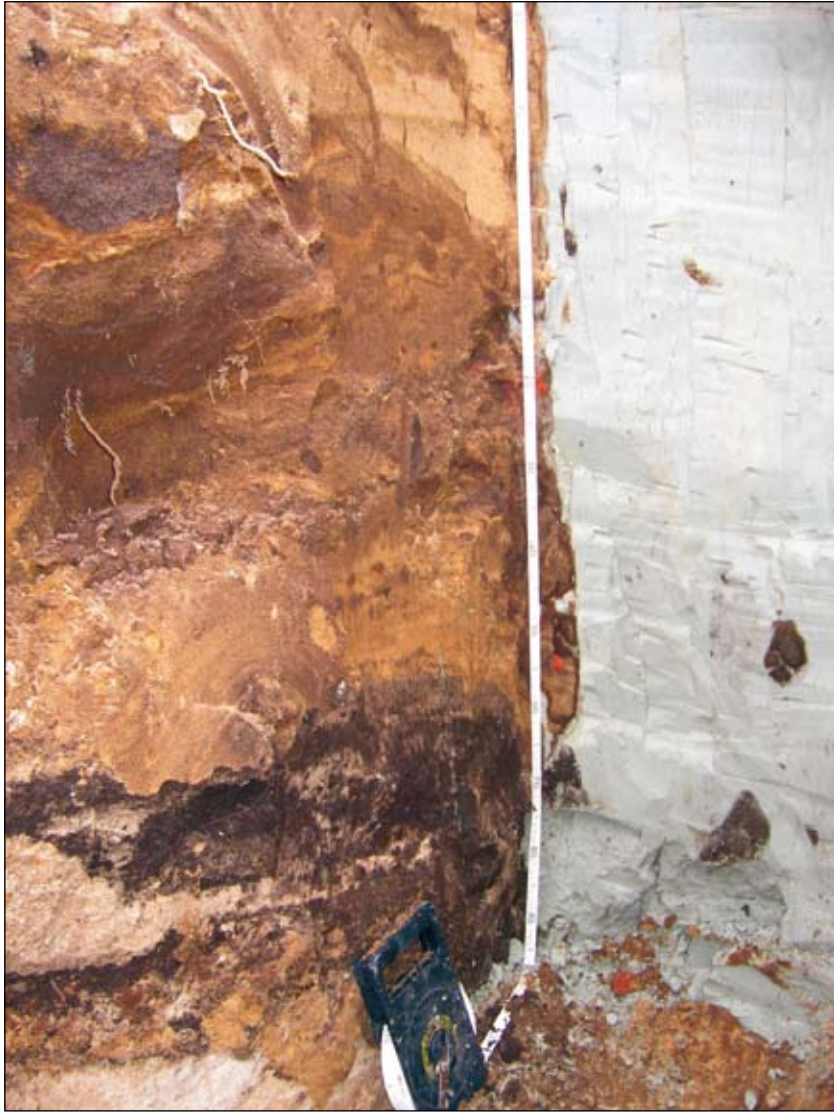
Photo 22. Boundary between the cut-off wall and the soils forming the embankment

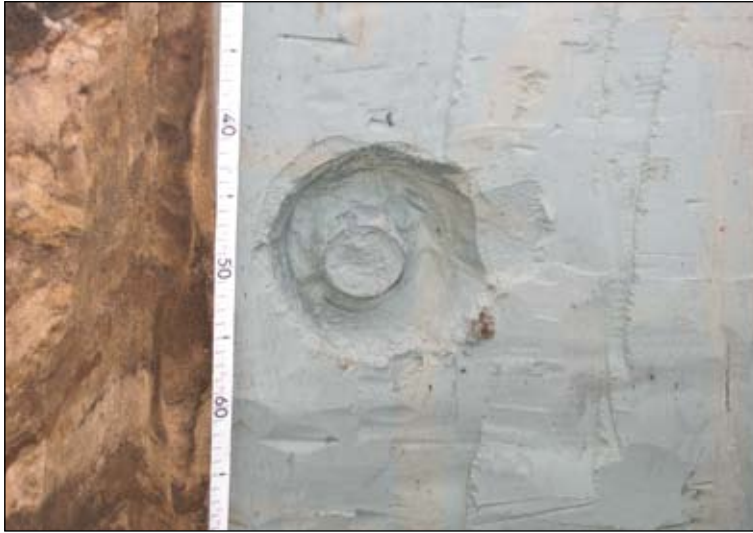
Photo 23. Open pit No. 4 – exposed cross-section through the bank on the contact point with the cut-off wall constructed with use of vibration injection technology from grout based on clay Belchatów

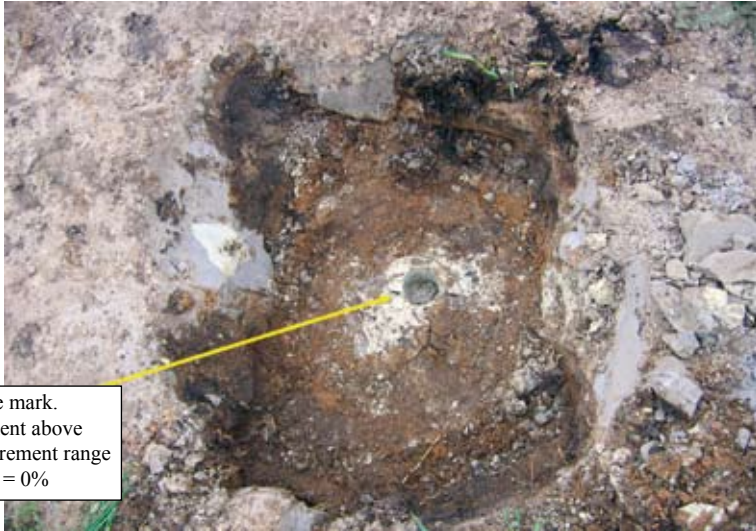
Photo 24. Mark of the CBRd plunge on the surface of the cut-off wall constructed with use of vibration injection technology from inject based on clay Belchatów

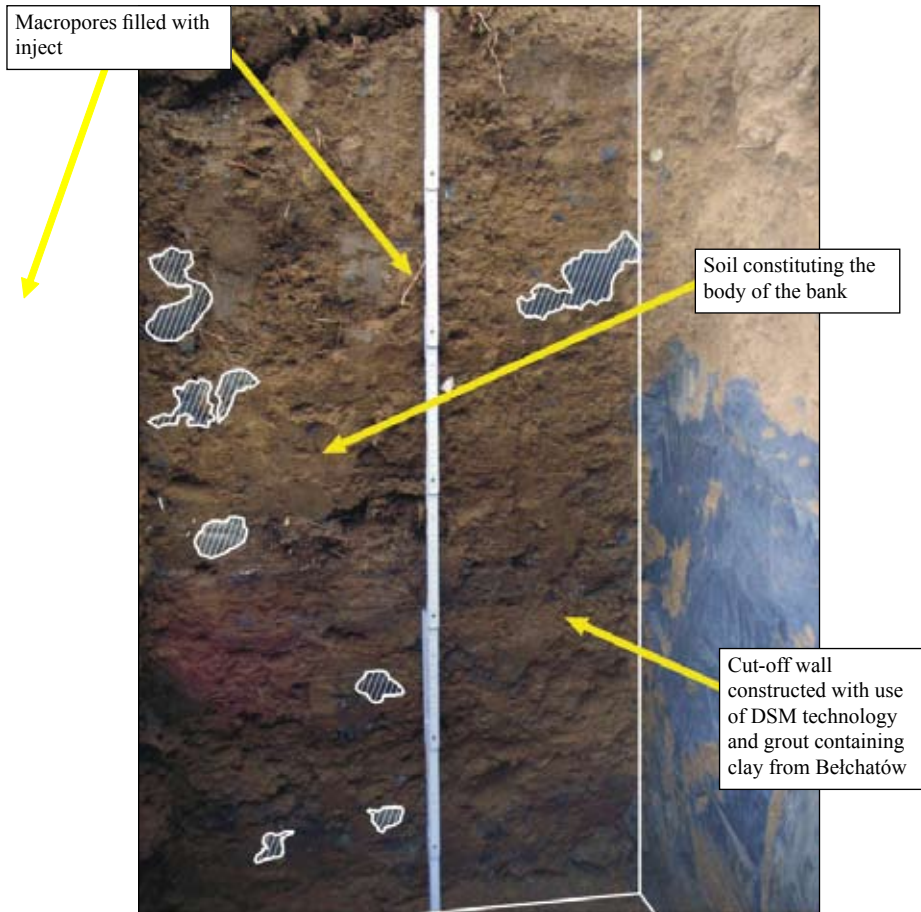
Photo 25. Exposed wall of the soil in the body of the bank. Places, where inject filled the macropores of soil outside of the zone of the cut-off wall are marked

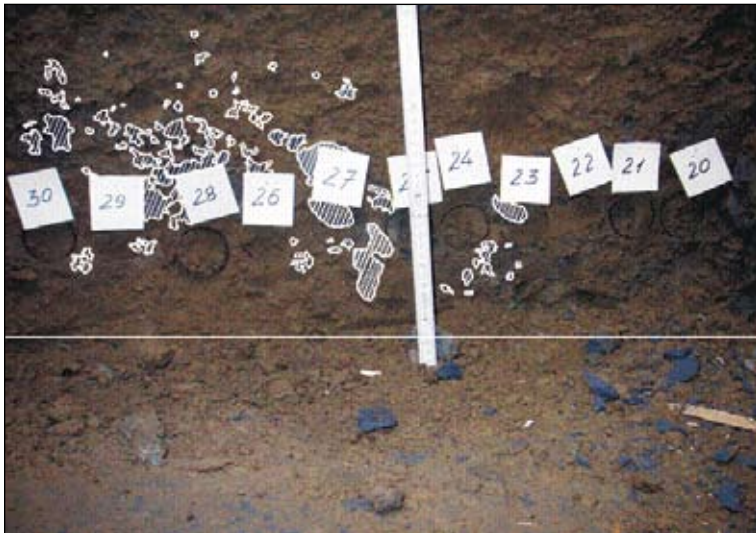
Photo 27. Level 1.25 m below the crown of the bank – marked locations where macro pores were filled with inject

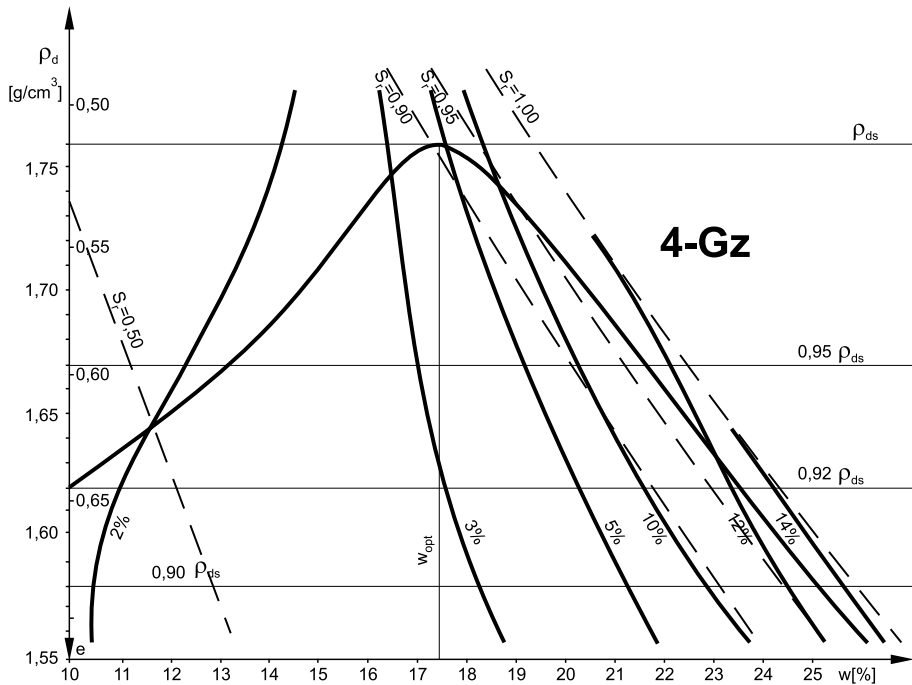
Fig. 16. Isolines of shrinkage of loam from the valley of Odra [Orzeszyna 1990]
