TECHNICAL NOTE

EXAMPLE OF THE APPLICATION OF JET GROUTING TO THE NEUTRALISATION OF GEOTECHNICAL HAZARD IN SHAFT STRUCTURES

PIOTR DYBEŁ, DANIEL WAŁACH, JUSTYNA JASKOWSKA-LEMAŃSKA

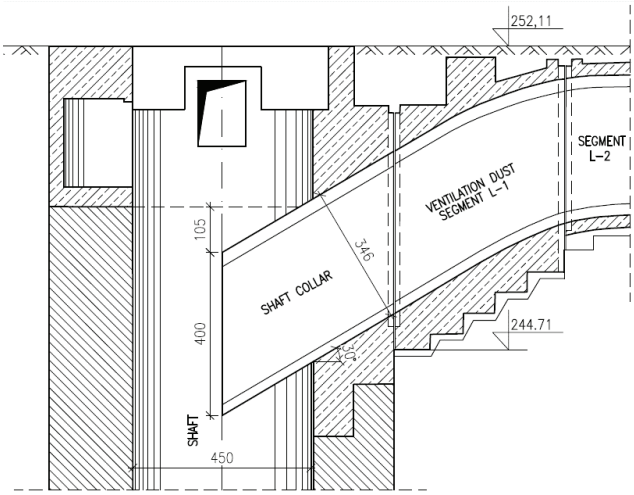
Fig. 1. Longitudinal section drawing of the ventilation duct and shaft collar

movement joints. Due to the high water content in the local soil and its low physical and mechanical properties, the ventilation duct was constructed using the ground freezing method. The segments of the ventilation duct are made of reinforced concrete.

After the dislocation of the ventilation duct, a site inspection was performed, including the immediate area around the shaft, ventilation duct and the shaft top building. As a result of the displacement of the first segment of the ventilation duct in relation to the shaft collar, a possibility of additional loads affecting the shaft lining was found. These loads were not taken into account in the initial design. The research conducted by the authors included the analysis of the current condition as well as control static and strength calculations helped to assess the real hazard to shaft structures and infrastructure. It was shown that further subsidence of the ventilation duct may lead to damaging the shaft structures. Immediate protection of the ventilation duct against further subsidence was recommended [2].

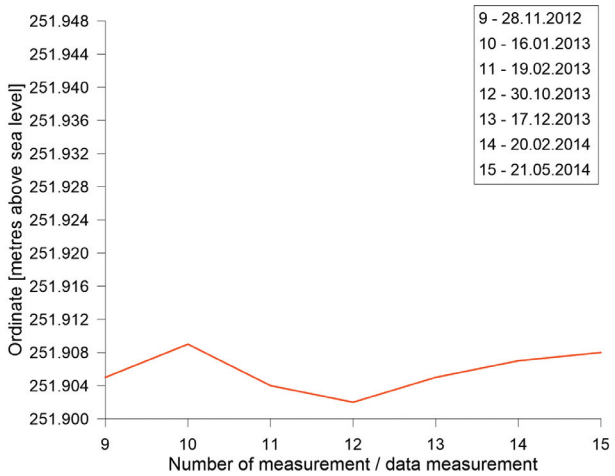
Continuous surveying monitoring enabled the determination of the current dislocations of measurement points as well as the assessment of the effectiveness of foundation soil reinforcement works. The results of the measurements show that due to the remedial measures provided, the dislocations have stabilised and do not pose further threat to shaft structures. Figure 5 shows an example diagram of vertical dislocations registered at the measurement point located in immediate proximity of the first segment of

the ventilation duct. Similar dependences were found for the remaining measurement points.

Fig. 5. Measurement point levels in the L-1 segment of the ventilation duct after the reinforcement of the foundation soil
