The Consequences of Non-Uniform Founding of Concrete Tank in Weak Wet Subsoil

Abstract: The article presents problem of non-uniform foundation of structures in weak wet subsoil. The problem is illustrated with the case study of two-chamber-reinforced concrete water tank constructed in 1920s of 20th century, which cracked during construction. Under part of foundation, where the peat was found, the concrete piles were introduced.

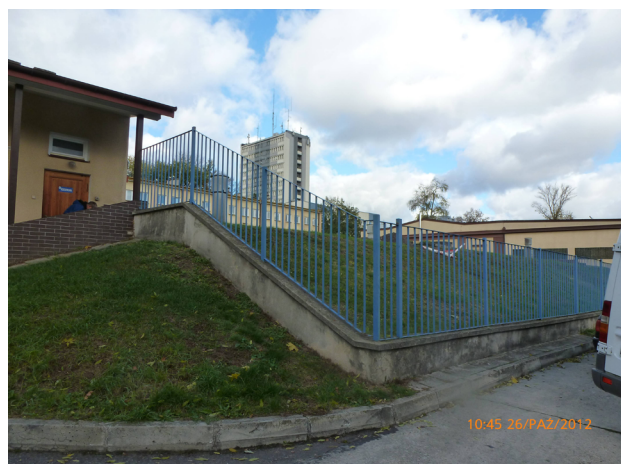
Figure 1: The outside view of water tank.

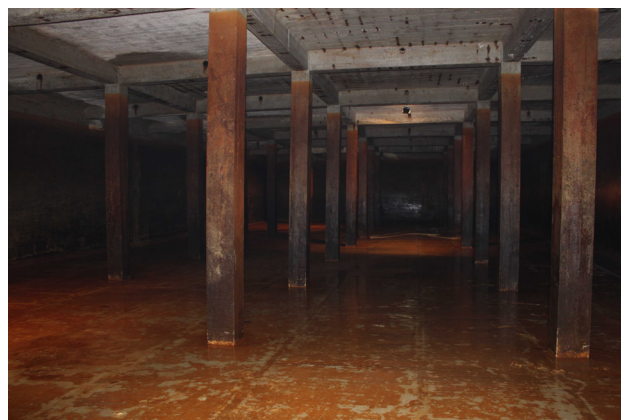
Figure 2: The interior of concrete tank.

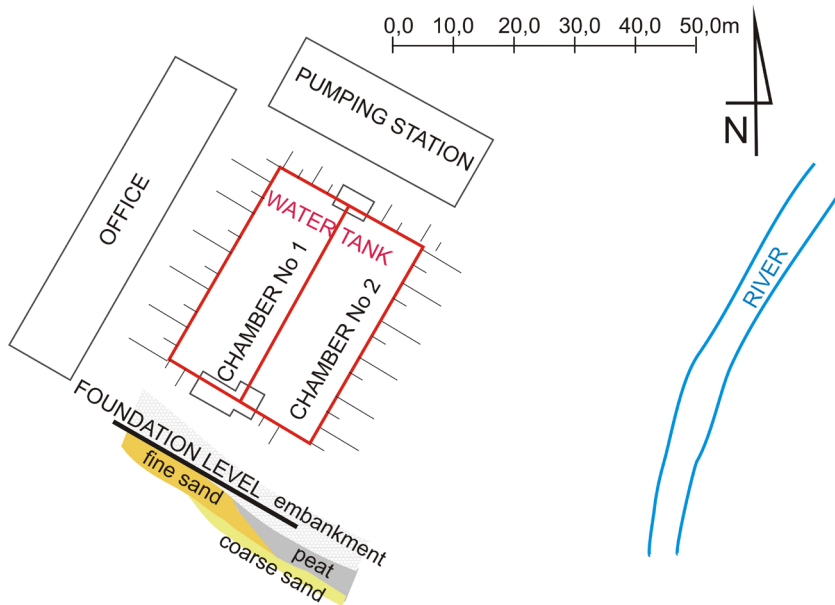
Figure 3: The location of water tank in relation to the river and the buildings of water supply plant with the scheme of geotechnical layers.

Geotechnical tests show that in this region (Fig. 3), the upper subsoil layer of up to 5-m thick is an embankment consisted of humus dust, sand and stones. Under the embankment in the west part of tank, the moderately compacted fine sand is deposited, and under it, there is moderately compacted sand of bigger particles. This part of tank is founded on the upper surface of sand. Towards the river and towards east direction, between embankment and sand, the mud and peat (wet but not highly plastic) are present. In the town archives, there is an information dating from the construction times [8] that pumping station adjacent in this side to the tank is founded in the water logged peat on the concrete foundations supported on the 340 timber piles.

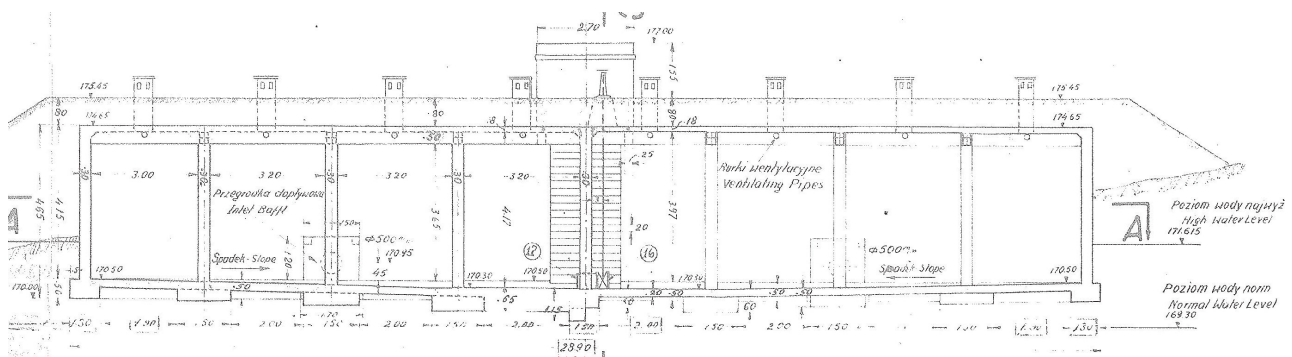
Figure 4: The original design drawing of tank cross section [1].

The tank is covered by cast in situ concrete roof slab of square segments, supported by crossing beams, which are rested on the columns and outer and inner walls. Reinforced concrete cast in situ walls are fixed in the continuous foundation and columns are fixed in the spot foundations. These foundations are connected monolithically with bottom slab. The level of bottom slab down surface is higher than that of down surface of spot and continuous foundations, whereas their upper surface is on the same level (Fig. 4).

In the design cross section (Fig. 4), underground water level is not provided. There is only an information that normal level of the river equals to 169.30 m above sea level (which is lower than foundation), and maximum river level equals to 171.615 m above sea level (which is higher than foundation). After river regulation in 1970s, fluctuations of river level were diminished.

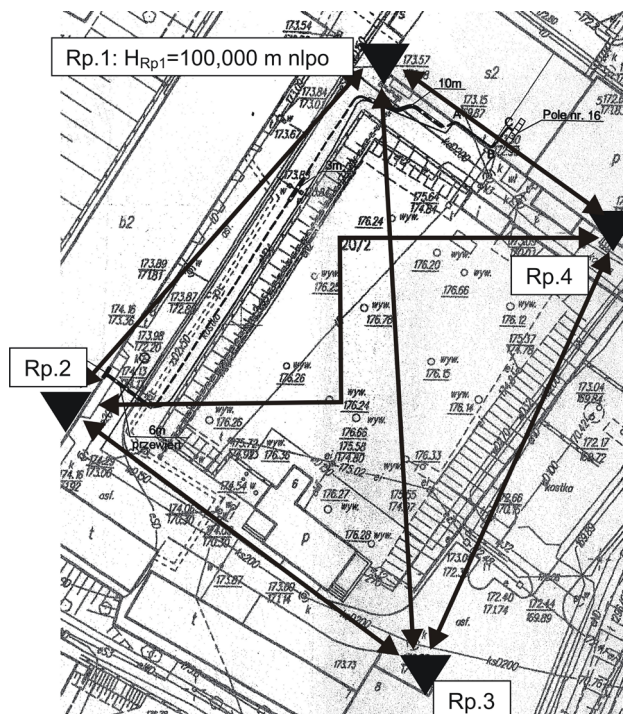
Moreover, the control levelling network based on benchmarks fixed to the walls of surrounding buildings was set up (Fig. 13). Vertical displacement was calculated in the local height system ($H_{RP1} = 100.000$ m), as relative displacement between the first and next elevations in several surveying epochs [6]. Elevations of each controlled point were determined by direct levelling based on the benchmarks of confirmed stability. The precise digital level instrument named Trimble DiNi was used. In each surveying epochs, benchmarks No. 1 and No. 2 only were designated as stable ones.

Figure 13: The benchmark control levelling network.
