Conservation studies of the ruins of the Gothic Kazimierz castle (2nd half of the 14th century) in Koło (Gozdów)

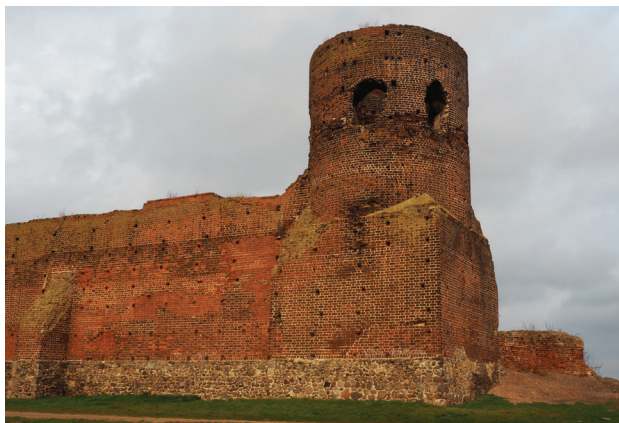
Fig. 1. Castle in Koło. A tower and a fragment of the western wall (photo by K. Witkowska, 2020)
