Anna Orchowska-Smolińska*, Anna Kriegseisen,
Jakub Szczepański*****

Interdisciplinary research as a form of monument protection and preparation for the investment process on the example of the former Gdańsk Shipyard complex

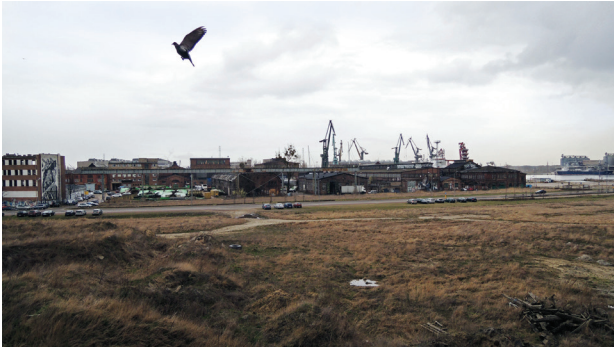
Fig. 1. View of a fragment of the area of the former Gdańsk Shipyard in 2019. Until the beginning of the 21st century, the area in the foreground of the photo was filled with shipyard halls constituting one of the main production lines of hull construction. Currently (2022), investment works related to the construction of multi-family buildings are underway there (photo by A. Orchowska-Smolińska)

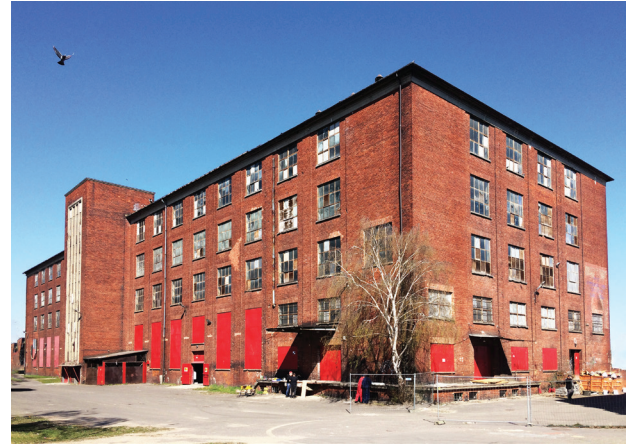
Fig. 5. The body of the Main Warehouse (89A), so-called the U-Boat Hall, in the view from the south-east, 2019 (before the start of conservation works) (photo by A. Orchowska-Smolińska)

An example of a detailed-scale study was the research prepared for the building of the former Main Warehouse (89A), the so-called U-Boat Hall¹⁰. Based on that research, *Wytyczne konserwatorskie rewaloryzacji budynku dawnego Magazynu Głównego 89A, tzw. Hali U-Bootów, na terenie dawnej Stoczni Gdańskiej* [The Conservation Guidelines for the revalorization of the building of the former Main Warehouse 89A, the so-called The U-Boat Hall, on the site of the former Gdańsk Shipyard] [22] were elaborated. The aim of architectural and conservation research was to determine the actions and solutions necessary to restore the historical building (Fig. 5). The research was undertaken at the stage preceding the design development of the building for adaptation to cultural, commercial and residential functions. It was meant to point out any works that could cause damage to the historic structure and indicate the way to carry out the conservatory works to maximize the value of historic architecture. The study included: (1) a historical study of the facility, (2) a detailed architectural and conservation description with photographic documentation, (3) a program of conservation

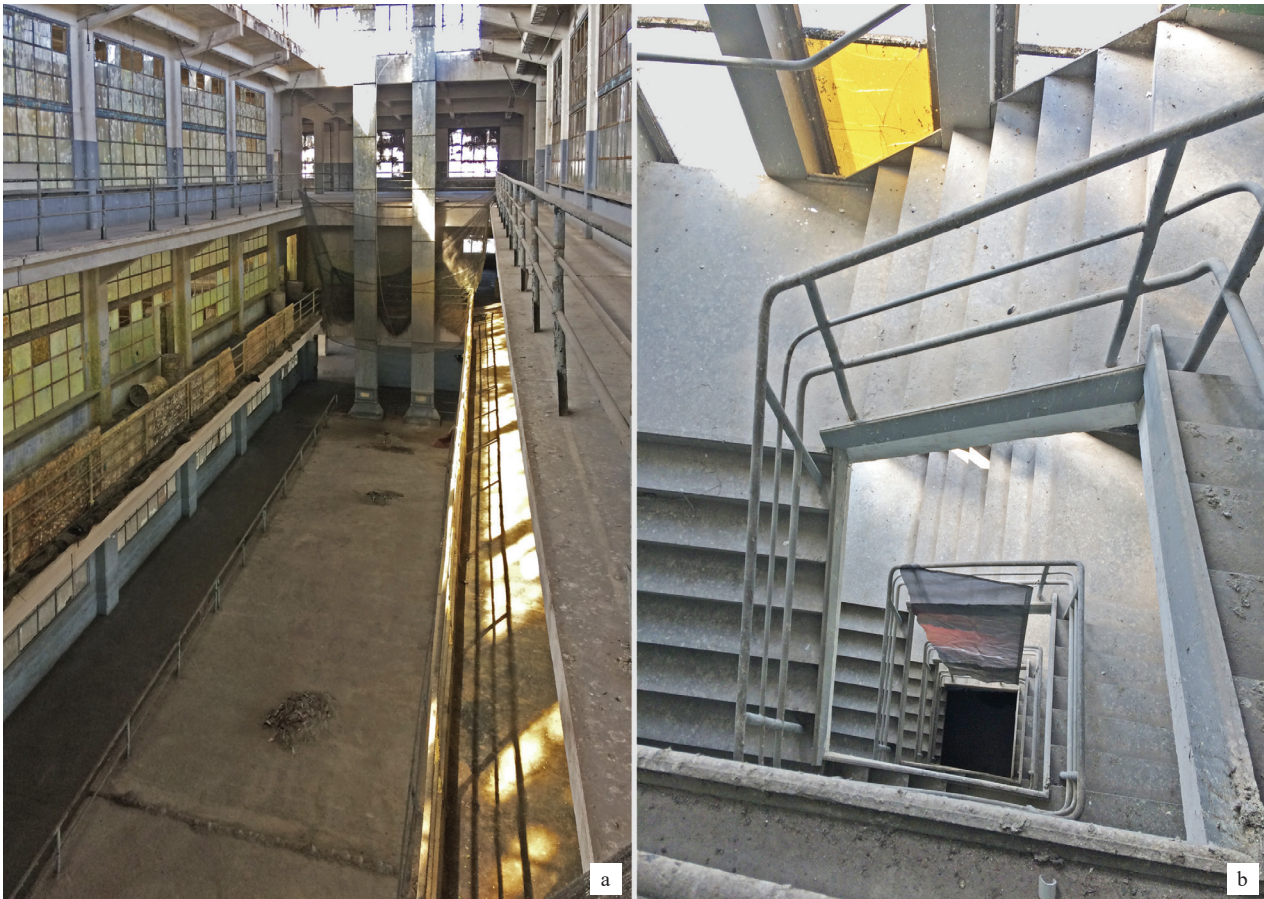
Fig. 6. Interiors of the Main Warehouse (89A), so-called the U-Boat Hall, 2019 (before the start of conservation works):
 a) repetitive floor of the building (6th floor) – top view of one of the atriums,
 b) the staircase – stairs in all three staircases – double L-shaped stairs, monolithic, reinforced concrete structure
 (photo by A. Orchowska-Smolińska)

buildings, these analyzes are performed using methods that would apply to historically more complex buildings (Fig. 6). The reason is the assumption made for the entire complex that the primary phase is not overriding, and the adaptations, repairs, and maintenance are to be carried out with respect to all layers by 1989 or even 1996¹¹. As a result of this assumption, not only a detailed analysis of bricks, joints, plasters, and artificial stone used for the façade decoration was carried out, but also such elements as metal gates, glazing of industrial window joinery, primary and subsequent colours of individual elements.
