## REDUCTION OF DERIVATIVE PIPELINE EFFORT IN WATER TURBINE

**Abstract:** The article presents an approach to evaluate and reduce the effort of the derivative pipeline in a water turbine of a hydroelectric power station in its vulnerable spots. Potential places of the biggest effort of the structure, as well as the coefficient of displacement and safety factor related to them were identified using FEM numerical method. Pipeline reinforcement was designed and made based on FEM analysis and non-destructive tests.

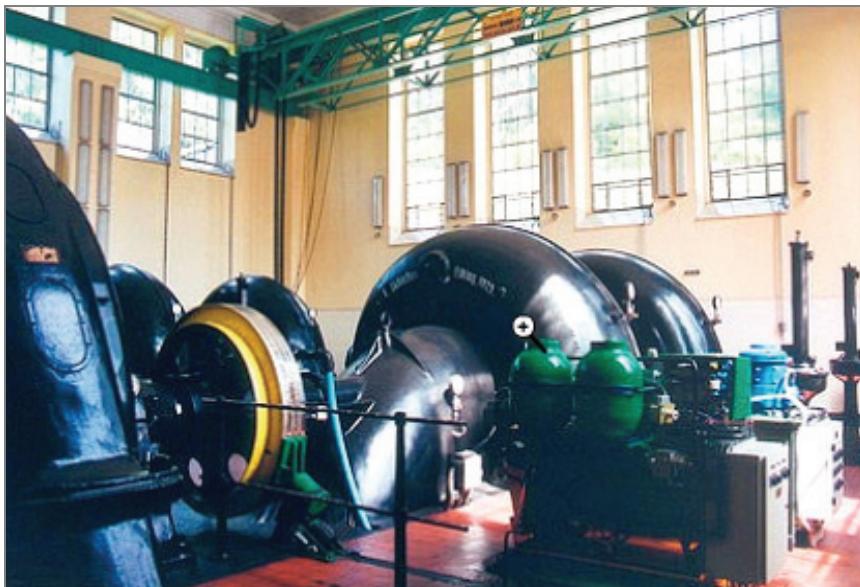
Fig. 1. View of water turbine generators in Łapino.  
Source: <http://energa-hydro.pl/2,26,0,Galeria-Lapino.html>

A general view of the water turbine generators of the hydroelectric station discussed is presented in Fig. 1. Figure 2 shows the view of water inlet pipelines between the turbo generators. A draft with selected dimensions is shown in Fig. 3.

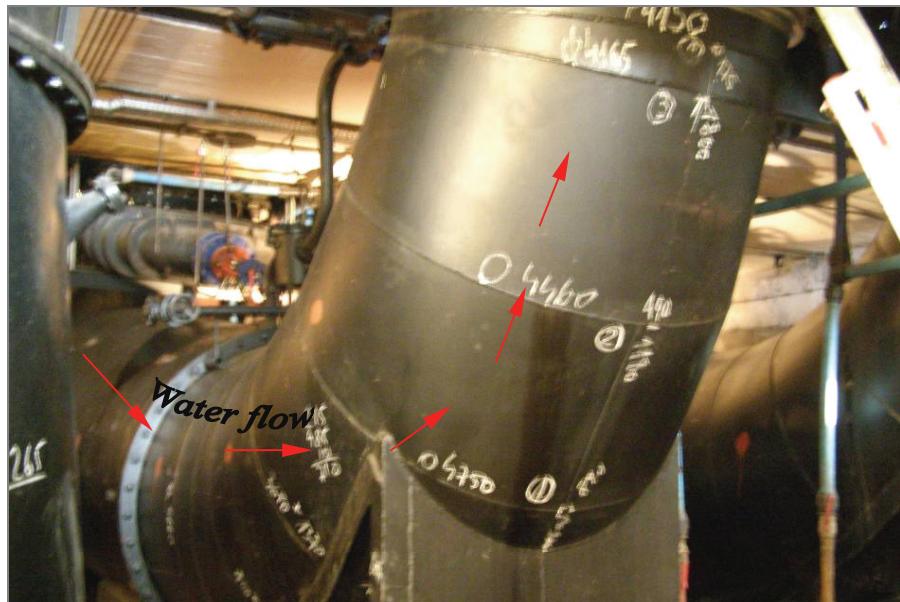
Rys. 2. View of water inlet pipelines.

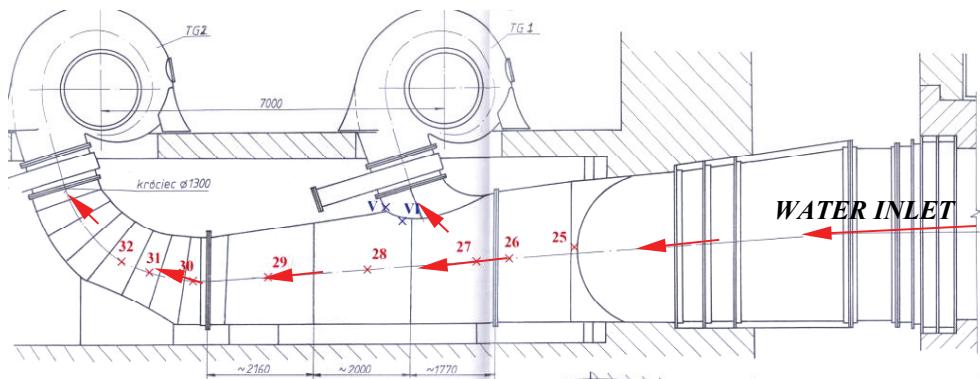
Fig. 3. Longitudinal section through the inlet pipe.

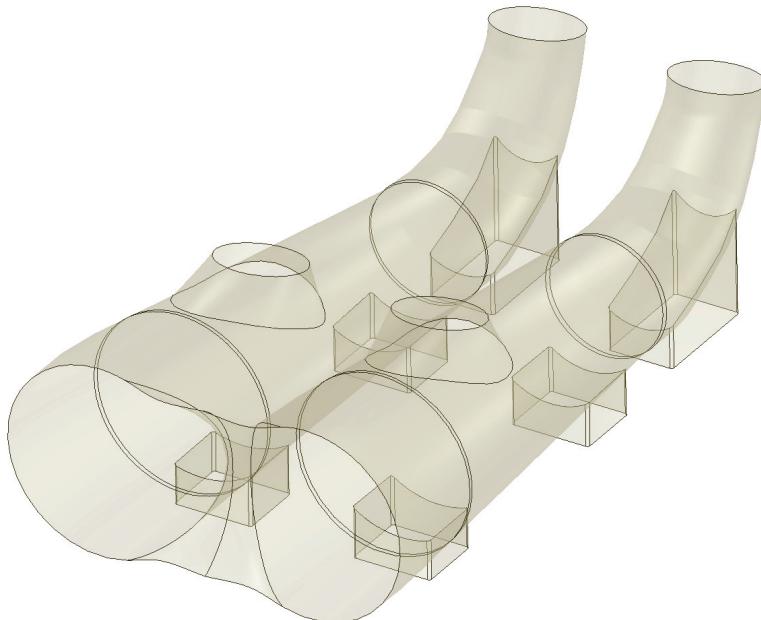
A CAD computer model of the object examined was created based on available data (Fig. 4). The model was used for a numerical analysis to assess the structure's level of effort.

The thickness of the pipeline wall is 8 mm. The geometric model and calculations were made for the shells.

Fig. 4. Surface model of the pipeline.

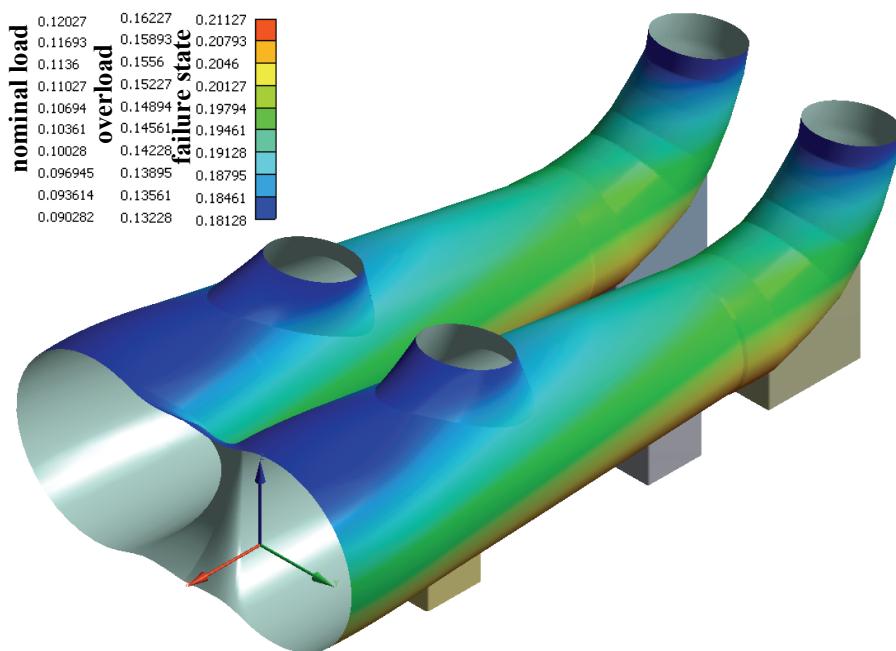
On the basis of the operating data the nominal hydrostatic load was set at 0.12 MPa, equivalent to water gauge of 10.5 m which occurs as a difference of water levels between the influent water and the bottom of the pipeline. For dynamic load states, as recommended, an overload factor of 1.4 was taken (start) – then the value of pressure loading the structure is 0.16 MPa. The value of 0.16 MPa matches the pressure that arises in reality when the turbo generator is launched [1]. The stresses have to exceed the ultimate strength of the material in failure state. A 0.21 MPa pressure meets this requirement.

Hydrostatic pressure distribution shown in Fig. 5 remains the same. Appropriate colour ranges correspond to calculated variants, which are provided with comments (nominal load, overload, failure state).

Fig. 5. Distribution of hydrostatic pressure in pipeline.

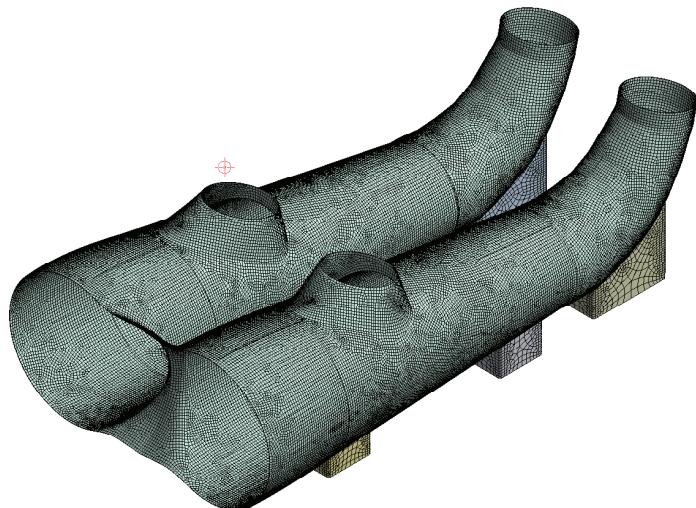
Finite element mesh is made out of shell finite elements with six degrees of freedom for each of the eight nodes per element (Fig. 6). The number of nodes in this range was 221231, with 73388 elements.

Fig. 6. Selected finite element mesh.  
Source: prepared by the authors

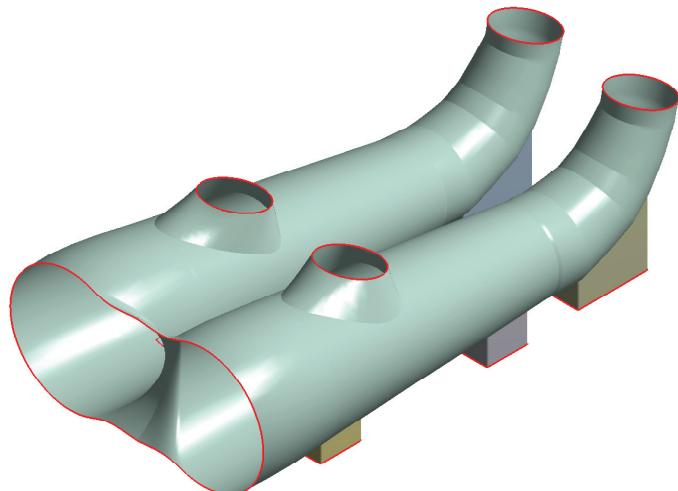
Red (Fig. 7) is used to mark the edges (nodes) whose degrees of freedom were eliminated. This way the places where the structure cannot displace were simulated. In general, these are the places where the structure is fixed to foundations, intake walls or where inlet flanges are fixed to the base of the turbine.

Fig. 7. Support of the model studied.  
Source: prepared by the authors

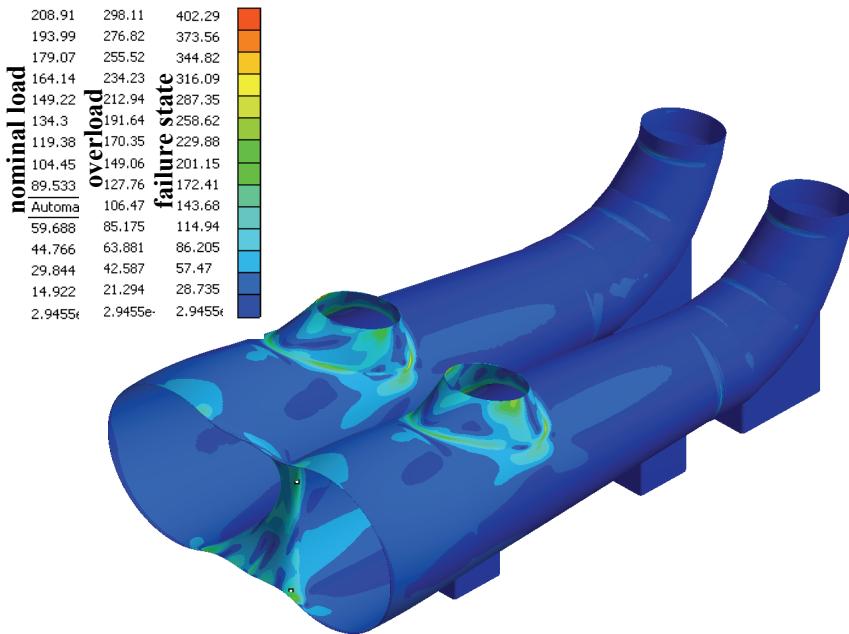
Figures 8 to 10 present the results of calculations as mapping of functions. Stresses reduced in accordance with Huber's hypothesis are shown in Fig. 8. The colour ranges represent, as before, nominal load, overload and failure state load, respectively. The value of reduced stress at its concentration points amounts to 80–150 MPa with nominal load. The maximum value of stress of 208 MPa (red colour in the range) may be ignored because this is the value for the point on the edge and its degrees of freedom were eliminated, thus it is the result of an approximation error of a finite element shape function. Stresses in notches under pressure of 0.16 MPa assume the value of 220 MPa and are lower than yield strength.

Fig. 8. Huber's reduced stress – colour range for 0.12, 0.16 and 0.21 MPa, respectively.

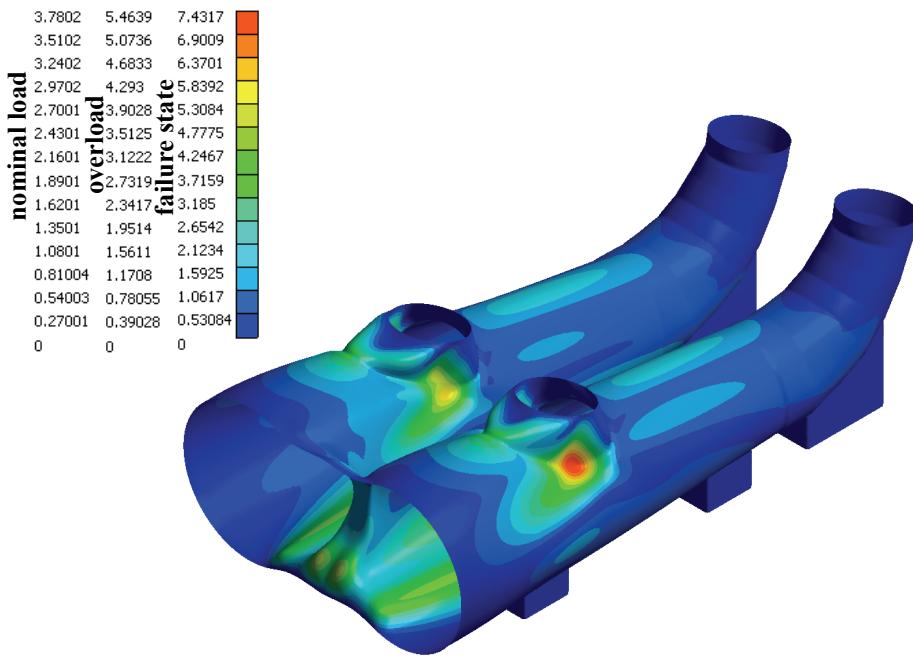
Figure 9 illustrates resultant displacement. In nominal load state displacement value was equal to 3.7 mm; however, in overload state it was equal to 5.4 mm. The value of displacement in failure state was 7.4 mm. The last one does not make physical sense since the material exceeded its ultimate strength.

Fig. 9. Failure displacement (values in mm) – colour range for 0.12, 0.16 and 0.21 MPa, respectively.  
Source: prepared by the authors

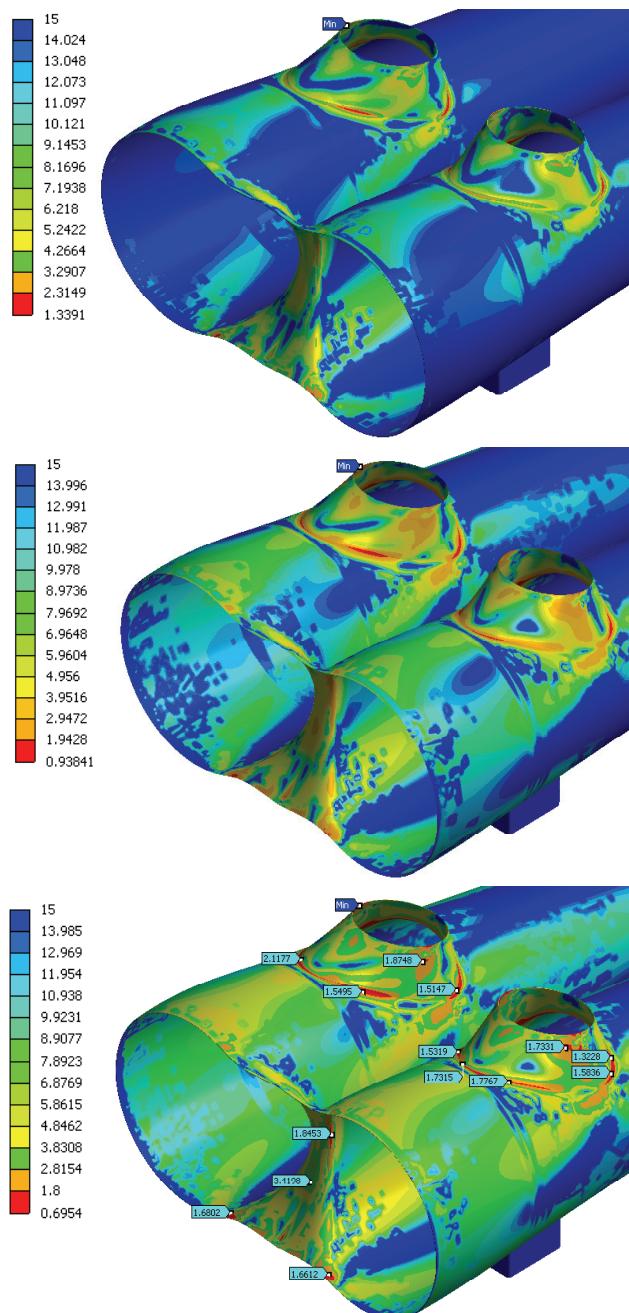
Figure 10 shows the distribution of safety factors with loads of 0.12, 0.16 and 0.21, respectively. The distribution of safety factors is different, therefore a separate analysis of each coefficient is necessary. The minimum value for nominal load is: 1.4, for overload – 0.93 and the minimum value for failure state is 0.69. When the value of the safety factor is below 1.0, the yield strength of the material has been exceeded.

The obtained results of calculations allowed us to assess the distribution of stress in the pipeline examined. From the point of view of the ultimate strength of the structure the effort of the pipeline is a disadvantage. There is a high concentration of stress in the branch of the main line of the pipeline. A high level of stress concentration may also be found in the area where the coatings of the pipeline and the inlet connection pipe of the turbine are joined.

Fig. 10. Safety factors for 0.12, 0.16 and 0.21 MPa, respectively.

The tensile strength of the material was not exceeded under nominal pressure of 0.12 MPa, yet it has been exceeded in the other cases. The level of stress where it piles up has to be reduced, for example, with locally placed reinforcement.

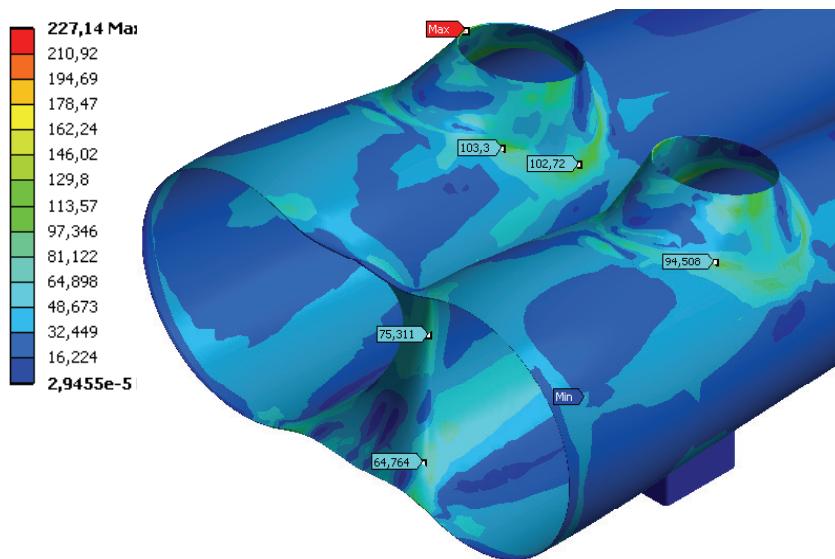
The previous results have revealed the necessity for the reinforcement of the branch and the inlet connection pipe. Initial simulation of the reinforcement (Fig. 11) has shown that an increase on the wall thickness of the branch and the connection pipes reduces the stress by half and therefore lowers the stress much under the tensile strength even in failure state under a 0.21 MPa pressure.

Fig. 11. Reduced stress for 0.21 MPa and an increase in local thickness of the branch and inlet pipes.  
Source: prepared by the authors

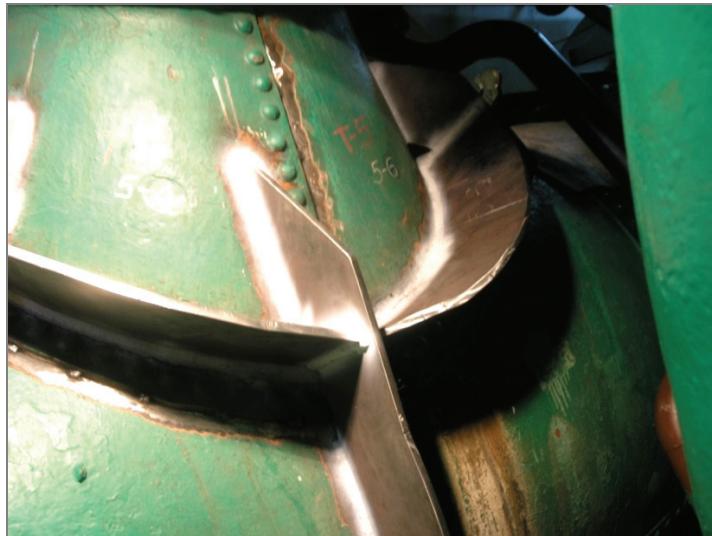
Fig. 12. Similar solutions.  
Source: prepared by the authors

Using the knowledge concerning existing solutions (Fig. 12) designed by the authors, the computer simulation was used again and multiple alternatives were examined to match an optimal way to reinforce the pipeline. The calculations were carried out for the pressure of 0.21 MPa at failure state until the achieved value of the reduced stress was below the yield strength.

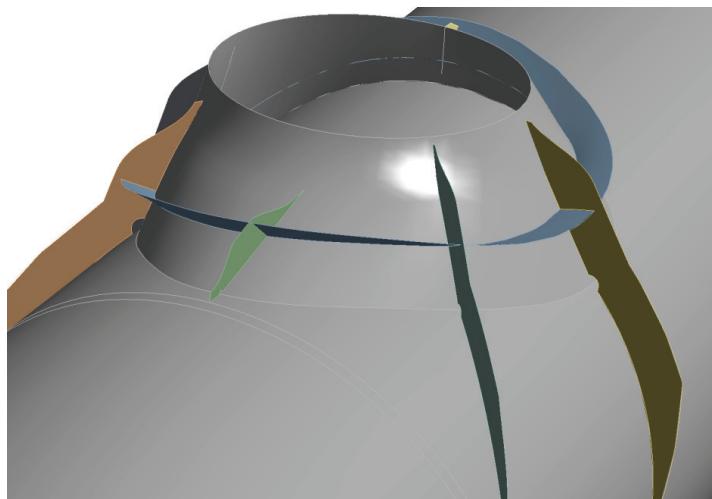
Fig. 13. Optimum location and shape of webs and bracing ring.  
Source: prepared by the authors

Finally, bracing with 6 webs and a ring was selected using 6 mm thick plates (Fig. 13). The location of the webs symmetrically to longitudinal section plane where the biggest distortion is observed was considered the most effective. Cladding with a 3 mm plate was chosen for branch reinforcement.

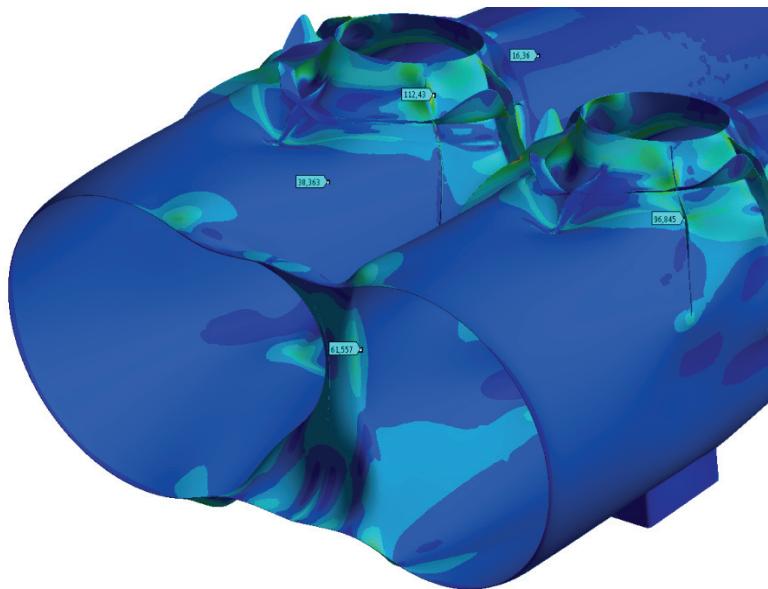
Fig. 14. Reduced stress in the pipeline with reinforcement under 0.21 MPa pressure below yield strength of the material  $Re = 280$  MPa (rescaled view).

Attention should be paid to the shape of the web edge. The webs are not supposed to be stripes of plate attached at a right angle, but there should be an arc which gradually closes the width of the web to zero, which eliminates the concentration of stress [4] at the edge, i.e., at the point of contact between the web and the pipeline wall. It is essential to make a relief notch in webs located in the areas where the webs contact welded joint of the connection pipe and the pipeline.

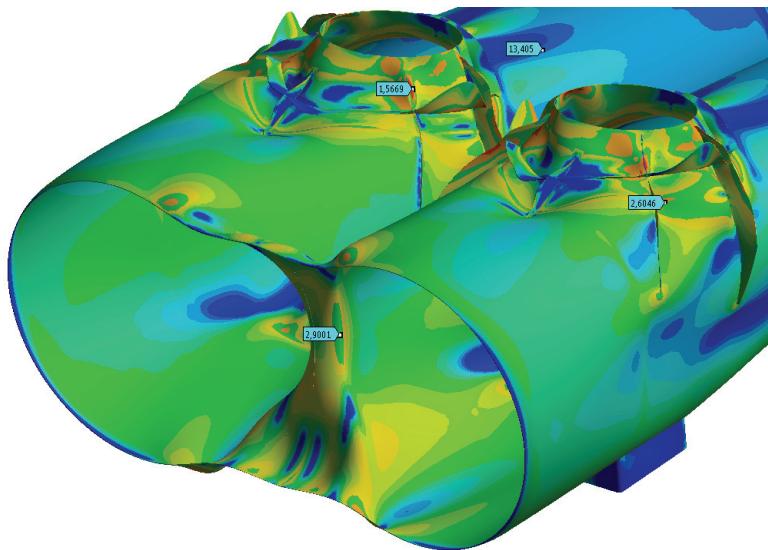
Fig. 15. Safety factor in the pipeline with reinforcement under 0.21 MPa pressure in the range above 1.5 (rescaled view).

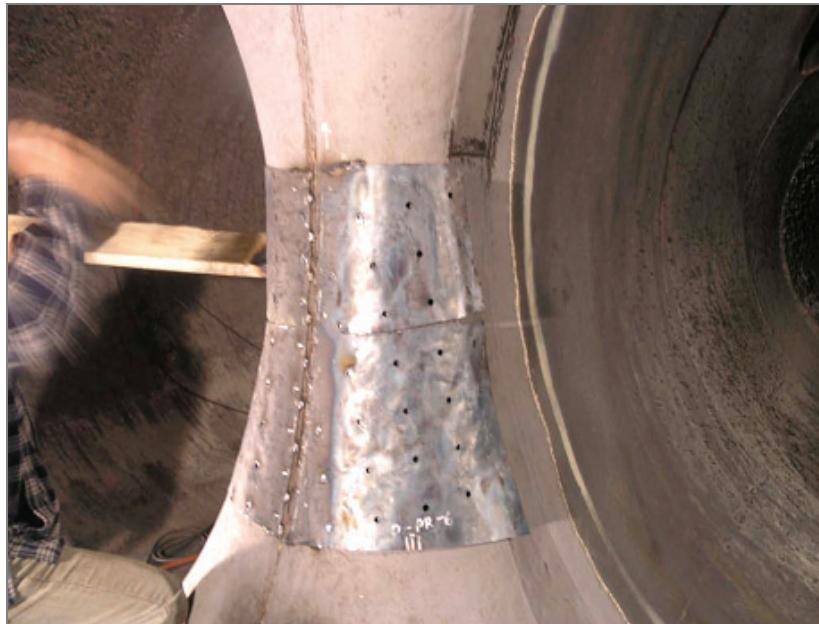
Fig. 16. Quadrangular components of the reinforcement in the process of tacking along centerline of the branch.

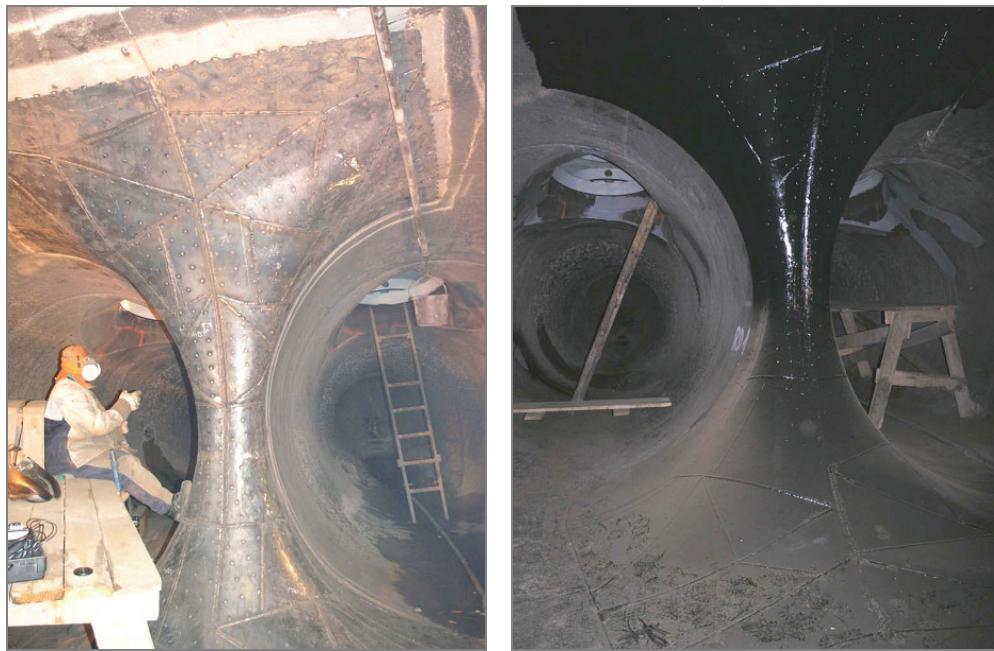
Fig. 17. Structure welding of the reinforcement components to the coating of the pipeline branch and the completed painted platering of the pipeline branch.

The next stage comprised of depositing circumferential fillet welds which joined three components simultaneously: adjoining edges of reinforcement components with pipeline coating, MAG welding process and 1.0 mm diameter solid wire with Ar + CO<sub>2</sub> gas shield were used.

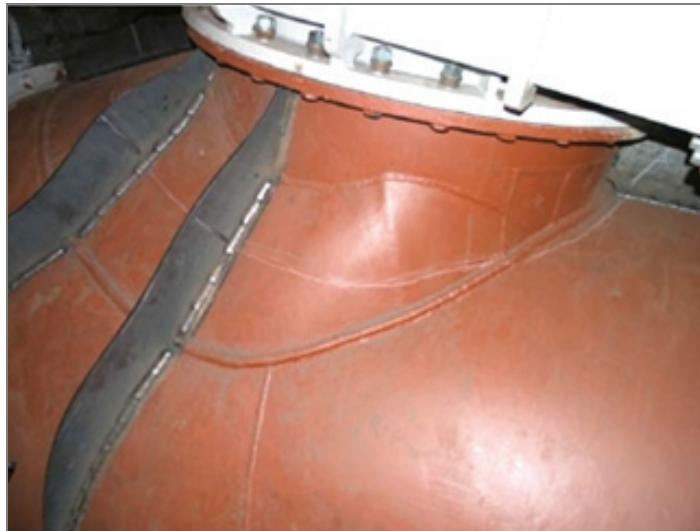
Fig. 18. Assembly of webs to the inlet pipe and the pipeline coating.

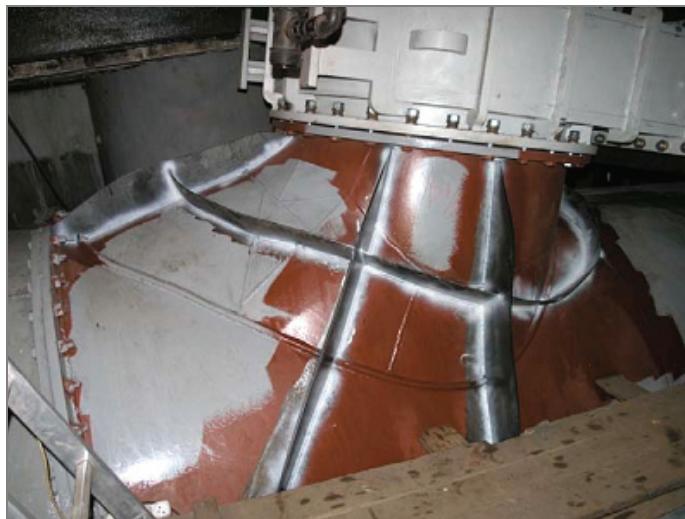
In accordance with the experimental procedure visual tests (VT) and magnaflux tests (MT) were conducted to examine the fillet welds (Fig. 19). Quality level C, as defined in PN ISO 5817 standard, was presumed in the study. Test results have shown that the quality of the welds fits level B, which is higher than the presumed level.

Fig. 19. Bracing webs with reinforcement ring on the inlet pipe.
